Erosion-Corrosion Behavior and Failure Analysis of Offshore Steel Tubular Joint

E. Mahdi^{}, A. Rauf, S. Ghani, A. El-Noamany and A. Pakari*

Received: 10 March 2013 / Accepted: 30 March 2013 / Published: 1 May 2013

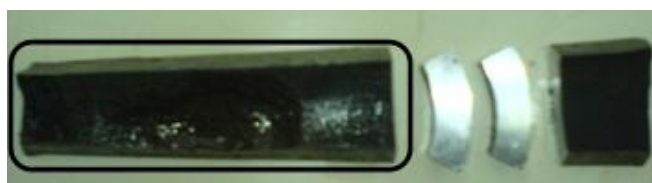
Figure 2. The part with the location of interest (first from the left)

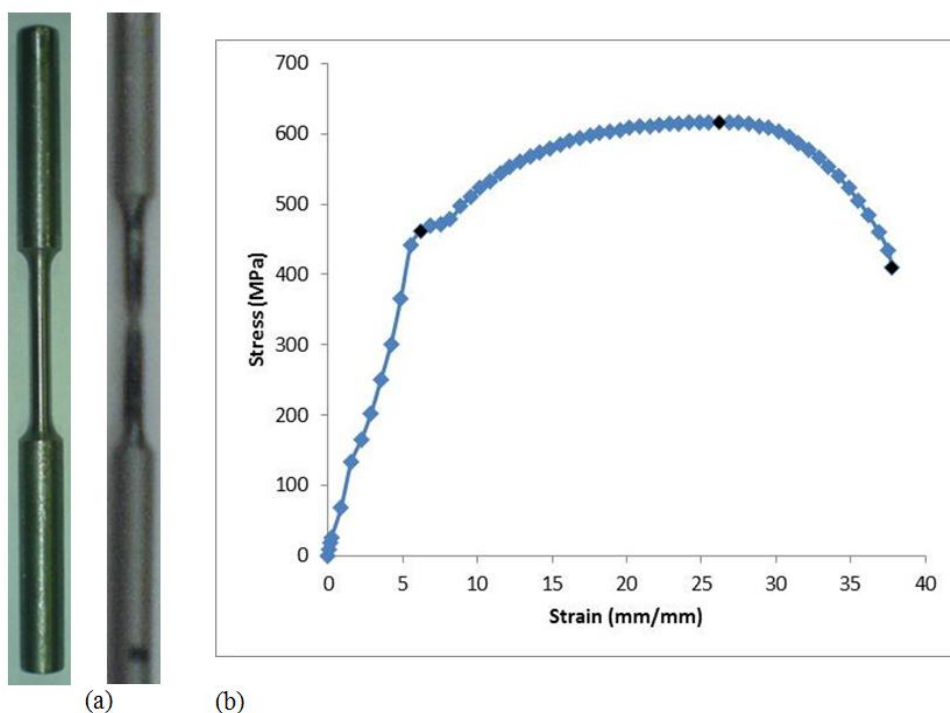
Figure 3. (a) Original and deformed specimens (b) Stress-Strain curve of the T-joint material

The results about tensile test are presented in Figure 3b. The ultimate tensile strength, fracture strength and the yield strength were calculated to be 628.15 (± 5.73) MPa, 426.02 (± 16.01) MPa and 473.85 (± 5.95) MPa, respectively. Mechanical properties were calculated and given in Table 1 along with the range for these properties obtained from ref. 15. The tested material is proven to be a ductile material since necking was observed, cup and cone fracture surfaces were noted, and because its stress-strain behavior resembles that of ductile materials. The values of the properties calculated for this material lie within the range of the properties of low carbon steels. This verifies the initial guess; however, it is still early to come to a conclusion. To accurately identify the material, the microstructure examination and chemical analysis has been carried out and will be highlighted in next section.

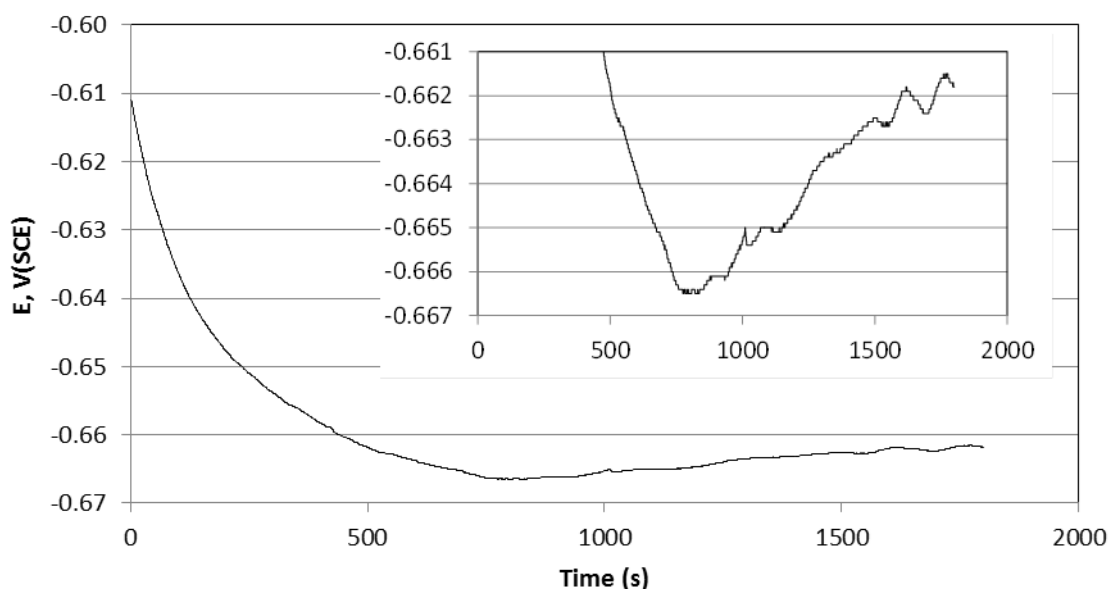
Figure 5. The OCP measured for the T-joint material in 0.6 M NaCl. Small pits were observed at the end of the test.

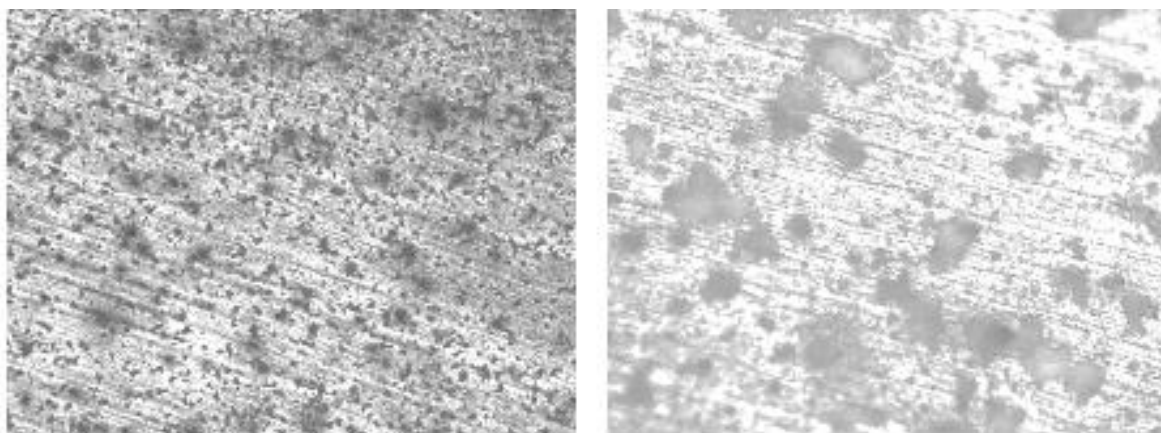
Figure 6. After measuring the OCP for the T-joint material in 0.6 M NaCl, the surface of the metal is shown at 500X and 1000X magnifications.

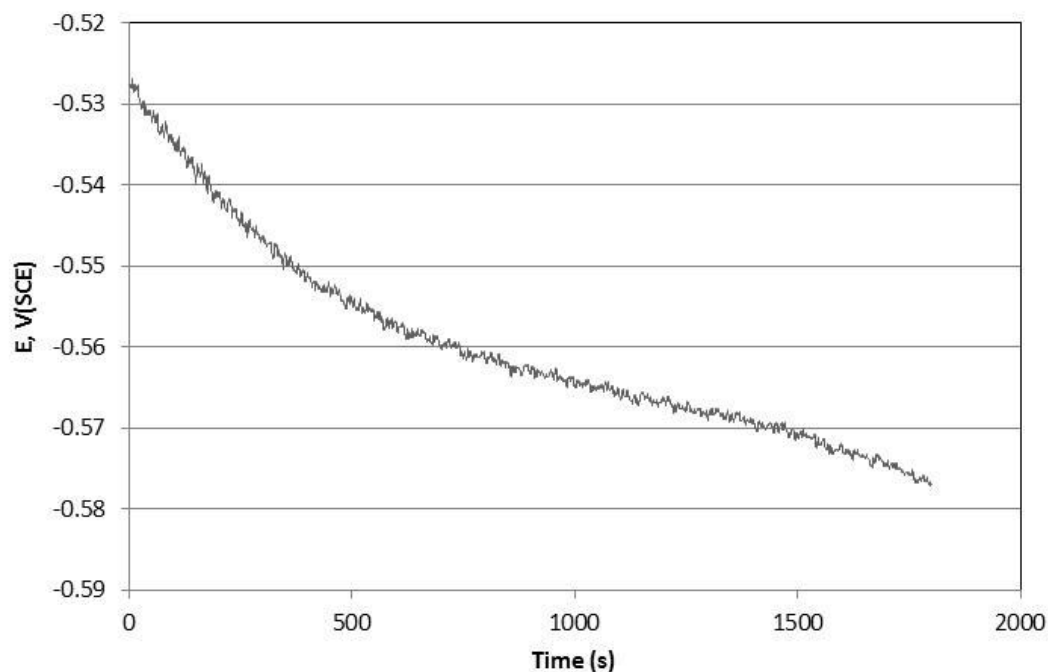
The OCP (Figure 7) turned noisier with higher fluctuations when tested with electrolyte erosion. Pitting corrosion (Figure 8) was observed after 30 min test with electrolyte erosion.

Figure 7. In 0.6 M NaCl, the erosion speed of 3.6 m/s was used to measure the OCP for T-joint sample. Big patches of uniform corrosion and many pits were observed.

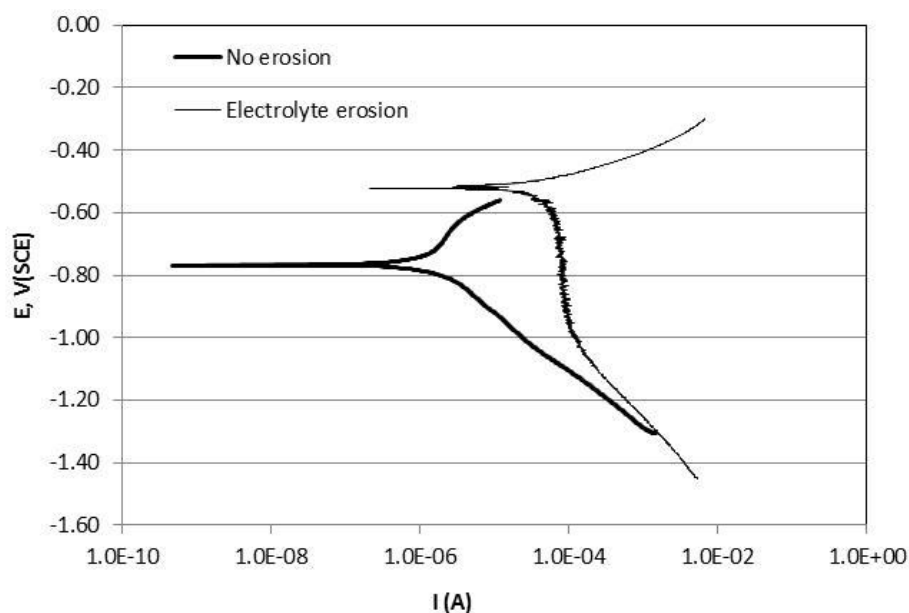
During polarization scan (Figure 9) in 0.6 M NaCl, the material sample taken from T-joint demonstrated a reasonable region of passivation. The corrosion and pitting potentials were observed at -768 mV and -630 mV vs. SCE. After finishing the scan, the surface of the metal was observed under optical microscope at 500X magnification and clear pits (Figure 10) were observed.

Figure 9. Pitting was observed after potentiodynamic polarization in 0.6 M NaCl without erosion for T-joint material. Corrosion and pitting potentials were found to be -768 mV and -630 mV vs. SCE.

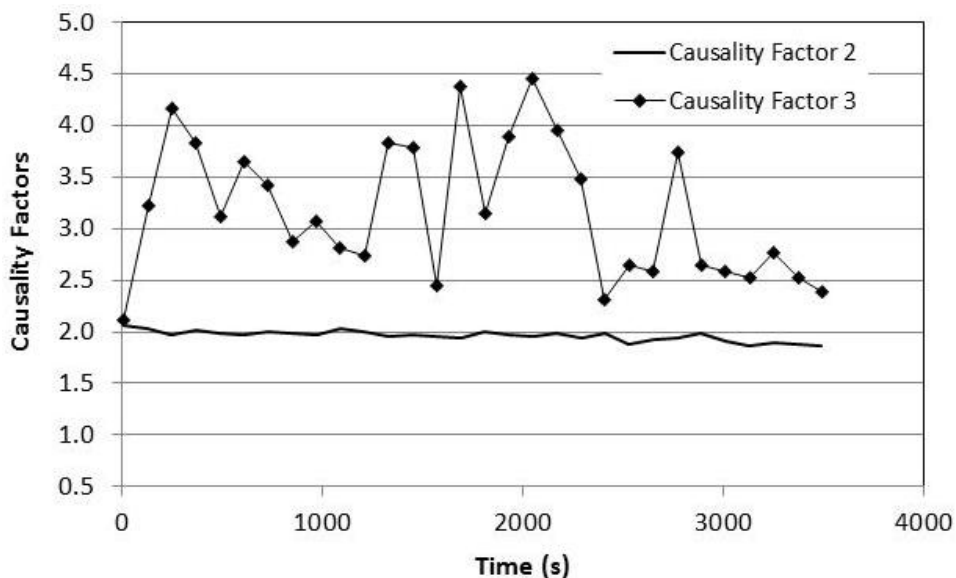
Figure 11. Causality Factors of EFM are fluctuating during pitting corrosion for T-joint sample in 0.6 M NaCl.

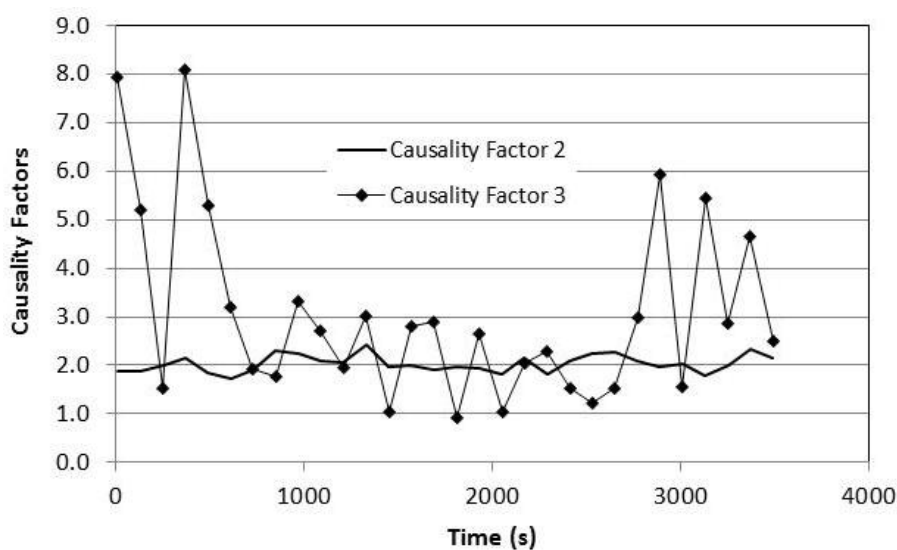
Figure 12. Causality Factors of EFM are fluctuating during pitting corrosion for T-joint sample in 0.6 M NaCl with electrolyte erosion. Many pits growing in the direction of erosion were found. After comparing, the size of pits was found larger than the case of without erosion.

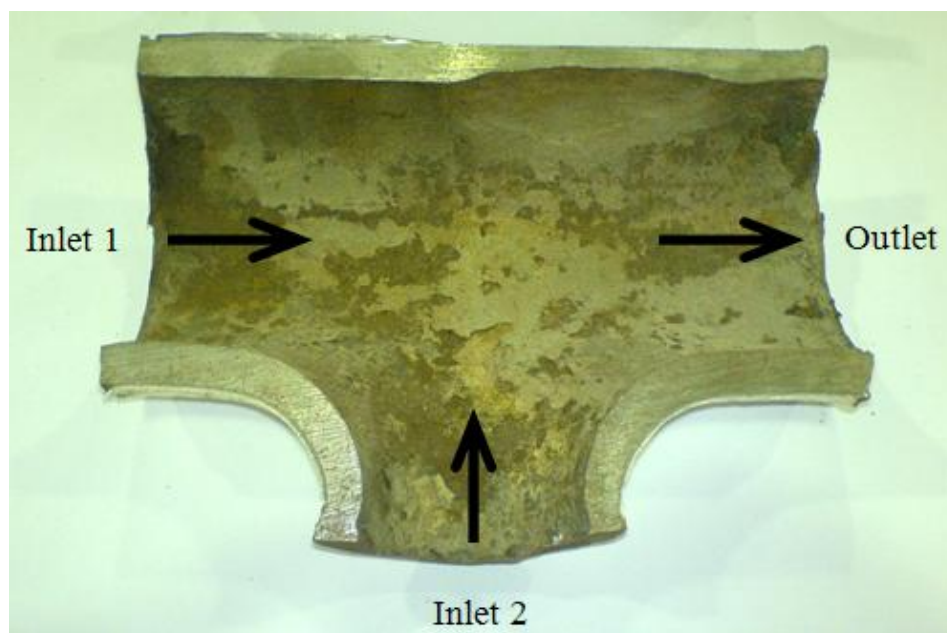
Figure 14. A section showing the flow direction

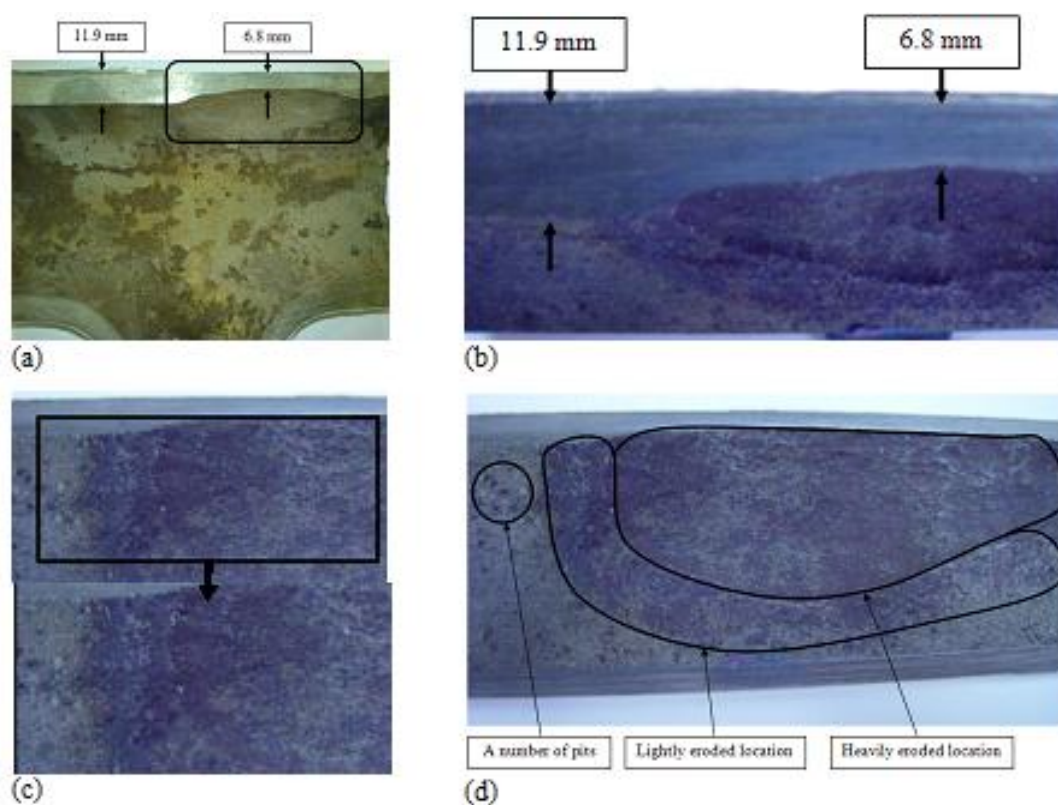
Figure 15. (a) The localized material removal location (b) Magnification of erroded section (c) Erroded section showing a scattered pits location (d) Failure locations.

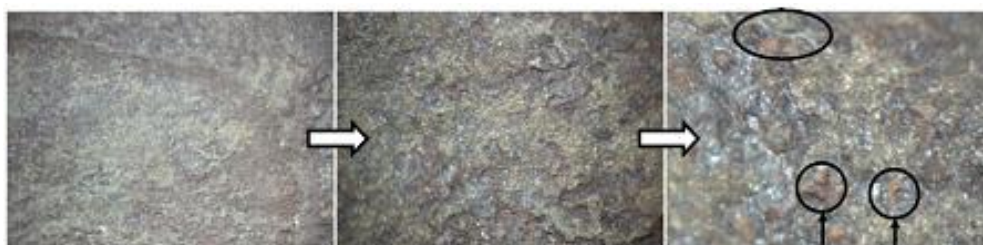
Figure 16. Zoomed-in views of the heavily eroded location (magnification increases from left to right)

However, it is noted that erosion was not the only cause of leakage, but fatigue due to the fluctuation of pressure inside the piping system may have initiated a crack similar to the one seen

which caused the leakage when it reached the outer surface. The pits that were noted on the surface may have formed during shutdowns when the working fluid stagnates in the rough eroded surface. These pits may have acted as starting points for cracks which grew due to fatigue and caused the leakage. It is also possible that one of the pits grew till it reached the outer surface of the T-joint and caused the leakage. Erosion, corrosion and fatigue are most likely the three main factors that resulted in the T-joint failure.

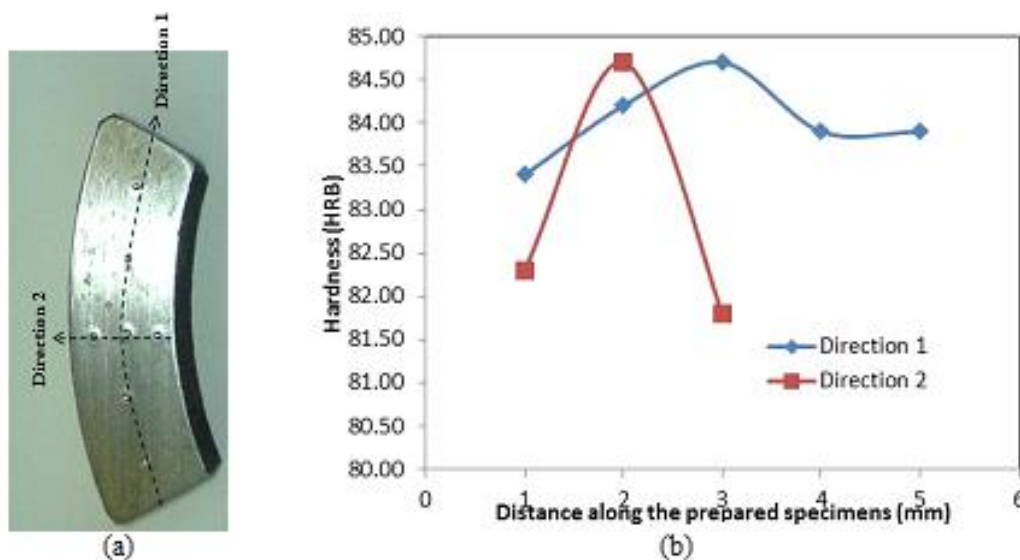
The hardness test was applied to the specimen in two directions as shown in Figure 17a. The hardness along direction 1 and 2 is presented in Figure 17b. It can be seen that there is almost no variation in hardness along direction 1, while the hardness is higher at the middle of direction 2. Using the average hardness the tensile strength of the T-joint material can be roughly approximated. Using the Standard Hardness Conversion tables the tensile strength is approximated. The average Hardness is 83.5 HRB which is equivalent to 160.5 HB. The relationship between the ultimate tensile strength and the hardness is

From the tensile test, the strength is approximately 628.15 MPa. The %deviation is approximately 11.85%. From Figure 17b, it can be seen that there is almost no variation of hardness along direction 1, while the hardness is lower near the edges along direction 2 which can indicate that the material is more vulnerable to scratch or indent at the locations where the hardness is lower. Hardness tests across the section cut through the T-joint showed a soft inner zone, followed by a harder zone and then a soft zone which can mean that the outer layers of the T-joint lost carbon due to the heat treatment during manufacture. Also, by performing the hardness test an approximation of the tensile strength of the T-joint material have been found.

Figure 17. (a) The specimen prepared for hardness test (second from the left) (b) Hardness along directions 1&2 as shown in (a)

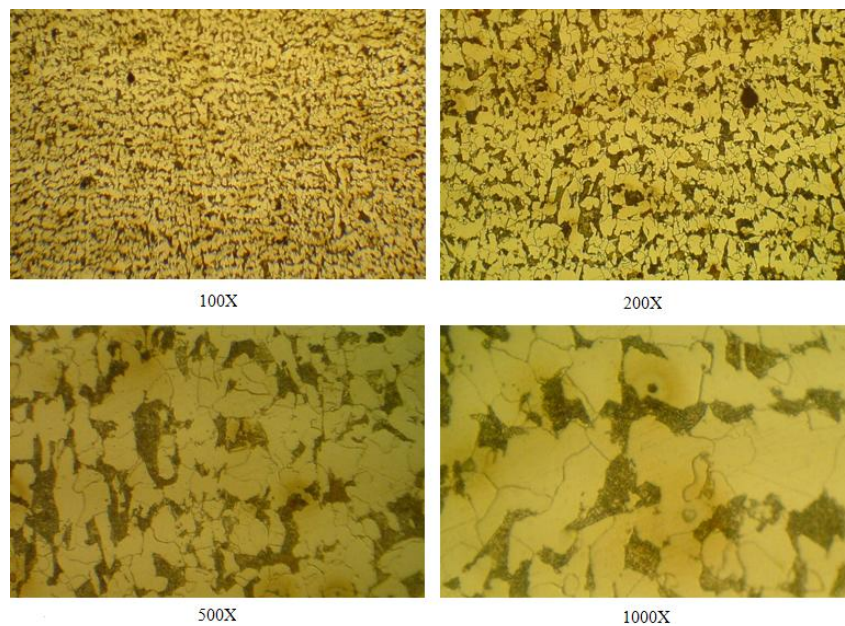
The microstructure at different magnifications (100X, 200X, 500X and 1000X) is shown in Figure 18. The fact that the microstructure was revealed using Nital validates the assumption that the material used to make the T-joint is Carbon Steel. To determine more information concerning this material, the microstructure at a magnification of 1000X is further studied (Figure 19). Two phases can be seen in the microstructure; the light Ferrite and the dark Pearlite phases. The availability of those two phases indicates that the material is Carbon Steel with Carbon content in the range from 0.022 to 0.76 wt% C. The Ferrite phase is a soft and ductile phase, but the Pearlite phase is a hard and brittle phase. The Ferrite phase is available in more quantities than the Pearlite phase. The ratio is approximately 7:3. This indicates that the material is actually Low Carbon Steel (0.05 to 0.25 wt% C). Due to the existence of those two phases, the material properties are expected to be intermediate between them but a little closer to the properties of the Ferrite phase since it is available in more quantities. Also, the metal has likely been slowly cooled during the heat treatment of manufacturing process. ASTM E112 standard test methods considers one of the most widely cited ASTM standards,

This indicates that the material has small grains. In addition the heat treatment or manufacturing process of the material included a slow cooling process. The material is believed to be soft and ductile rather than hard and brittle; with generally good mechanical properties.

Figure 18. The microstructure of the T-joint at different magnifications (as indicated)

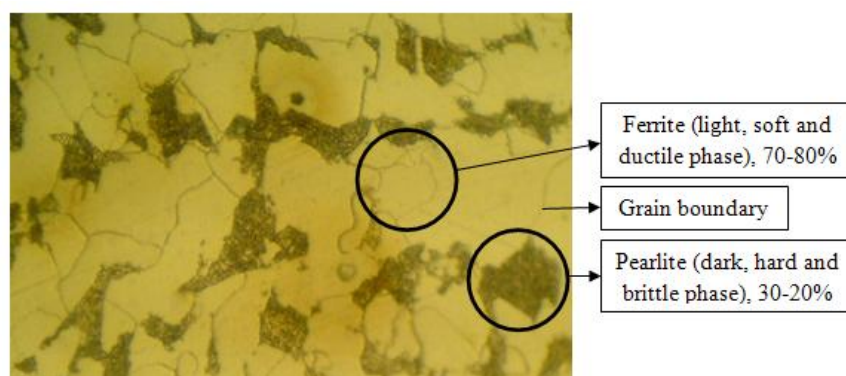
Figure 19. The microstructure at a magnification of 1000X

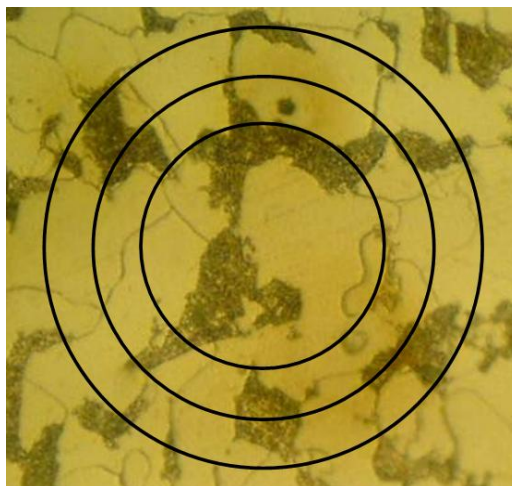
Figure 20. Determination of grain size based on ASTM standard E112.

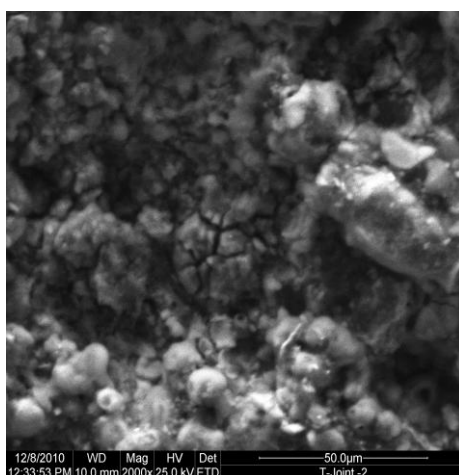
Figure 23. The SEM image of the second location at 2000X

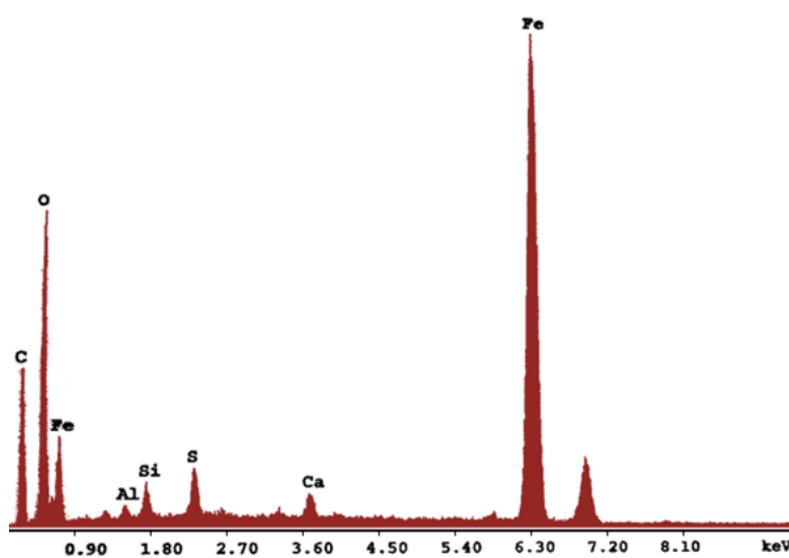
Figure 24. The EDS spectrum of the second location

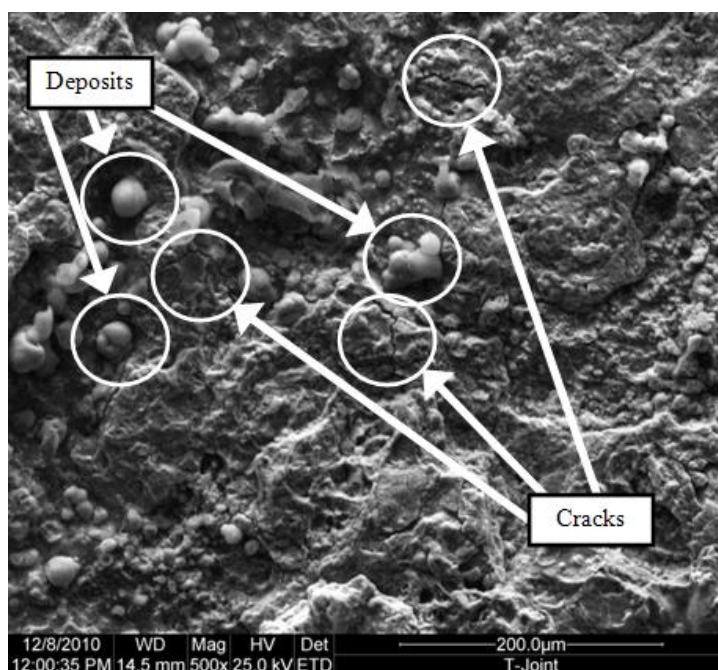
Figure 25. The SEM image at the first location at 500X showing deposits and cracks

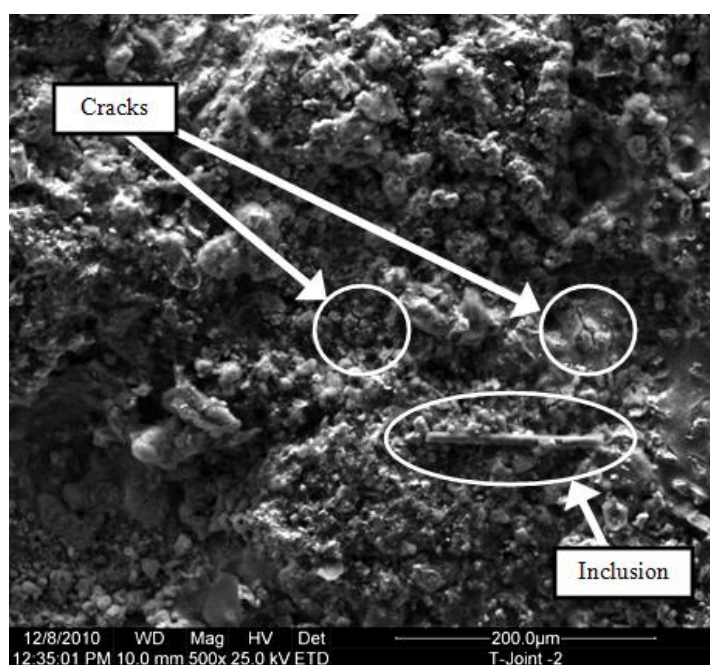
Figure 26. The SEM image of the second location at 500X showing cracks and an inclusion

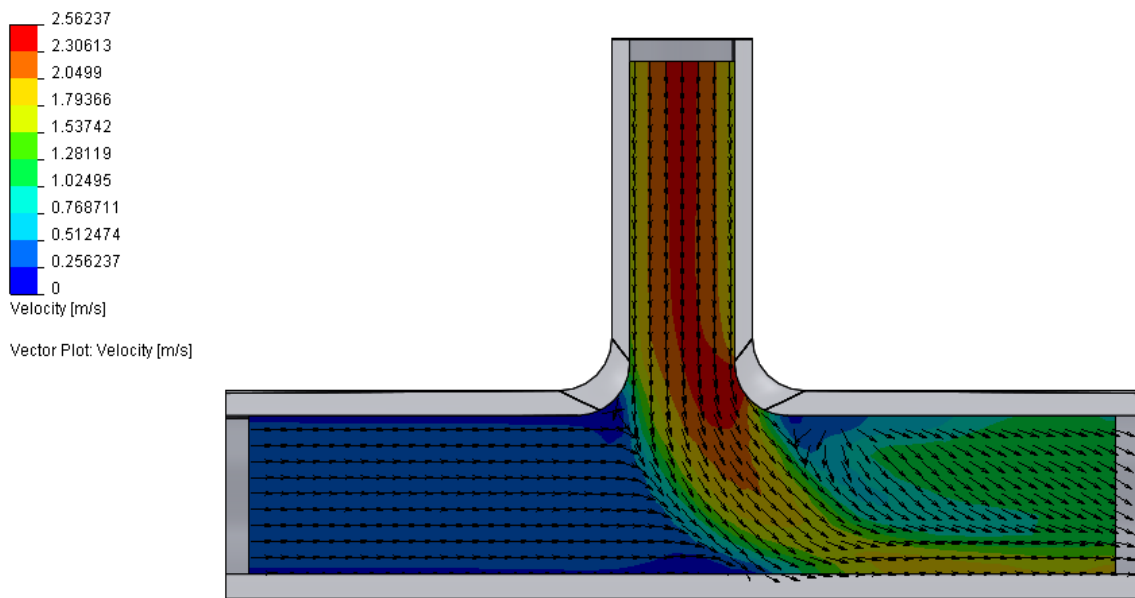
Figure 28a. A cut plot of the velocity contours and vectors of the T-joint model

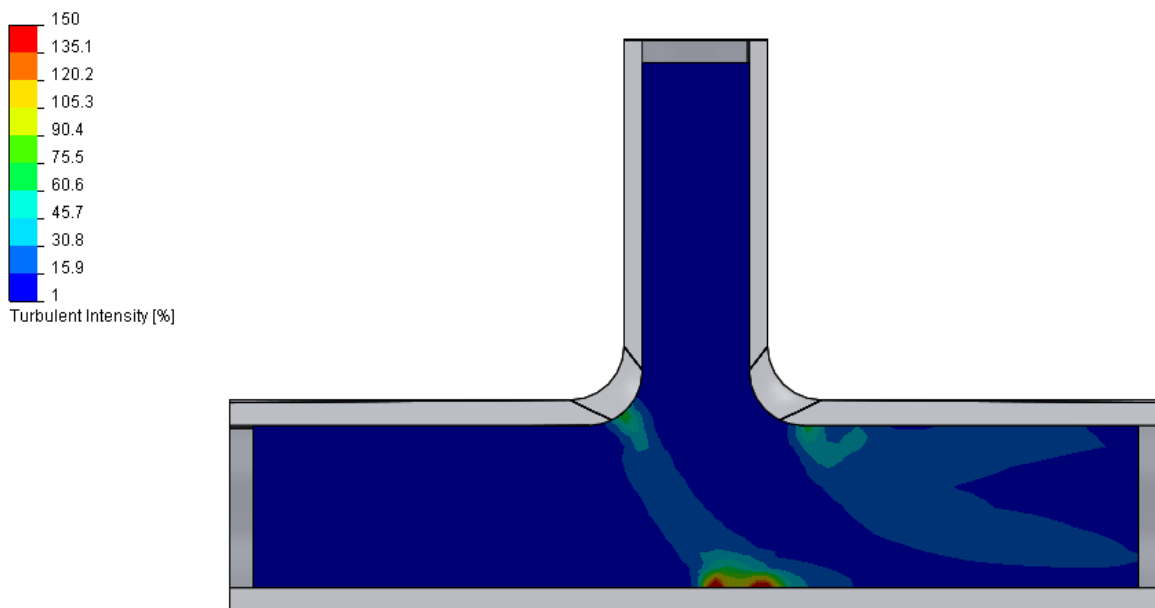
Figure 28b. A cut plot of the turbulence intensity contours of the T-joint model

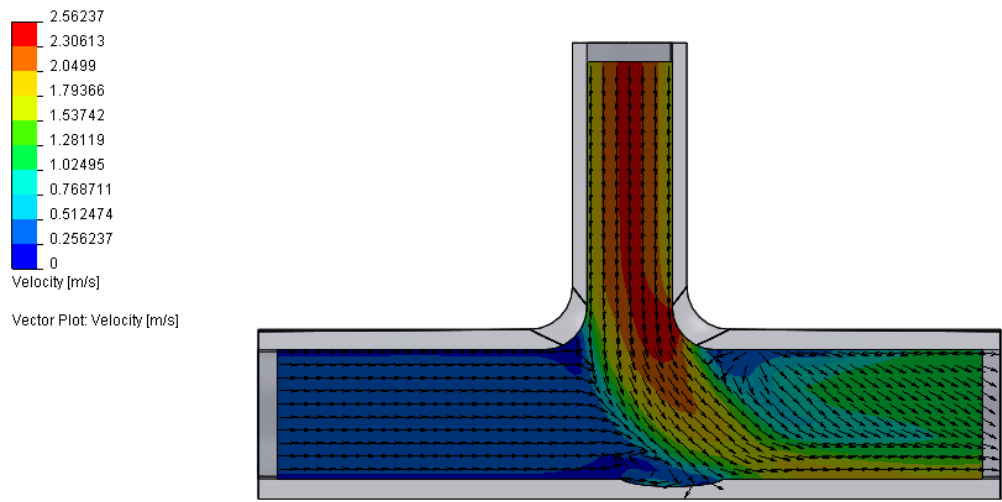
Figure 28c. A cut plot of the velocity contours and vectors of the eroded T-joint model

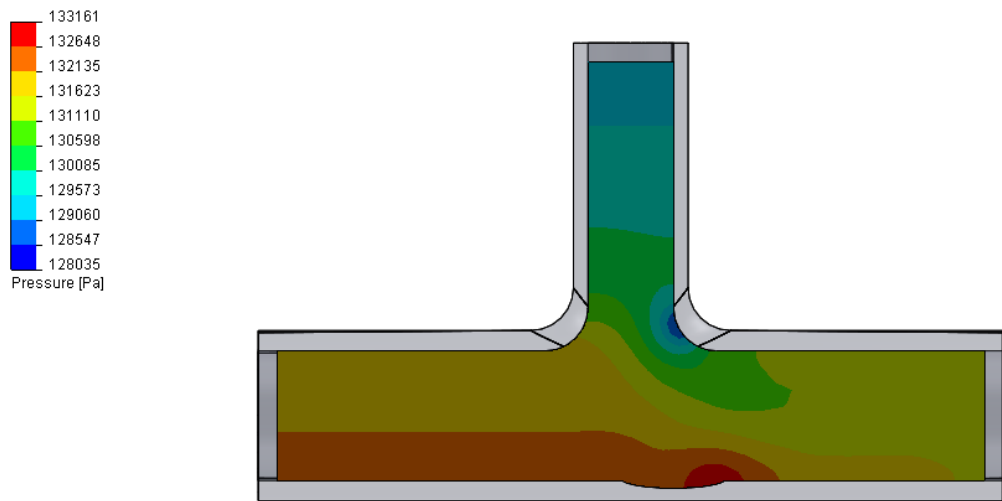
Figure 28d. A cut plot of the pressure contours of the eroded T-joint model

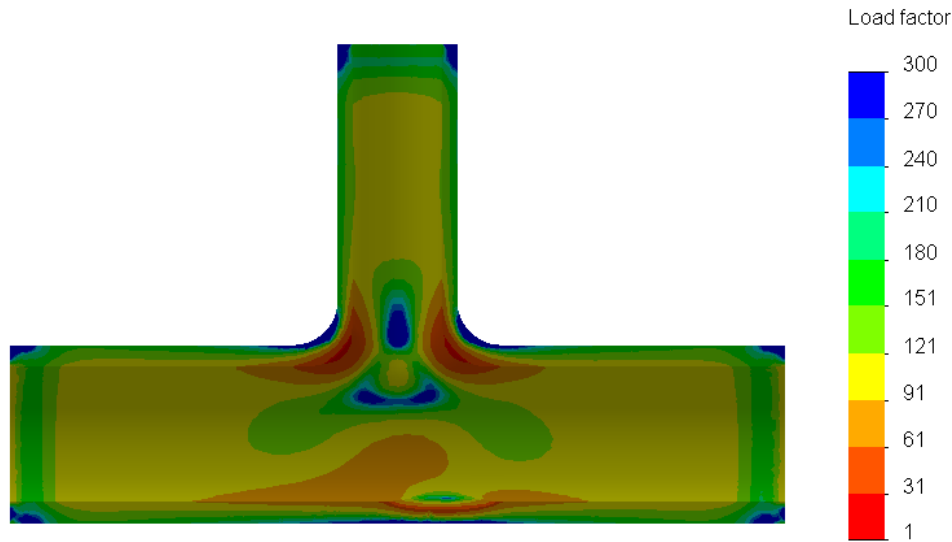
Figure 28e. A section plot of the fatigue load factor of the eroded T-joint model

The material of the T-joint is Low Carbon Steel (AISI 1026). Inclusions are noted in the material. The harsh working conditions are believed to have caused the failure. The failure is believed to have started with erosion which reduced the thickness of the wall at the location of leakage. General corrosion and pitting are believed to have helped in initiating a crack which ultimately led to leakage when it reached the outer surface of the T-joint. The crack grew due to the fluctuation of the pressure inside the T-joint. Using a Y-joint is believed to be one of the possible solutions for this failure.
