Atmospheric Corrosion Behaviour and Degradation of High-Strength Bolt in Marine and Industrial Atmosphere Environments

The atmospheric corrosion behaviour and properties degradation law of 1Cr17Ni2 high-strength bolt exposed in marine and industrial atmosphere environments up to 36 months were investigated in virtue of scanning electron microscope (SEM), energy dispersive spectroscopy (EDS), X-ray diffractometer (XRD), potentiodynamic polarization curve (PPC), electrochemical impedance spectroscopy (EIS), optical microscope (OM), tensile strength test, double shear strength test and tension fatigue test. The test results showed that, compared with industrial atmosphere environment, high-strength bolt exhibited higher corrosion susceptibility in marine atmosphere environment. Lepidocrocite and goethite were the major constituents of the rust layer in two types of atmosphere environments, and chlorides and sulphates were detected in marine atmosphere environment and industrial atmosphere environment, respectively. Electrochemical corrosion analysis showed that the anti-corrosive properties of different parts were in this order: screw part > thread part > joint between thread and scr

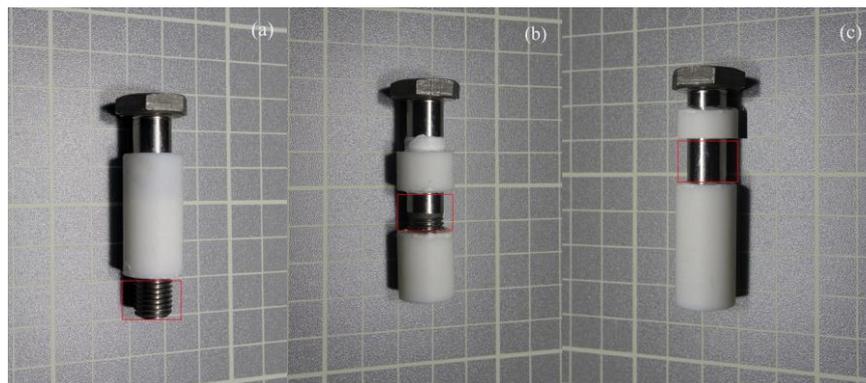
Figure 1. Photos of electrochemical measurement samples with different test regions (a) thread part, (b) joint between thread and screw part, (c) screw part.

Electrochemical corrosion tests, which consisted of potentiodynamic polarization curve (PPC) and the electrochemical impedance spectroscopy (EIS), were carried out using a classical three electrodes cell with platinum as counter electrode, saturated calomel electrode SCE (+0.242V vs SHE) as reference electrode, and 1Cr17Ni2 high-strength bolt as working electrode. Three local regions including thread part (containing the bottom area), joint between thread and screw part, screw part were selected as electrochemical test area. The height of test region is 10 mm, and the rest was sealed by the processed polytetrafluoroethylene ring and silicone rubber, as shown in Fig.1. According to the calculation results based on GB/T 5267 standard [22], the test area of thread part (containing the bottom area), joint between thread and screw part, screw part were 561.1mm², 398.6mm² and 314.2mm², respectively.

The observation localization for micromorphologies was the joint between thread and screw part (as shown in Fig.1b), in which the fracture position of 1Cr17Ni2 high-strength bolt concentrated during the tensile strength test and the tension fatigue test. The typical surface micromorphologies of the joint

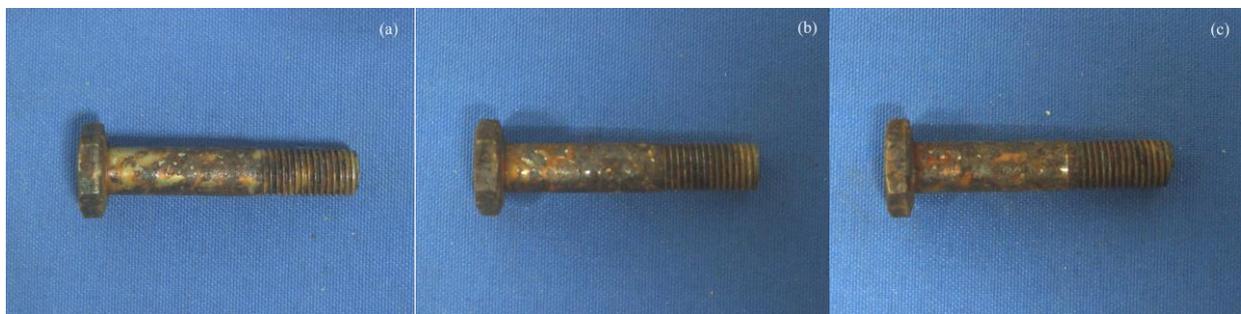
Figure 2. Typical surface macromorphologies of 1Cr17Ni2 high-strength bolt exposed in marine atmosphere environment (Wanning) for (a) 12 months, (b) 24 months and (c) 36 months

The typical surface macromorphologies of 1Cr17Ni2 high-strength bolt exposed in marine atmosphere environment and industrial atmosphere environment with the prolongation of the exposure time are shown in Fig. 2 and Fig. 3, respectively. It can be seen that the corrosion extent of 1Cr17Ni2 high-strength bolt increased with the prolongation of the exposure time in two types of atmosphere environments. Clearly, the corrosion degree of 1Cr17Ni2 high-strength bolt exposed in marine atmosphere environment was more serious than that of 1Cr17Ni2 high-strength bolt exposed in industrial atmosphere environment, which attributed to the high chloride ion concentration in marine atmosphere environment and the strong penetration effect of chloride on the passive film formed on the stainless steel. What was interesting in industrial atmosphere environment was that the corrosion phenomena occurred hardly in the whole screw of 1Cr17Ni2 high-strength bolt, which would be explained by dint of electrochemical method in the following section of electrochemical corrosion analysis.

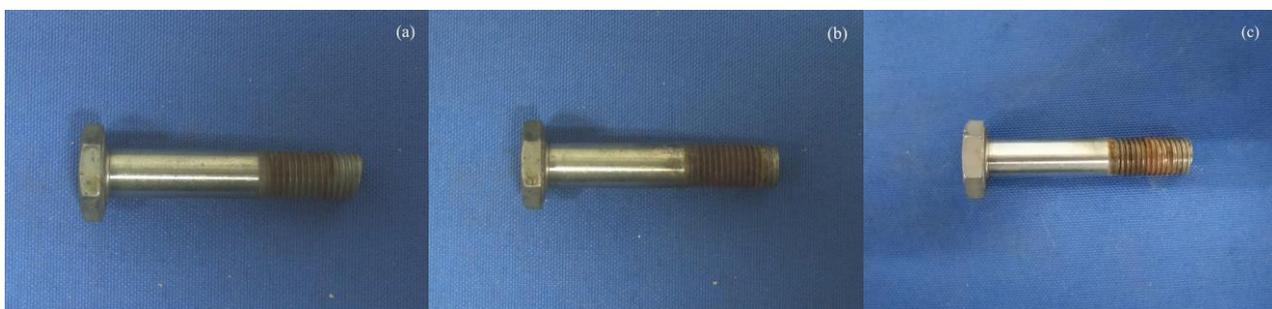
Figure 3. Typical surface macromorphologies of 1Cr17Ni2 high-strength bolt exposed in industrial atmosphere environment (Jiangjin) for (a) 12 months, (b) 24 months and (c) 36 months

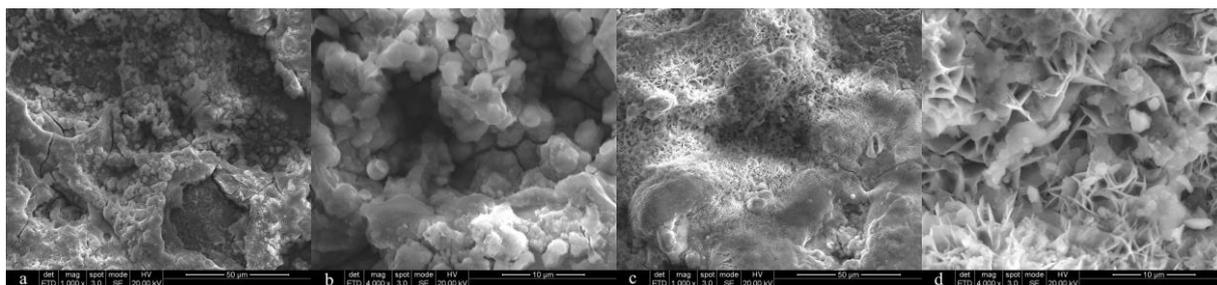
Figure 4. Typical surface micromorphologies of screw for joint between thread and screw part in marine atmosphere environment for 12 months

The typical surface micromorphologies of the screw for the joint between thread and screw part exposed in marine atmosphere environment are shown from Fig. 4 to Fig. 6. It can be seen from Fig. 4 that rust layer of the screw mainly presented petaloid and granulated morphologies which were the characteristics of goethite (α -FeOOH) and lepidocrocite (γ -FeOOH), respectively. With the exposure time of 24 months, as shown in Fig. 5, the morphologies with the shape of granula, threadiness and spherality, which were the characteristic of lepidocrocite (γ -FeOOH), were observed. Under much higher magnification, as shown in Fig. 5b, the needles (whiskers) formations around the periphery of the globules was actually observed, indicating the existence of goethite (α -FeOOH) which formed by the transformation of lepidocrocite (γ -FeOOH).

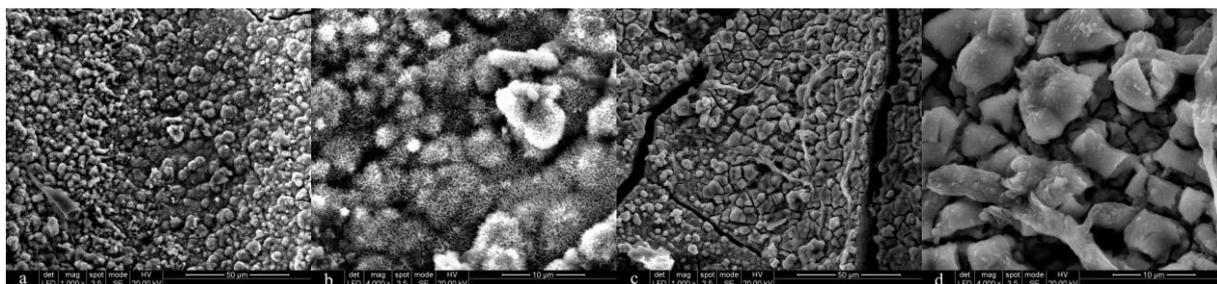
Figure 5. Typical surface micromorphologies of screw for joint between thread and screw part in marine atmosphere environment for 24 months

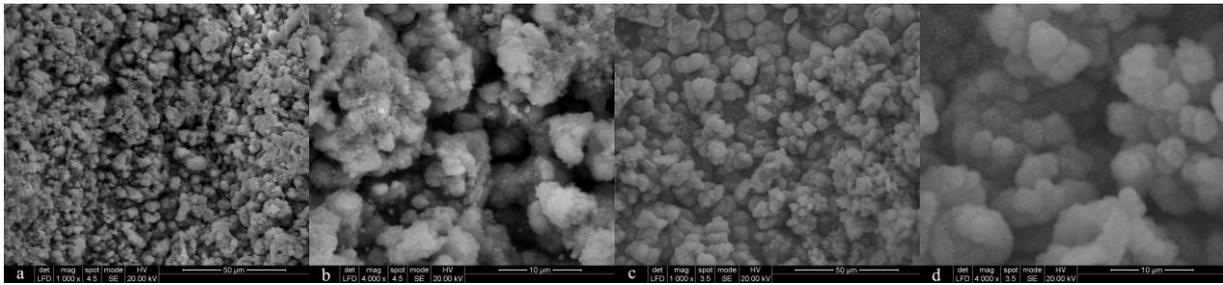
Figure 6. Typical surface micromorphologies of screw for joint between thread and screw part in marine atmosphere environment for 36 months

When the exposure time was 36 months, as shown in Fig.6, the rust layer of the screw mainly presented granulated morphologies, which were the characteristic of lepidocrocite (γ -FeOOH).

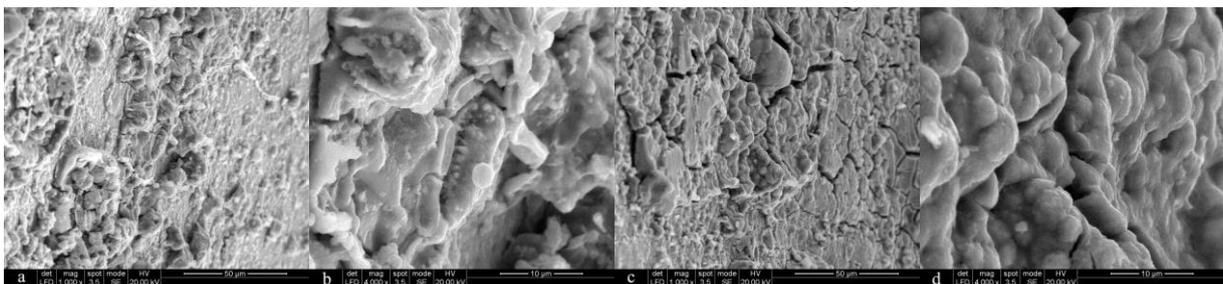
Figure 7. Typical surface micromorphologies of thread for joint between thread and screw part exposed in marine atmosphere environment (Wanning) for 12 months

The typical surface micromorphologies of the thread for the joint between thread and screw part exposed in marine atmosphere environment are shown from Fig. 7 to Fig. 9. From Fig.7 it can be seen that rust layer of thread mainly presented cellular morphologies which was the characteristic of lepidocrocite (γ -FeOOH). With the exposure time of 24 months, as shown in Fig.8, the morphologies with the shape of granula and spherality, which were the characteristic of lepidocrocite (γ -FeOOH), were observed. Under much higher magnification as shown in Fig.8d, the needles (whiskers) formations around the periphery of the globules was actually observed, indicating the existence of goethite (α -

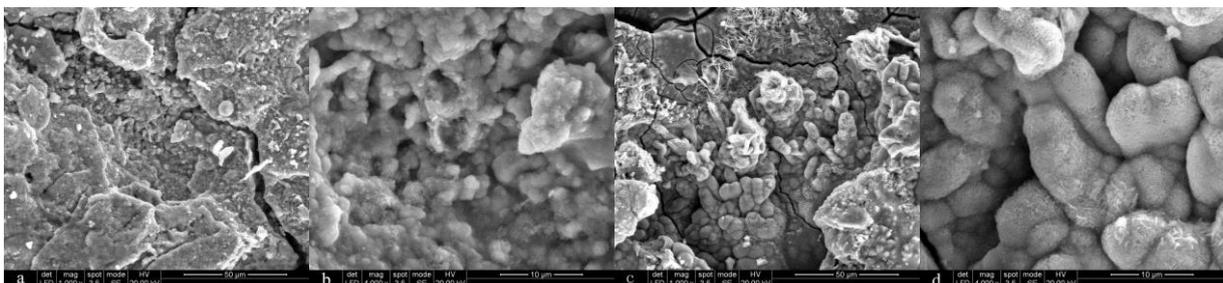
Figure 8. Typical surface micromorphologies of thread for joint between thread and screw part exposed in marine atmosphere environment (Wanning) for 24 months

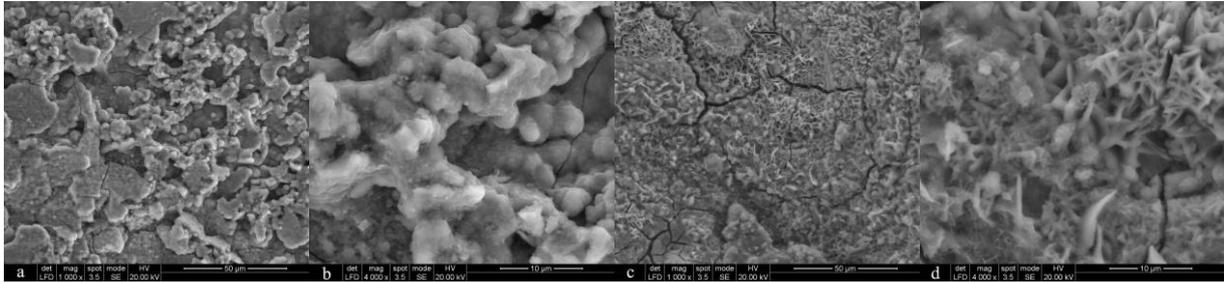
Figure 9. Typical surface micromorphologies of thread for joint between thread and screw part exposed in marine atmosphere environment (Wanning) for 36 months

FeOOH). When the exposure time was 36 months, as shown in Fig.9, the rust layer of the thread mainly presented granulated and feather-like morphologies, which were the characteristic of lepidocrocite (γ -FeOOH). The microcrack always occurred in rust layer during the exposure time.

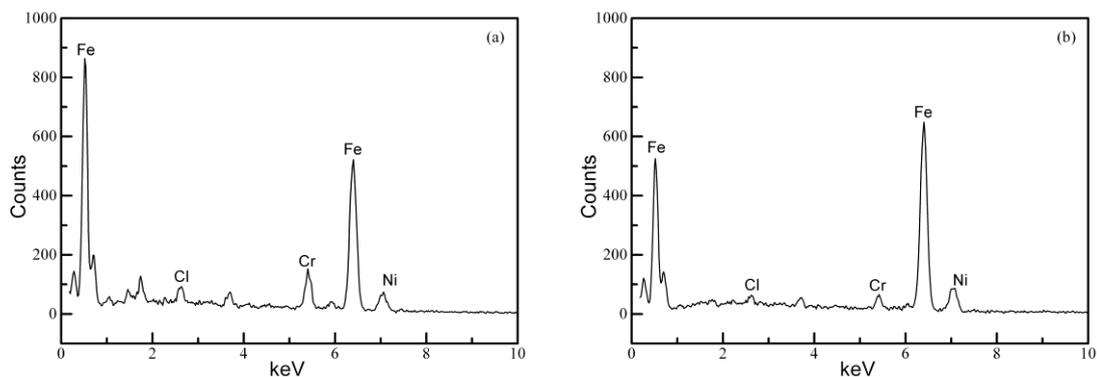
Figure 10. Typical EDS plots of joint between thread and screw part exposed in marine atmosphere environment (Wanning) for 36 months (a) thread, (b) screw

The Typical EDS plots of the joint between thread and screw part exposed in marine atmosphere environment, as shown in Fig.10, revealed the existence of chlorine element, indicating reasonably that the existence of the water-soluble compounds such as ferrous chloride (FeCl_2) and ferric chloride (FeCl_3).

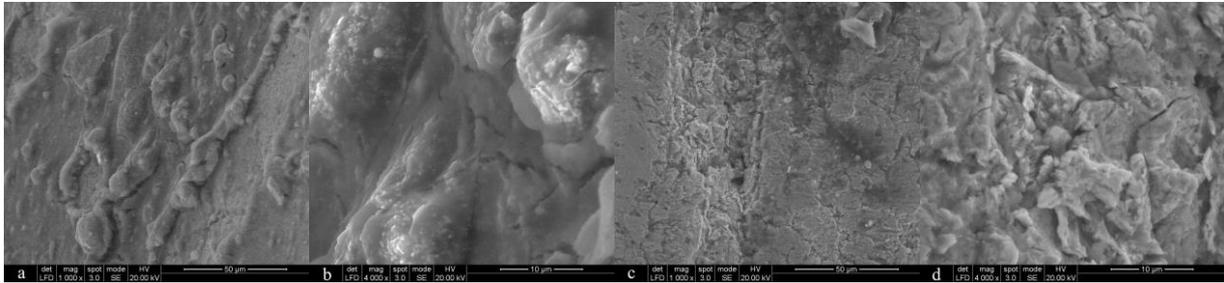
Figure 11. Typical surface micromorphologies of thread for joint between thread and screw part exposed in industrial atmosphere environment (Jiangjin) for 12 months

The typical surface micromorphologies of the thread for the joint between thread and screw part exposed in industrial atmosphere environment are shown from Fig. 11 to Fig. 13. From Fig.11 it can be seen that the rust layer of the thread was compact, and mainly presented cellular and muddy

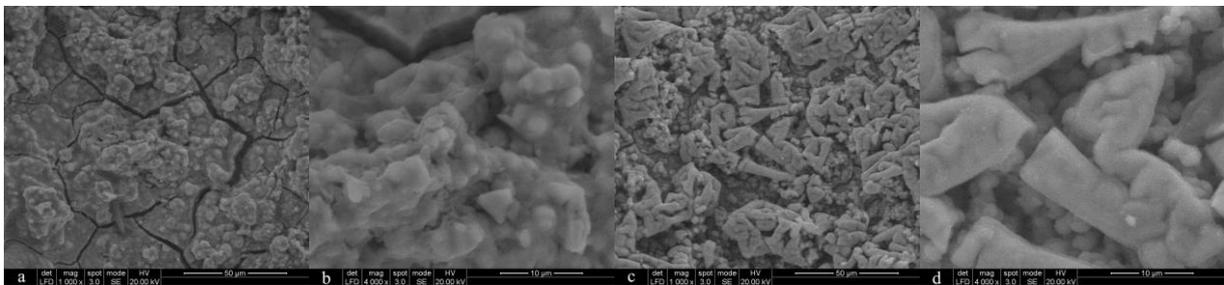
Figure 12. Typical surface micromorphologies of thread for joint between thread and screw part exposed in industrial atmosphere environment (Jiangjin) for 24 months

morphologies which were the characteristic of lepidocrocite (γ -FeOOH). With the exposure time of 24 months, as shown in Fig.12, the morphologies with the shape of granula, which were the characteristic of lepidocrocite (γ -FeOOH), were observed. The tubulous morphologies indicating the existence of goethite (α -FeOOH) were also observed. When the exposure time was 36 months, the morphologies with the shape of granula and threadiness, which were the characteristic of lepidocrocite (γ -FeOOH), were observed.

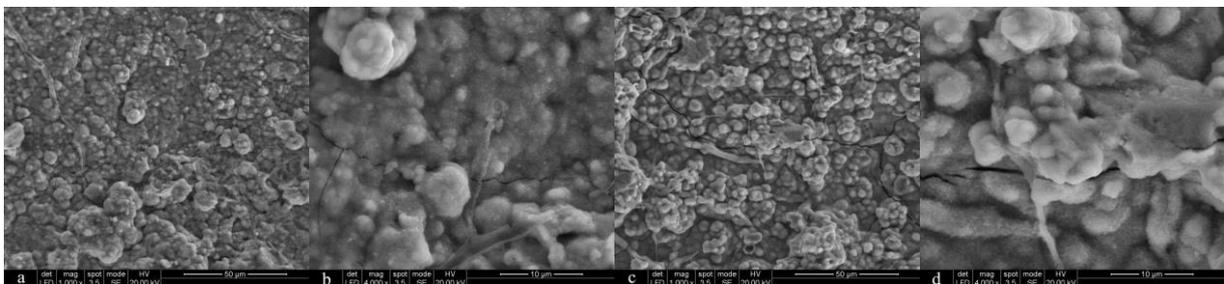
Figure 13. Typical surface micromorphologies of thread for joint between thread and screw part exposed in industrial atmosphere environment (Jiangjin) for 36 months

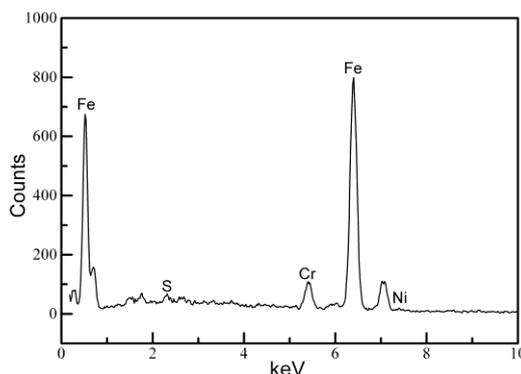
Figure 14. Typical EDS plots of thread for joint between thread and screw part exposed in industrial atmosphere environment for 36 months

The Typical EDS plots of the thread for joint between thread and screw part exposed in industrial atmosphere environment, as shown in Fig.14, revealed the existence of sulfur element, indicating reasonably the existence of ferrous sulphate (FeSO_4) and ferric sulphate ($\text{Fe}_2(\text{SO}_4)_3$).

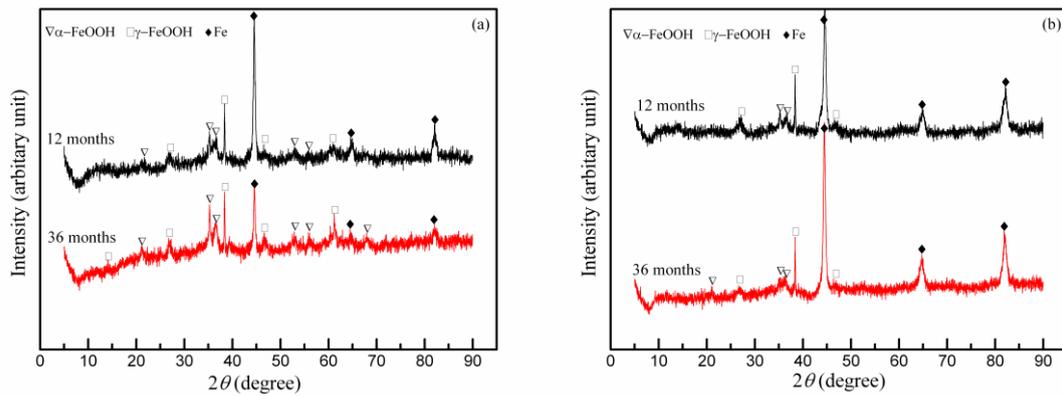
Figure 15. XRD patterns of rust layer (a) Wanning, (b) Jiangjin

The crystalline phases of the rust layer in two types of atmosphere environments with the exposure time of 12 months and 36 months are shown in Fig. 15. It can be seen from Fig.15 that the rust constituents in marine atmosphere environment and industrial atmosphere environment were quite similar, and were mainly composed of goethite (α -FeOOH) and lepidocrocite (γ -FeOOH). The nature of the rust constituents wasn't affected with the prolongation of the exposure time in two types of atmosphere environments, and the same species were always detected at a given atmosphere environment.

It was interesting to note that, when the exposure time was 36 months, the goethite (α -FeOOH) was not observed in two types of atmosphere environments which can be seen from the surface micromorphologies analysis. It seemed to be in contradiction with the XRD analysis. The occurrence of phenomenon mentioned above can be attributed that lepidocrocite (γ -FeOOH) was primarily present in external surface of the layer and was the most abundant when observing the external surface of the

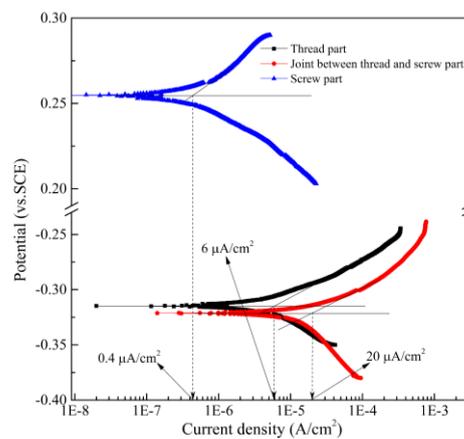
Figure 16. Typical potentiodynamic polarization curves of three test regions in neutral 5.0 wt. % NaCl solution

Typical potentiodynamic polarization curves of three test regions in neutral 5.0 wt. % NaCl solution are presented in Fig.16. Corrosion current density (i_{corr}) derived from Fig.16 using the Tafel extrapolation is also summarized. It can be found that the i_{corr} of the screw part is $4 \times 10^{-7} \text{ A cm}^{-2}$, which is respectively approximately 1/15 and 1/50 that of the thread part and that of the joint between thread and screw part, suggesting the best corrosion resistance of the screw part among three test regions.

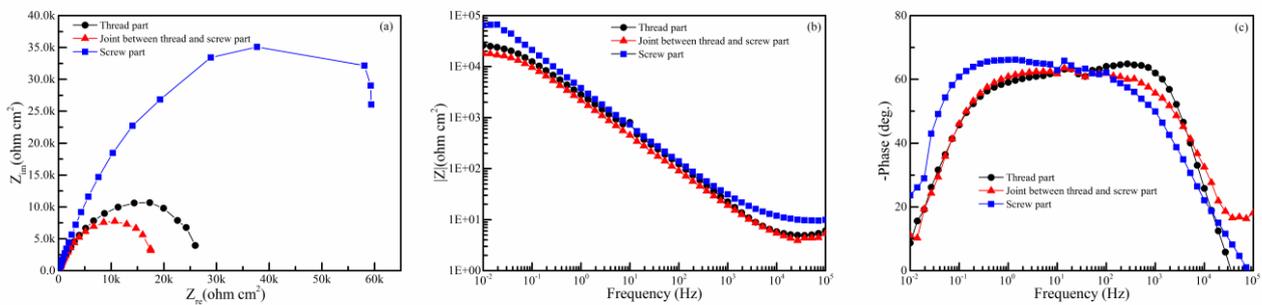
Figure 17. Typical electrochemical impedance spectroscopy of three test regions in neutral 5.0 wt. % NaCl solution (a) Nyquist plots, (b and c) Bode plots

The typical electrochemical impedance spectroscopy of the different test regions in neutral 5.0 wt.% NaCl solution are presented in Fig.17. A low-frequency inductive loop, whose shape was characterized with retractile real part, was observed in the Nyquist plots of the three test regions. The appearance of the low-frequency inductive loop may originate from the pitting corrosion on the electrode surface [32]. It can be seen from Fig. 17a that the diameters of capacitance loop were in this order: screw part > thread part > joint between thread and screw part, indicating the highest corrosion resistance of screw part among three test regions. From the Bode plots (impedance modulus $|Z|$) as a function of

frequency), as shown in Fig.17b, it can be detected that the impedance value of three test regions was also in this order: screw part > thread part > joint between thread and screw part. The changes of the Bode plots (phase angle as a function of frequency) , as shown in Fig.17c, indicated that there was only one time constant for three test regions in 5.0 wt. % NaCl solutions over the whole frequency range studied, which reflected one relaxation process, i.e. dissolution of working electrode during the corrosion process.

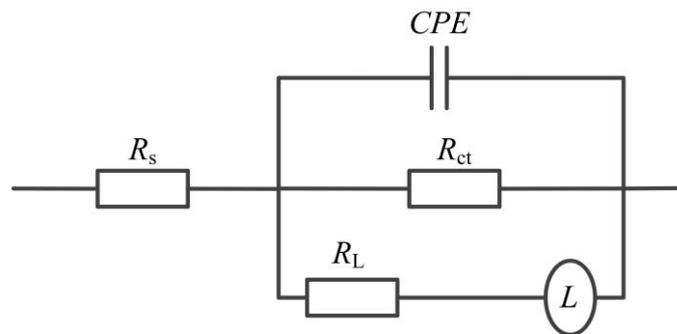
Figure 18. Electrochemical equivalent circuits used for fitting EIS data of three test regions in neutral 5.0 wt. % NaCl solution

In order to further and quantitatively study the corrosion process of three test regions, a more detailed interpretation of EIS measurement is performed by fitting the experimental plots using the electrochemical equivalent circuit depicted in Fig. 18.

The circuit, presented in Fig.18, consisted of parameters namely solution resistance (R_s), charge transfer resistance (R_{ct}), inductance resistance (R_L), inductance (L) and a constant phase element (CPE) which replaces the capacitance of the double layer (C_{dl}). A constant phase element (CPE) replaces the capacitance of the double layer (C_{dl}) due to the roughness and inhomogeneity of the electrode surface.

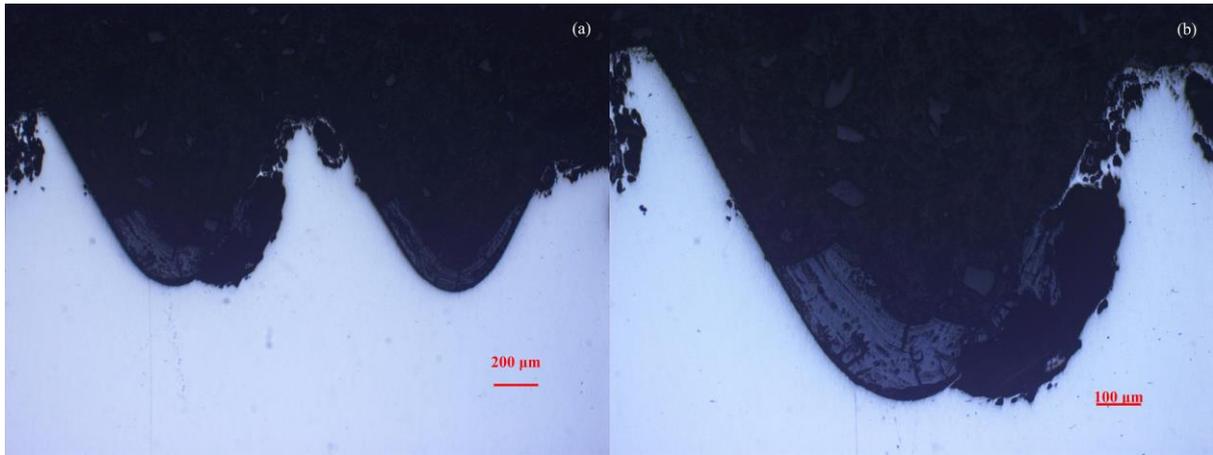
Figure 19. Cross section morphologies of thread for joint between thread and screw part exposed in marine atmosphere environment (Wanning) for 36 months

The typical cross section morphologies of thread for the joint between thread and screw part of 1Cr17Ni2 high-strength bolt exposed in marine atmosphere environment and industrial atmosphere environment with the exposure time of 36 months are shown in Fig. 19 and Fig. 20, respectively. Obviously, the corrosion area and the corrosion depth of thread in marine atmosphere environment were greater than that of thread in industrial atmosphere environment.

Furthermore, the thickness of the rust layer was quite uneven. According to the study reported by Asami and Kikuchi [34], there can be no argument that the origin of unevenness came from the non-uniform distribution of physical and chemical factors, such as environmental deposits and the direction of crystallites in the steel.

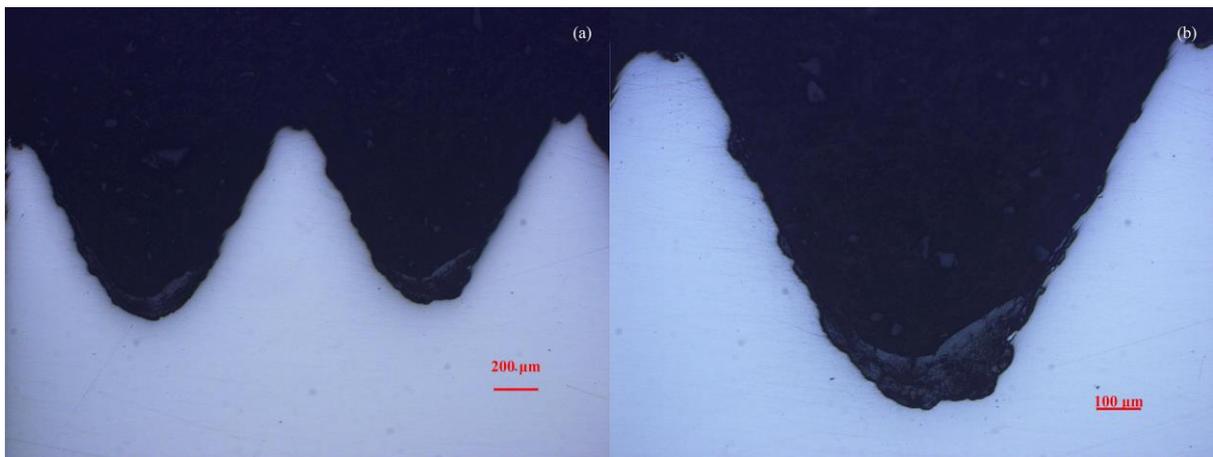
Figure 20. Cross section morphologies of thread for joint between thread and screw part exposed in industrial atmosphere environment (Jiangjin) for 36 months

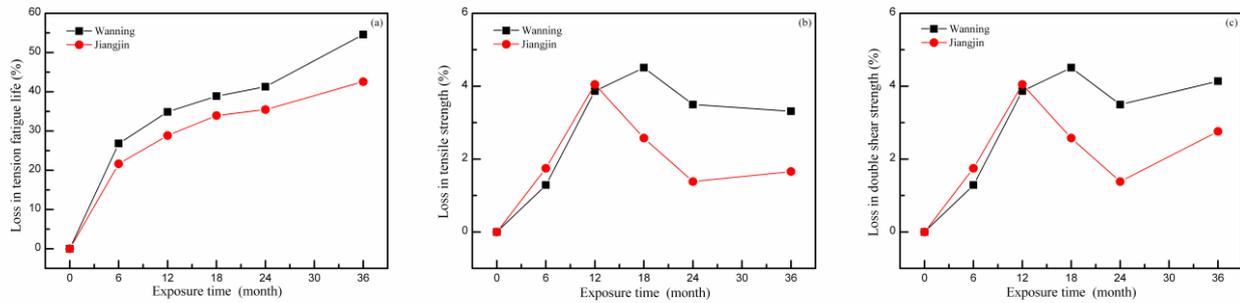
Figure 21. Losses in mechanical properties for 1Cr17Ni2 high-strength bolt versus exposure time at two test sites (a) tension fatigue life, (b) tensile strength and (c) double shear strength.

The losses in mechanical properties of 1Cr17Ni2 high-strength bolt with the prolongation of the exposure time at two test sites are shown in Fig. 21. Apparently, the losses in tension fatigue life of 1Cr17Ni2 high-strength bolt were distinct, and the losses in tension fatigue life increased with the prolongation of the exposure time. However, the double shear strength and tension strength fluctuated during the whole exposure time, and the fluctuant extent limited the scope of 5% compared with the original properties value. This indicated that the corrosion on the surface of 1Cr17Ni2 high-strength bolt and the etch pits has no obvious effect on the double shear strength and tension strength after the exposure time of 36 months.

From the cross section morphologies analysis mentioned above, it can be seen that some etch pits occurred in two types of atmosphere environments, especially the root of thread, along which crack initiation was prone to propagate, resulting the decreases in tension fatigue life. The losses in tension fatigue life of 1Cr17Ni2 high-strength bolt in marine atmosphere environment were larger than that of 1Cr17Ni2 high-strength bolt in industrial atmosphere environment, which can be attributed to the corrosion extent of thread exposed in marine atmosphere environment was larger than that of thread exposed in industrial atmosphere environment, as shown in Fig. 19 and Fig. 20. After 36 months of exposure test, the losses in tension fatigue life of 1Cr17Ni2 high-strength bolt in marine atmosphere environment and industrial atmosphere environment were 55% and 43%, respectively.
