Erosion-Corrosion Behavior and Failure Analysis of Offshore Steel Tubular Joint

E. Mahdi^{}, A. Rauf, S. Ghani, A. El-Noamany and A. Pakari*

Received: 10 March 2013 / Accepted: 30 March 2013 / Published: 1 May 2013

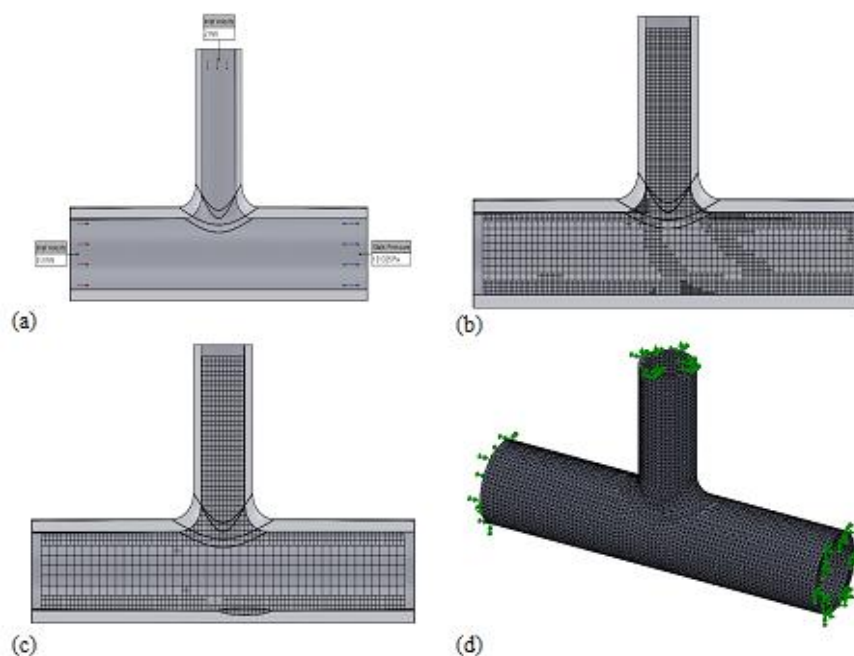
Flow simulation is carried out using SolidWorks [24]. Flow Simulation on undamaged and damaged (i.e. eroded) models with the boundary conditions shown in Figure 27. Using flow simulation results (Figure 28), fatigue analysis is performed assuming repeated loading conditions. The results include cut plots of the velocity contours and vectors, the turbulence intensity contours, the velocity contours and vectors of the eroded section, the pressure contours of the eroded section, the fatigue load factor of the eroded section. From these figures, it is noted that the flow from the 2 m/s velocity inlet directly hits the eroded location and that a swirl is developed in that location. It can also be seen that the highest turbulence intensity is noted in the eroded location. These observations indicate that our earlier discussion of flow direction is valid. It is also noted that the swirl developed is growing in size as the location erodes. The highest pressure is noted in the vicinity of the eroded location. This indicates that the eroded location is under high loads. It can also be noted that the eroded location is susceptible to fatigue. Noting that this location has a very rough surface and thin walls, and that fatigue life is highly depended on surface condition, the eroded location is, in fact, the location most susceptible to fatigue cracking. FEA greatly helped in determining and verifying the failure mechanism.

Figure 27. (a): Section of the T-joint model with boundary condition (b) The mesh of undamaged T-joint model (c) The mesh of the eroded T-joint model (d) Complete model.
