Investigation on the Corrosion and Cavitation Erosion Behaviors of the Cast and Friction Stir Processed Ni-Al Bronze in Sulfide-Containing Chloride Solution

Corrosion and cavitation erosion behaviors of the cast and friction stir processed (FSP) Ni-Al bronze (NAB) in sulfide-containing (polluted) 3.5% NaCl solution were investigated in the present study. The electrochemical impedance spectroscopy (EIS) results demonstrated that the corrosion product film formed in the polluted solution was of poor protectiveness, and the gravimetric measurements results indicated that the sulfide ions increased the corrosion rate by a factor of 1.13 for the cast and 2.12 for the FSP NAB, compared with the results in clean 3.5% NaCl solution. The sulfide ions promoted the formation of a thick and porous corrosion product film, which consisted of sulfides and oxides. Deep pits were found propagated along the eutectoid microstructure for the cast and the β' phases for the FSP NAB. The cavitation erosion mass loss with the addition of sulfide was 0.92 times and 2.52 times more than that in the clean solution for the cast and FSP, respectively. The increased corrosion damage induced by the sulfide ions

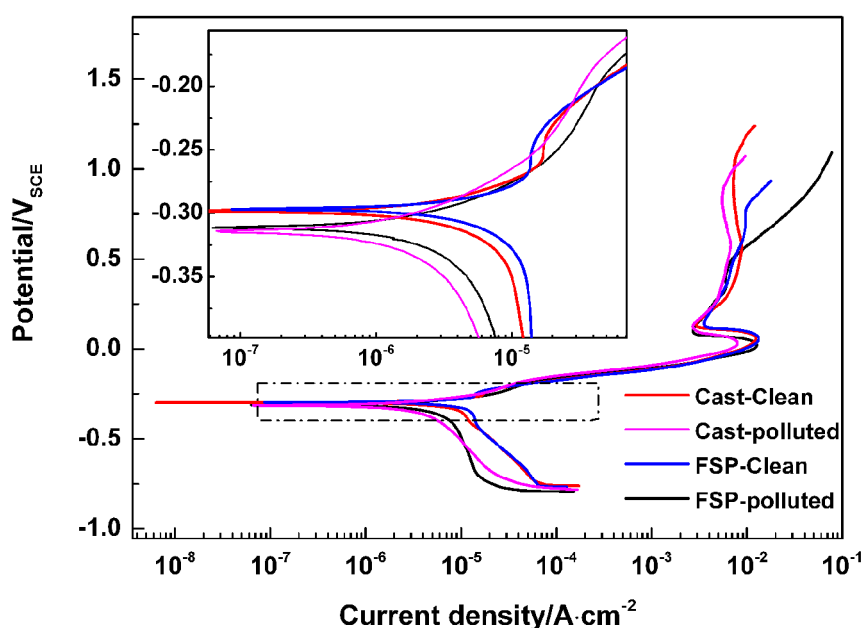
Fig. 4 shows the polarization curves. It can be seen that the cast and FSP experienced similar cathodic and anodic processes in both solutions. In the polluted solution, the cathodic process was slower for both the two materials, compared with the result in the clean solution. The cathodic process was suppressed and the corrosion current density decreased as a result of the film formation. As seen in the magnification part of Fig. 4, there existed a current density peak at about -0.275 V in the polarization curve which corresponded to the formation of cuprous oxide [19]. Therefore, the corrosion rate was kept at a low value and the two materials exhibited a passive behavior. However, such a current density peak disappeared in the polluted solution. With the addition of sulfide ions, the corrosion product films formed on the two materials contained sulfides, in addition to the oxides [13]. The mixture of sulfides and oxides was less compact and protective than that of the oxides [20], therefore with increasing the applied potential, the current density progressively increased, and no obvious passivation was found.

**Figure 4.** Polarization curves of cast and FSP NAB in clean and polluted solutions

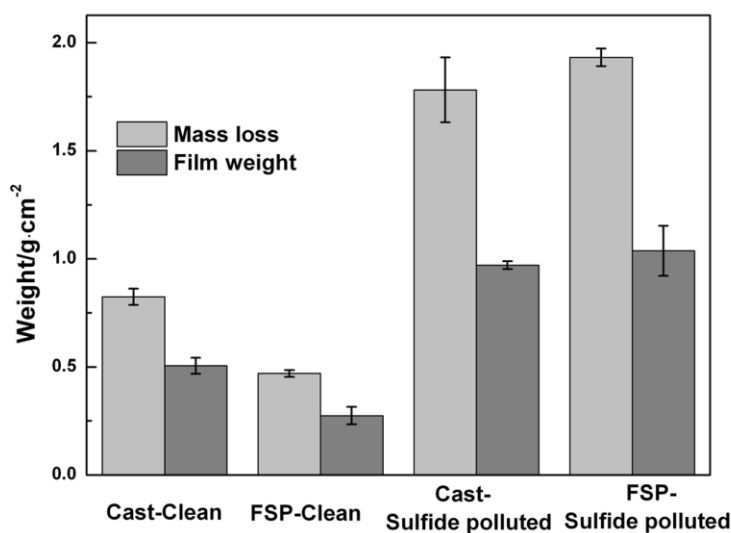
Fig. 6 shows the gravimetric measurement results in the clean and polluted solutions. After 15 days' immersion, the corrosion mass loss rates of the cast and FSP NAB were $0.0023 \text{ mg} \cdot \text{cm}^{-2} \cdot \text{h}^{-1}$ and $0.0017 \text{ mg} \cdot \text{cm}^{-2} \cdot \text{h}^{-1}$ in the clean solution, respectively. However, the corrosion mass loss rate reached $0.0049 \text{ mg} \cdot \text{cm}^{-2} \cdot \text{h}^{-1}$ for the cast NAB and $0.0053 \text{ mg} \cdot \text{cm}^{-2} \cdot \text{h}^{-1}$ for the FSP one in the polluted solution. Namely, the addition of sulfide ions raised the corrosion rate by a factor of 1.13 for the cast and 2.12 for the FSP NAB. Fig. 6 also showed that the weight of the corrosion product film was much larger in the presence of sulfide, indicating the formation of a much thicker film. However, the film possessed poor protectiveness according to the mass loss result. The gravimetric measurement results were consistent with the EIS results shown in Fig. 5.

**Figure 6.** Gravimetric measurement results of the cast and FSP NAB after 15 days' immersion in clean and polluted solutions.
