Corrosion Degradation of Two Coating Systems Exposed for Three Years in a Tropical Oceanic Atmospheric Environment

Two commercial coating systems applied to aluminum alloy screw connections exposed naturally in a tropical oceanic atmospheric environment were studied. The degradation process after different exposure times was analyzed by a series of test methods: visual appearance, color change, gloss loss, Surface FTIR and EIS. Our experimental results indicated that for the screw connection structure, the joint area was not only more susceptible to corrosion, but also increased the inconsistency of the flat area nearby. The protective ability of coating system 1 was superior to that of coating system 2. The effective protective time of coating system 1 was about two years, while the coating system 2 was less than one year.

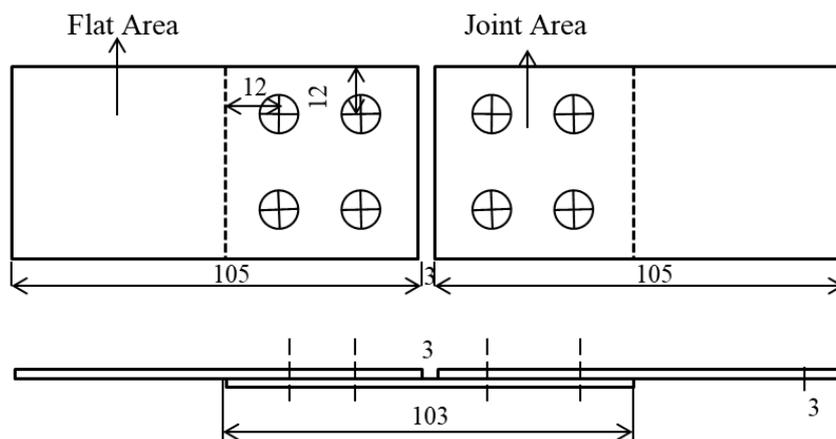
The sample in this study is a screw connection structure with a joint area and a flat area, as shown in Fig. 1. The metal substrate is made of 7B04 aluminum alloy through T74 heat treatment, and the material of the fastener is 30CrMnSiA alloy steel, the main chemical compositions of which are listed in Table 1 and Table 2, respectively. For surface treatment, the aluminum alloy substrate was under anodizing treatment by sulfuric acid.

Figure 1. Schematic drawing of the screw connection sample (with scale in mm).

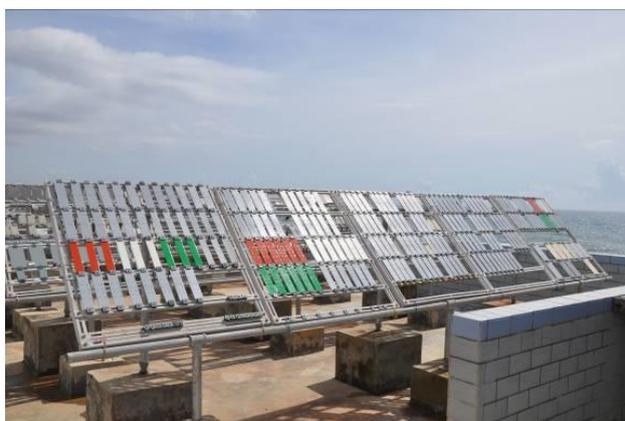
The natural weathering test was carried out in Wanning Test Station, located on the east coast of Wanning City, Hainan province of China. The test environment is a tropical marine climate with a typical high corrosion level, as shown by the main environmental factors listed in the table. 4. Natural Exposure tests were facing south with a 45° exposure angle, as shown in Fig. 2. During the exposure, the color change and gloss of the coating surface were measured and recorded at 1, 2, 3, 4, 5, 9, 12, 15, 18, 21, 24, 30, and 36 months. FTIR and EIS tests were carried out to evaluate the corrosion protection ability of the coating system before exposure, and after nature weathering for one, two, and three years.

Figure 2. Physical photo of offshore platform exposure test site

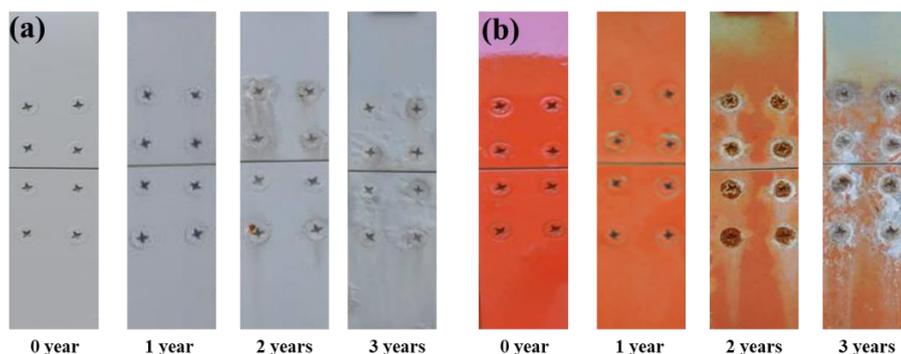
The surface appearance of the two coating systems after different times of exposure is shown in Fig. 3.

For coating system 1, as shown in Fig 3a, the overall coating system was in good condition after 1 year of exposure. No apparent change of color in the coating surface was observed, there was no obvious chalking in both the joint area and flat area and no screw corrosion occurred. After 2 years of natural weathering, the images clearly showed that the integrity of the coating was compromised especially in the joint area. More than half of the screws started to corrode. Besides, blisters appeared in the vicinity of the corrosive screws in the joint area, and a small degree of chalking was observed in

the flat area. At the end of the exposure (3 years), the coating system was severely damaged. Almost all screws suffered severe corrosion. The blistering of the coating in the joint area was significant and there was a tendency to spread to the flat area. The average thickness of the coating system in the flat area was slightly reduced to about 75 μm , as a medium degree of chalking was observed on all samples.

Figure 3. Appearance observed of tested coating systems before and after outdoor exposure with 1, 2, and 3 years (a) coating system 1; (b) coating system 2.

For coating system 2, a large degree of color change and gloss loss could be observed on the coating surface only after one year of exposure, as shown in Fig 3b. As the natural exposure time increased to two years, severe chalking occurred and the orange color of the finish gradually faded away. Almost all screws suffered severe corrosion and loose corrosion products adhere to the screw surface. At the end of the exposure (3 years), the coating system exhibited severe degradation. Parts of the coating in the joint area was almost completely peeled off, and the metal matrix was severely corroded. In the flat area, the orange color of the finish almost disappeared. the average thickness of the coating system was reduced to about 40 μm .

The results in Fig. 3 indicated that the integrity of the coating was compromised in the joint area. Compared with the flat area, the joint area of the samples was more susceptible to corrosion. This result was also supported by Momber [18], as flange connections were critical structural parts in terms of corrosion. Despite adequate coating protection applied to the screws, the joint area was still a relatively weaker area of the whole structure. Water and erosive ions in the atmosphere were more likely to penetrate the coating in this region and eventually induce corrosion and gradually spread to the flat area [18, 20, 21]. Thus, it is useful to perform the local repair at the joint area promptly after corrosion occurred near the screw spot during maintenance, which slowed the expansion of the corrosion to the flat area and delayed large-scale corrosion of the whole structure.

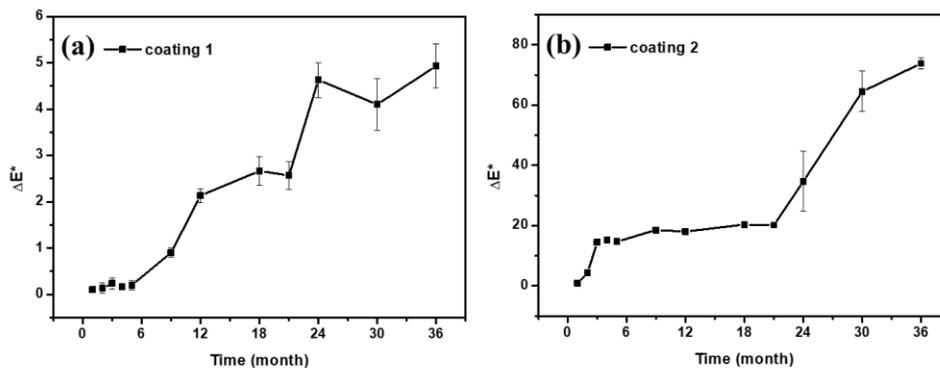
The changes in appearance for the surface of two coatings systems were quite different. To quantize and better understand the appearance change of the coating surface, the color change results before and after different natural exposure times are presented in Fig. 4. The surface color change of coating system 1 was not as obvious as the coating system 2.

Figure 4. Color change results of tested coating systems before and after outdoor exposure with different time (a) coating system 1 and (b) coating system 2

Fig. 4(a) displayed the color change of coating system 1 under different exposure times. During the first 9 months of exposure, ΔE^* values were all less than 1.5, which means the surface of the finish was generally not discolored. When the natural weathering time increased to 12 ~ 21 months, the coating system showed slight discoloration, with ΔE^* values concentrated in 2 ~ 3. After 24 months of exposure, the ΔE^* values further increased but still less than 5, and the ΔE^* value between 3.1 to 6 indicated that the coating system suffered a slight degree of discoloration [22].

As shown in Fig. 4(b), the surface of coating system 2 had undergone a large degree of color change at a very early time of exposure. Only after 3 months of exposure, did the ΔE^* values exceed 12, indicating a severe degree of discoloration [22]. After two years of exposure, the ΔE^* value further increased rapidly and even reached over 70 at the end of natural weathering. Such a large degree of color change was due to the severe chalking of the coating, which corresponded to the disappearance of the surface orange (Fig. 3(b)) and thinning of the overall thickness of the coating system.

Overall, the protective ability of coating system 1 was better than that of coating system 2, as it was also testified by smaller values of ΔE^* and gloss loss (Fig. 4 and Fig. 5), as well as larger $|Z|_{0.01\text{Hz}}$ values (Fig. 7) with different time of exposure. Our results indicated that the effective protective time of coating system 1 was about two years, while the coating system 2 was less than one year.

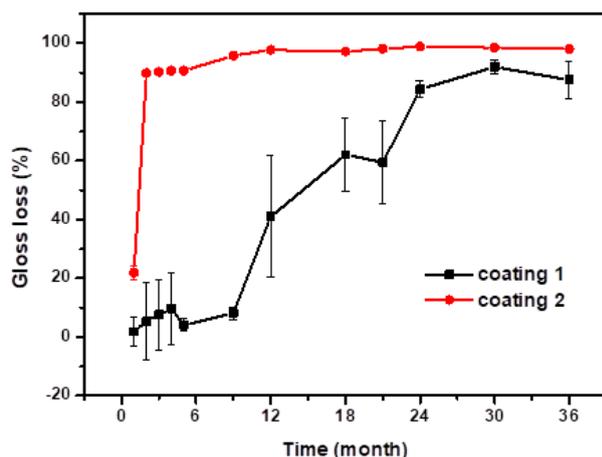
Figure 5. Gloss loss results of tested two coating systems before and after outdoor exposure with different time

Concerning gloss loss results shown in Fig. 5, a similar trend between gloss loss and color change was observed. The gloss loss of coating system 2 increased rapidly and reached about 90% only after only two months of exposure, indicating the gloss of the coating surface was almost completely lost at the beginning of the exposure. With the increase of exposure time, The gloss loss value of coating system 1 gradually increased: less than 30% within the first 9 months of exposure, about 40% to 60% with the exposure time from 12 to 21 months, and over 80% after 24 months of exposure. After 2 years of outdoor exposure, the coating system 1 also suffered severe gloss loss.

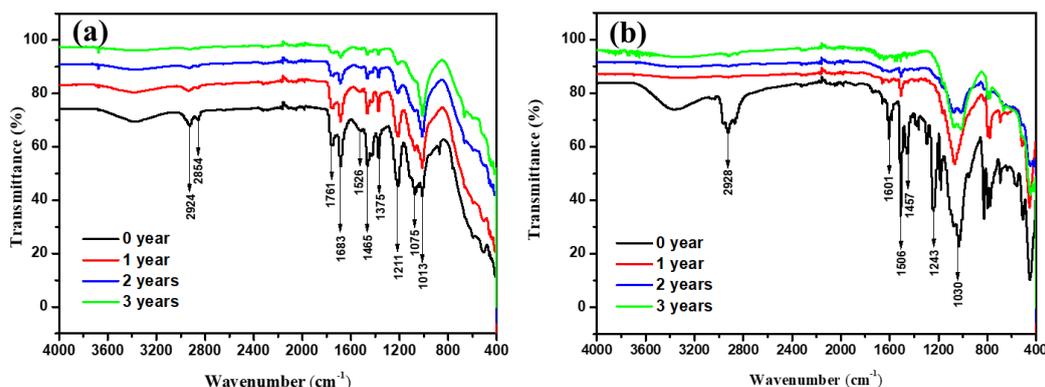
Figure 6. FTIR spectra obtained of tested coating systems before and after outdoor exposure with 1, 2, and 3 years (a) coating system 1 and (b) coating system 2

Fig. 6 shows the surface FTIR results of two coating systems obtained at different times of exposure. The absorption frequencies of major functional groups to the band attribution are summarized in Table 5. The peaks at 2928/2924 cm⁻¹ and 2854 cm⁻¹ were corresponding to the asymmetric and symmetric stretching vibration of -CH₂- respectively, while the bands of -CH₂- and -CH₃ bending vibration were at 1465/1457 cm⁻¹ and 1375 cm⁻¹. The strong peaks at 1761/1683 cm⁻¹ and 1243/1211 cm⁻¹ were attributed to stretching vibration of C=O and C-O in ester, respectively. It was also obtained bending vibration of N-H at 1526 cm⁻¹. And the peaks at 1601 cm⁻¹ and 1506 cm⁻¹ could be associated with C=C stretching vibration in aromatic rings, as well as C-F stretching vibration at 1075 cm⁻¹. The peak at 1030/1011 cm⁻¹ could be determined by C-O-C stretching vibration [9, 24-26].

Compared to the surface FTIR results before and after a certain period for exposure (Fig. 6), the peak intensity for major functional groups of both coating systems had occurred to decrease. However, the extent of variation of two coating systems was quite different, indicating the degradation processes of the two coating systems were somewhat different. For coating system 1 (Fig. 6(a)), with the increase of outdoor exposure time, the characteristic peaks such as C=O at 1761/1683 cm⁻¹ and C-O in ester at 1211 cm⁻¹ gradually decreased, but did not completely disappear even after three years of exposure, indicating that the main functional groups of the fluorinated polyurethane coating were in a process of gradual degradation. For coating system 2 (Fig. 6(b)), only after one year of exposure, a significant change in the chemical composition of the coating could be expected. Except for the peak at 1030 cm⁻¹ might be contributed by pigments, almost every peak, such as C=C in aromatic rings at 1601 cm⁻¹ and 1506 cm⁻¹ disappeared directly. The major functional groups of polymer resin were seriously damaged. A large degree of chalking occurred and small molecule products were gradually taken away by wind and rainfall, resulting in the severe loss of gloss and thickness under natural exposure [10]. Compared with the polyurethane finish, it is obvious that fluorinated polyurethane finish is more resistant to photoaging in the tropical marine atmosphere, as it is widely known that the anti-light aging capabilities of a coating system are mainly reflected in finish.

values of Y_{01} and Y_{02} were one to two magnitude higher than that of coating system 1 under the same exposure period, the larger values of coating capacity indicating the structure of coating were under greater damaged, further confirmed that the coating system 2 was less resistance to light aging, consistent with the results of FTIR spectra (Fig. 6).

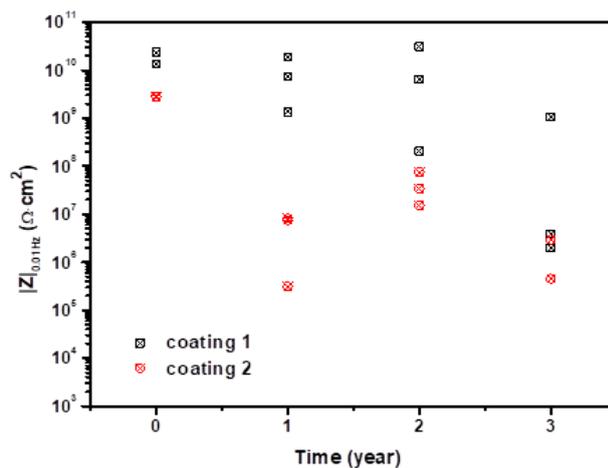
Fig. 7 shows the Impedance modulus at 0.01 Hz as measured by EIS for tested coating systems after different times of exposure. The $|Z|_{0.01\text{Hz}}$ data under each experimental condition were obtained from the same sample at three different test spots in the flat area. Before weathering, the $|Z|_{0.01\text{Hz}}$ values were relatively constant, in the order of $10^{10} \Omega \cdot \text{cm}^2$ for coating system 1 and $10^9 \Omega \cdot \text{cm}^2$ for coating system 2, demonstrating the initial coating systems had good uniformity at different test spots. After exposure for a certain time, the $|Z|_{0.01\text{Hz}}$ values at different test spots were somewhat different, and the variation trend of the two tested coating systems was different. For coating system 1, the $|Z|_{0.01\text{Hz}}$ values varied by about one order of magnitude at different test spots after exposure for one year. The variation further increased by about two and three orders of magnitude, as the $|Z|_{0.01\text{Hz}}$ values for different test spots were on the order of $(10^8 - 10^{10}) \Omega \cdot \text{cm}^2$ and $(10^6 - 10^9) \Omega \cdot \text{cm}^2$ after exposure for two and three years, respectively. For coating system 2, the $|Z|_{0.01\text{Hz}}$ values were on the order of $(10^5 - 10^6) \Omega \cdot \text{cm}^2$, $10^7 \Omega \cdot \text{cm}^2$ and $(10^5 - 10^6) \Omega \cdot \text{cm}^2$ with one, two, and three years of exposure, varied by about one order of magnitude at different test spots.

Figure 7. Impedance modulus at 0.01 Hz of tested two coating systems in 3.5 wt.% NaCl solution before and after outdoor exposure with 1, 2, and 3 years

The results in Fig. 7 indicated that there existed differences in the protective ability of the coating system within the flat area, especially for coating system 1. And the variation of $|Z|_{0.01\text{Hz}}$ value was about two and three orders of magnitude. After three years of exposure, the protective ability of two test spots was poor while one test spot still maintained good protection. It could be inferred that the joint area of a screw connection was not only more susceptible to corrosion, but also further increased the inconsistency of degradation performance for the coating in the flat area nearby. Therefore, to better evaluate the protective ability of an organic coatings system applied to a connection structure, it is necessary to select the test point at multiple locations.

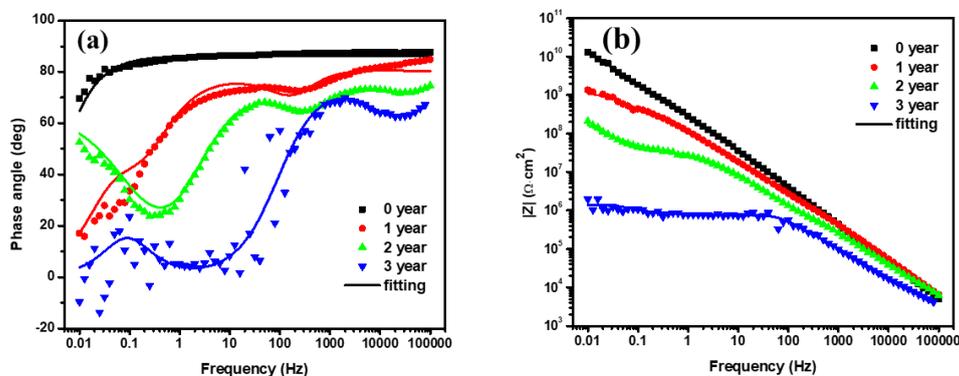
Fig. 8 and Fig. 9 show the typical EIS data in the form of Bode plots for the two tested coating systems after different times of exposure. Different equivalent electrical circuits (EEC), shown in Fig. 10, were used in this study to analyze and quantify the EIS data.

Figure 8. Typical EIS result for coating system 1 in 3.5 wt.% NaCl solution before and after outdoor exposure with 1, 2, and 3 years (a) Bode phase angle plots and (b) Bode impedance modulus plots.

Before the outdoor exposure of the sample, the phase angle of the impedance was close to 90° and the logarithm of impedance modulus and frequency was approximately a straight line over a wide frequency range: 10^5 - 10^{-1} Hz for coating system 1 as well as 10^5 - 10^0 Hz for coating system 2. The coating system can be viewed as a barrier with large resistance and small capacity. Thus, an EEC with a one-time constant (Fig. 10(a)) was used to fit the EIS data [25, 31]. In this equivalent circle, R_s is the resistance of solution, while Q_c and R_c represent the coating capacity and coating resistance, respectively. Pure capacitance was substituted by a constant phase element (Q) containing two parameters, Y_0 , and n to compensate for the non-ideality of the actual electrode system.

After exposure for a while, the electrode process of the coating system became much more complicated, as the combination of the coating deteriorated with the sunlight and corrosive related media such as H₂O, O₂, and Cl⁻ passed through the coating. A significant drop in impedance modulus had occurred (Fig. 8(b) and Fig. 9(b)) and more than one peaks and troughs appeared in the Bode phase angle plots (Fig. 8(a) and Fig. 9(a)). To better analyzed the coating system, EEC with three time constants (Fig. 10(b)) was applied to fit these EIS data. And in this equivalent circle, the first two time constants Q₁ R₁ and Q₂ R₂ represented the two-layer structure of the coating system, finish, and primer respectively, while the third time constant at the low-frequency region reflect the corroding information of anodized layer and aluminum alloy substrate. Due to the transfer difficulty of corrosive related media to the substrate and/or corrosion products away, a diffusion-controlled reaction sometimes happened following the corrosion process of substrate. Under this circumstance, a Warburg resistance (Z_w) at the low-frequency region was added to the EEC to fit the EIS data, as shown in Fig. 10(c) [32, 33].

In this study, three kinds of equivalent electrical circuits (Fig. 10) were used to fit these EIS data. The fitting data was also shown in straight lines in Fig. 8 and Fig. 9 and the fitting parameters of two coating systems are listed in Table 6 and Table 7, respectively.

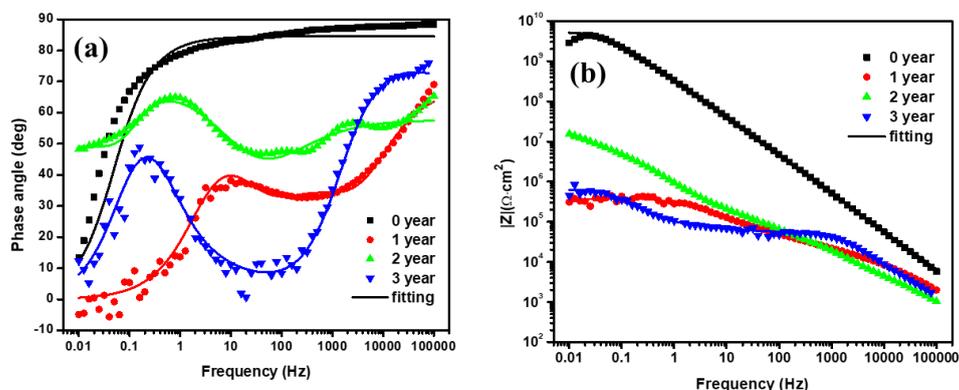
Figure 9. Typical EIS result for coating system 2 in 3.5 wt.% NaCl solution before and after outdoor exposure with 1, 2, and 3 years (a) Bode phase angle plots and (b) Bode impedance modulus plots

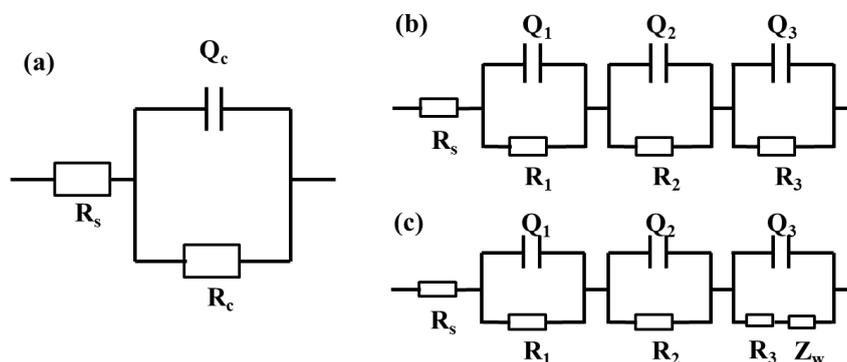
Figure 10. Equivalent electrical circuits (EEC) proposed to fit the EIS data in this study: (a) EEC with one time constant; (b) EEC with three time constants; (c) EEC with three time constants and diffusion characteristic.
