# The Corrosion Characterization in Simulated Heat-Affected Zones of X80 Pipeline Steel in Near-Neutral Solution

The microstructure evolution and corrosion characterization under elastic stress in near-neutral chloride bearing solution of X80 pipeline steel simulated heat-affected zone (HAZ) were studied. It is shown that the corrosion resistance in fine grain HAZ (FGHAZ) is the best which can be attributed to the fine grains and the uniform distribution of M/A islands. In addition, the corrosion resistance of coarse grain HAZ (CGHAZ) with high peak temperature is the weakest which can be attributed to the coarse microstructure. In addition, relatively high heat input should be taken to improve the corrosion resistance in CGHAZ. It is found that four couples of galvanic effects exist at least which can promote the occurrence of localized corrosion. The presence of two obviously different parts in corrosion morphologies and the presence of pitting holes which locate in M/A islands sites on base material and CGHAZ surfaces can be attributed to the galvanic effects.

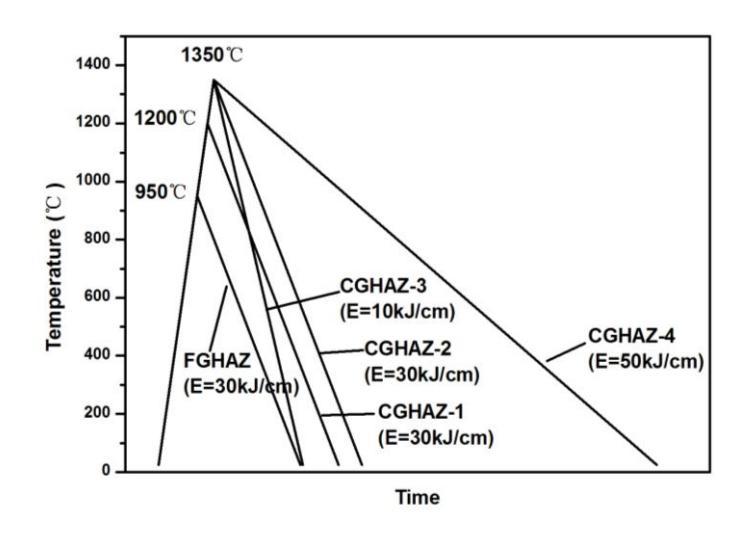
Figure 1. The schematic diagram of the thermo-mechanical simulation processing

from X80 pipeline steels of 26.4mm thickness and then dried for 1h at 150°C. The vacuum levels were down to  $10^{-9}$  atm in the machine during heating and cooling cycles. The samples were heated up to different peak temperature at a rate of 160°C/s and then cooled down to ambient temperature. The specific parameters are shown in Fig.1 and Table 1.

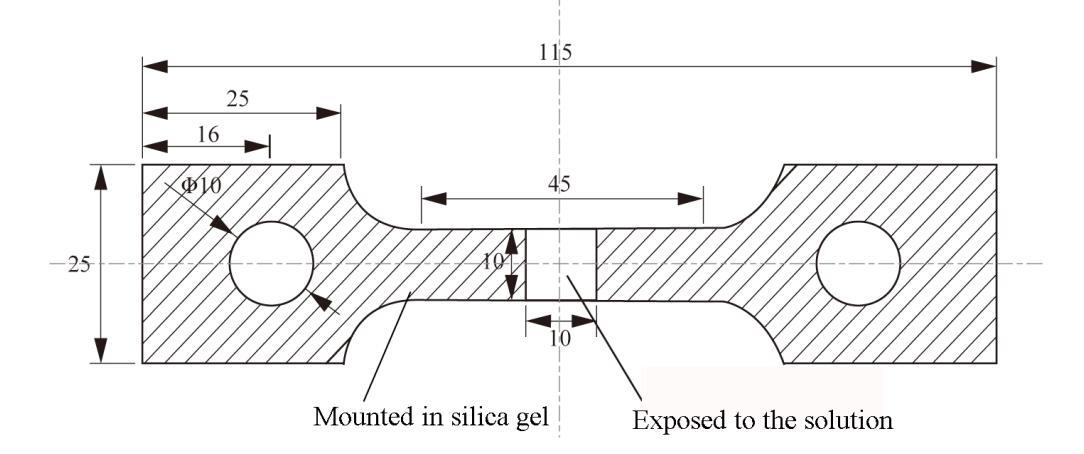
Figure 2. The schematic diagram of specimens for the corrosion experiments

The schematic diagram of specimens for the corrosion experiments is shown in Fig.2 in which it can be seen the area exposed to the solution is  $1 \text{cm}^2$  and the electrochemical measurements were performed on this rectangle-type area. Prior to the immersion and electrochemical measurements, the specimens were grounded up to 800 grit emery paper along the tensile direction, cleaned with acetone, alcohol and distilled water in sequence and then mounted in silica gel. In the immersion and electrochemical tests, the stress of 500MPa which is close to the yielding strength was applied on the specimen.

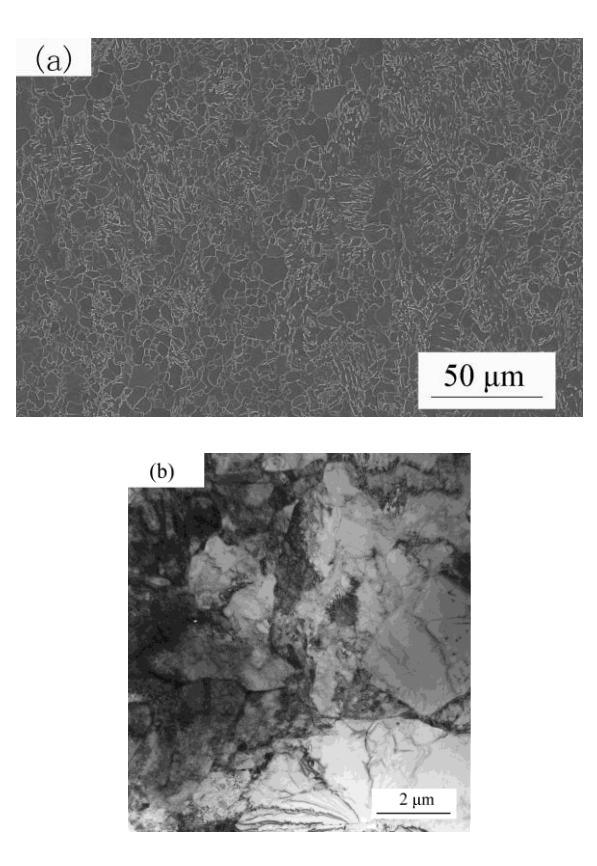
Figure 3. The morphologies of base material microstructure (a) SEM (b) bright field of TEM

The microstructure of X80 pipeline steel base material used in this study is shown in Fig.3. It is shown that the X80 steel is one kind of dual-phase steel, The microstructure is polygonal ferrite with fine grain and granular bainite embellished by martensite plates and retained austenite (so called M/A islands) as the secondary phase. In Fig.3 (b), it can be seen clearly that the dislocation density in granular bainite zone is much higher than the polygonal ferrite zone. It has been demonstrated that the appropriate dual-phase design can promote the mechanical properties, especially the high-deformation capacity [20-22].

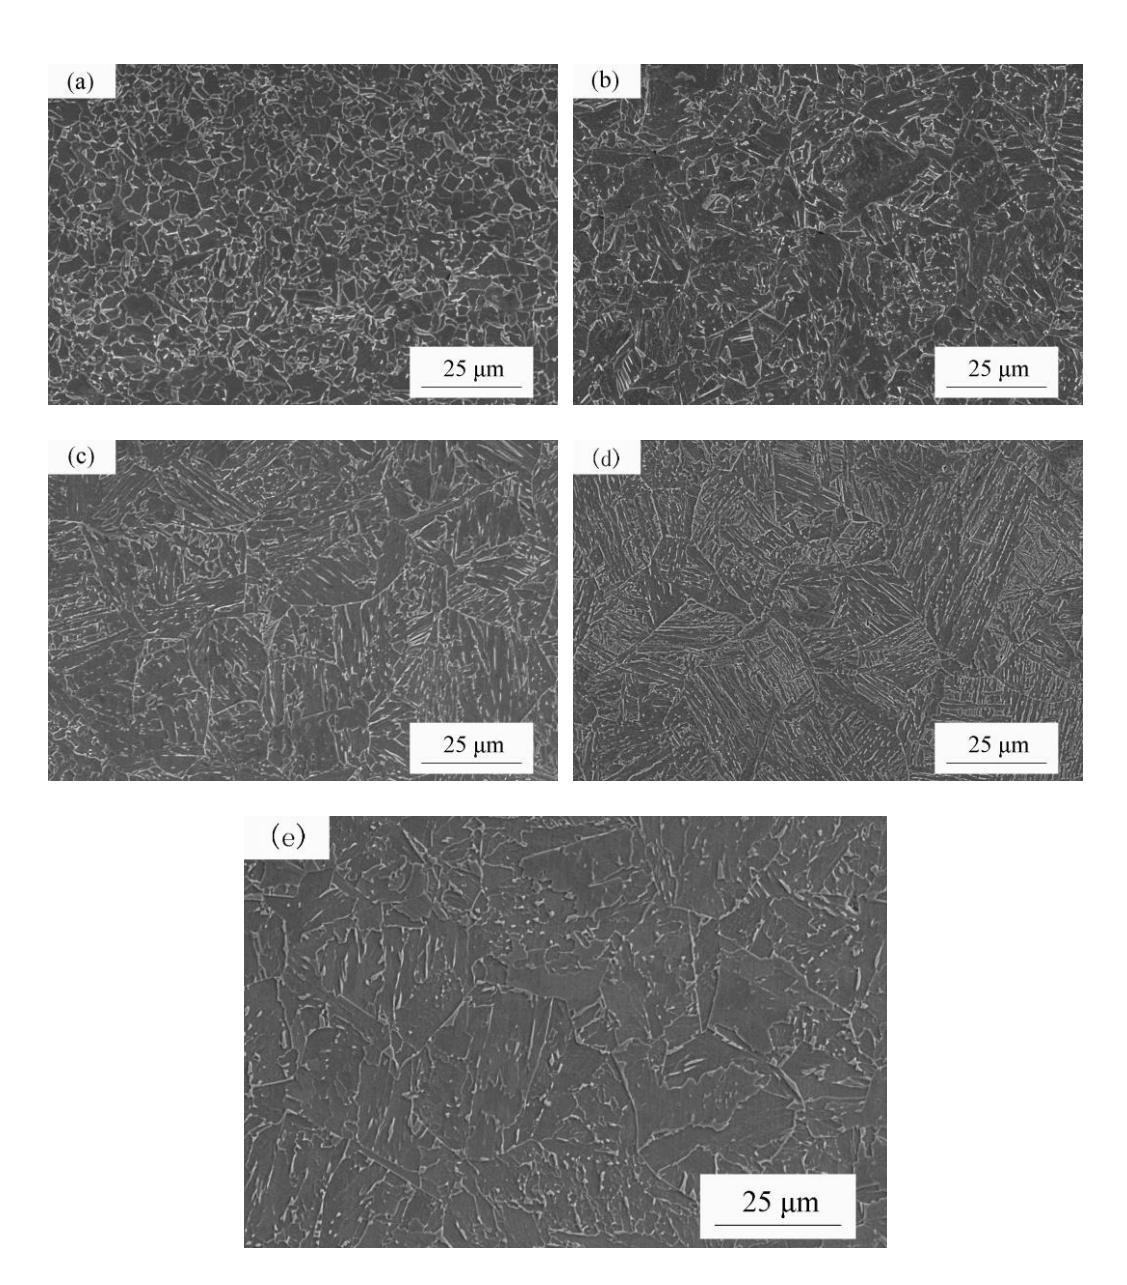
**Figure 4.** The SEM micrographs of microstructure in HAZs (a) FGHAZ (b) CGHAZ-1 (c) CGHAZ-2 (d) CGHAZ-3 (e) CGHAZ-4

It is known that the HAZ microstructure depends highly on the applied welding thermal cycles [16,23,24] in which the peak temperature and heat input are responsible for the process of nucleation and growth of the grains. It can be seen that an obvious microstructure gradient is generated due to the peak temperature differences in Fig.4 (a)-(c). It is shown that the FGHAZ microstructure is mainly polygonal ferrite with finer grains than base material which is beneficial to the mechanical properties as the Hall-Petch form. In addition, a little sum of M/A islands as secondary phase can be seen which distributes more dispersively compared with base material. However, the microstructure in CGHAZ-1 and CGHAZ-2 is mainly granular bainite in which the prior austenite grain boundaries and granular bainite grain boundaries are embellished by M/A islands. In addition, the M/A islands are parallel to each other in one prior austenite grain, but not in different austenite grains. What's more, the prior austenite grain size in CGHAZ-2 is much larger than CGHAZ-1 due to the higher peak temperature.

The prior austenite grain size is similar for the CGHAZs with the same peak temperature and different heat inputs, as is shown in Fig.4 (c)-(e). The microstructure in CGHAZ-3 is mainly bainite ferrite in which the M/A islands present needle-like with high length-width ratio. It is known that the lower the heat input, the higher the condensate degree and the more the nucleation sites resulting that the ferrite lath and M/A islands are much narrower. However, the microstructure is coarsened seriously when the heat input is 55 kJ/cm as is shown in Fig.4(e). The M/A islands show coarsen granular-like with low length-width ratio. In addition, the Widmannstatten ferrite can be seen near the prior austenite

grain boundaries. What's more, it can be seen clearly that the concentration of M/A islands decreases and the size increases as heat input increases for the CGHAZs with the same peak temperature.

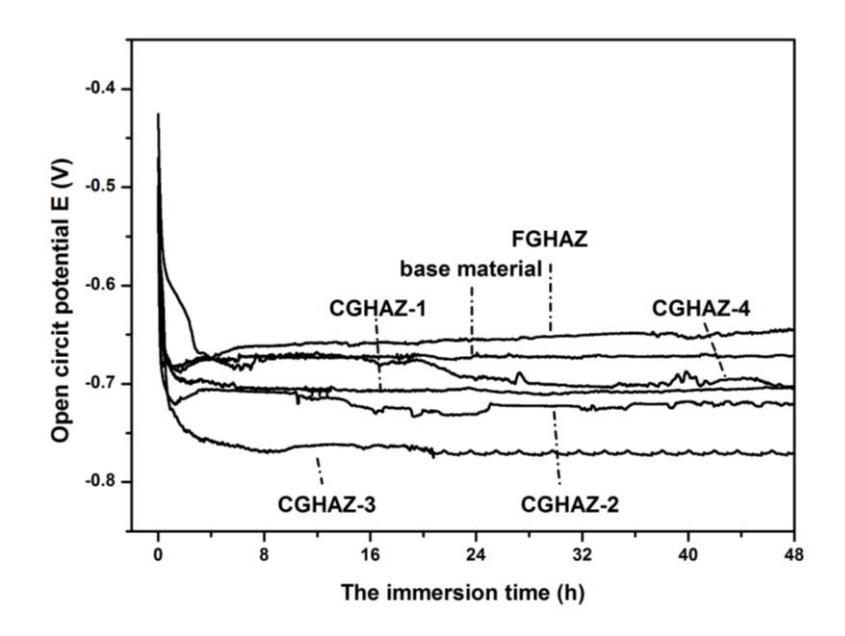
Figure 5. The change regular of OCP vs. immersion time of different electrodes in the studied condition

The OCP time dependence of different electrodes in the studied condition is shown in Fig.5. It is seen that the OCP values of all electrodes shifted negatively at first and tended to be stable after about several hours indicating that the electrochemical measurements should be conducted after immersion for several hours to make sure the results accuracy.

It can be seen that the OCP is obviously different for different electrodes indicating that the galvanic effect (the first couple of galvanic effect) will be introduced when the welded joint is immersed in the solution. It is known that the more negative the OCP, the higher the driving fore to be attacked. It is apparent that the OCP of base material is more negative than FGHAZ and much more positive than CGHAZ indicating that the CGHAZ may be attacked preferentially. In addition, the OCP of CGHAZ-1 is more positive than CGHAZ-2. In addition, it can be seen that there is a high content increase of OCP with the increasing of heat input.

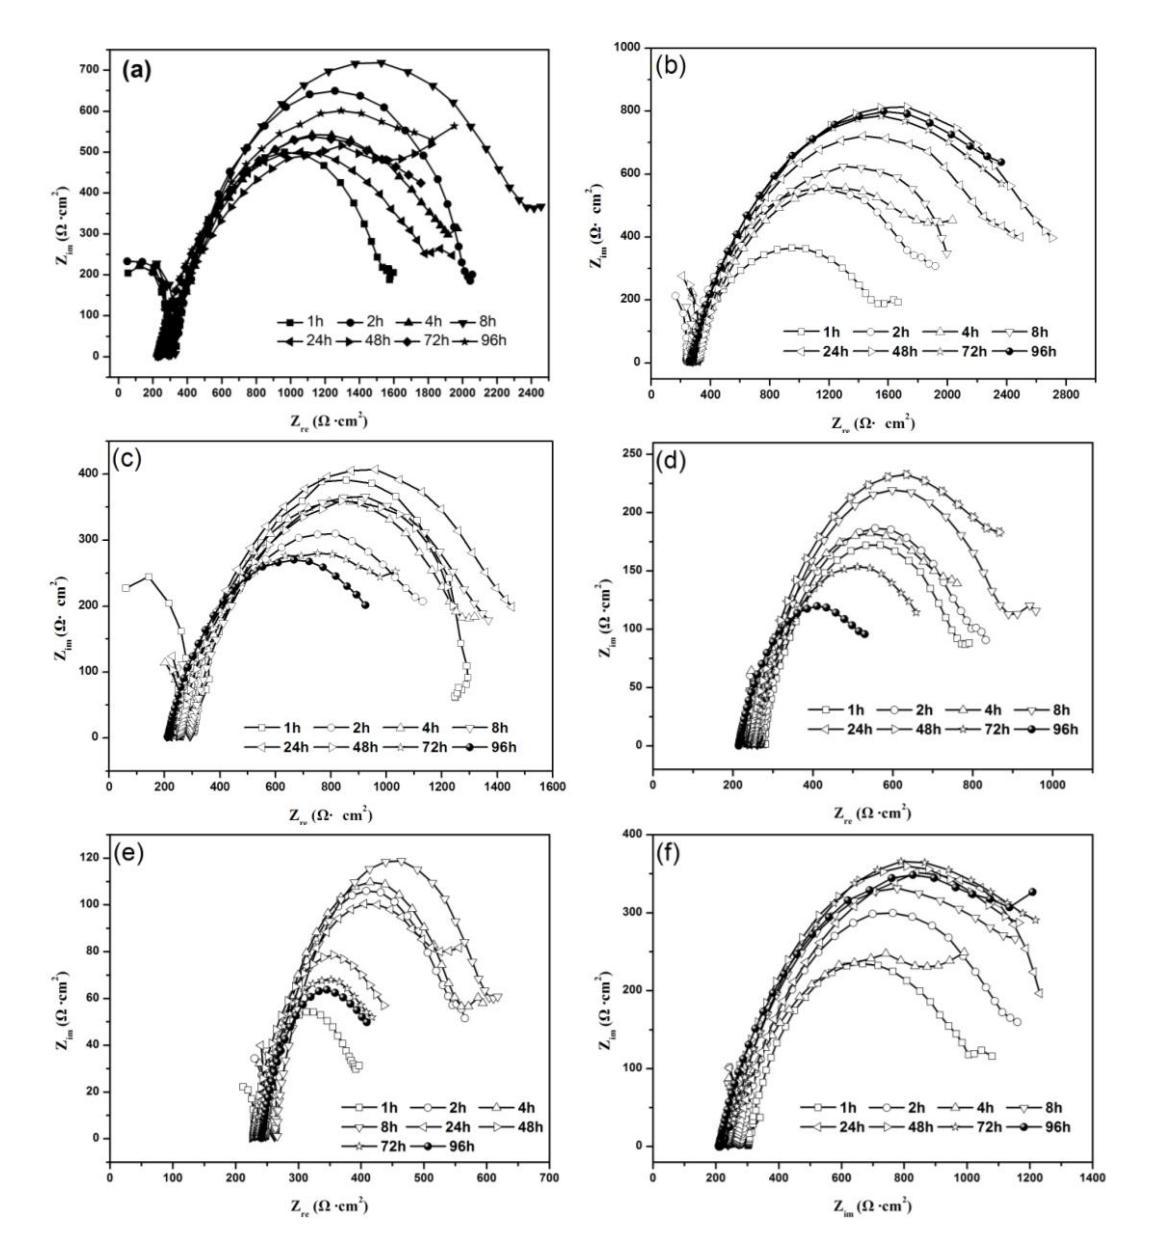
**Figure 6.** The Nyquist plots of electrodes under different immersion time (a) base material (b) FGHAZ (c) CGHAZ-1 (d) CGHAZ-2 (e) CGHAZ-3 (f) CGHAZ-4

The EIS measurements were carried out to study the effects of microstructure on corrosion behaviors under different immersion time. The Nyquist diagrams under immersion for 1h, 2h, 4h, 8h, 24h, 48h, 72h and 96h were shown in Fig.6. It can be seen that the impedance feature of all electrodes under different immersion times is similar, i.e., only depressed semicircle in the first quadrant over the whole measured frequency range. The electrochemical equivalent circuit of  $R_s(Q_{dl}R_{cl})$  was used to fit the impedance data, in which  $R_s$  is solution resistance,  $Q_{dl}$  is the constant phase element (CPE) for the double-charge layer and  $R_{ct}$  is the charge transfer resistance. The CPE was used as the non-ideal capacitance (n<1) to account for heterogeneities of the double-charge layer, as:  $Z_{CPE} = [Q(jw)^n]^{-1}$ , where  $j = \sqrt{-1}$ , n is the CPE exponent, and w is the angular speed. Actually, pure capacitive behavior is represented by n=1 and Warburg resistance is represented by n=0.5. Fig.7 shows the fitted values of charge transfer resistance  $R_{ct}$  which can represent the corrosion resistance.

It is apparent that the change regulars of the size of the semicircle and  $R_{ct}$  are the same which depends highly on the microstructure and immersion time. It is seen that  $R_{ct}$  increases at initial 24h for all electrodes which can be attributed to the oxidation of the initially fresh surface and the formation of relatively thick corrosion product layers on the steel surface. For base material, CGHAZ-1, CGHAZ-2 and CGHAZ-3,  $R_{ct}$  continues to decrease as the immersion time increases continuously. However,  $R_{ct}$  increases continuously for FGHAZ and CGHAZ-4 although the increase extent slows down. It is indicated that there must be different phenomena happened on different electrodes surface indicating that it needs further studies.

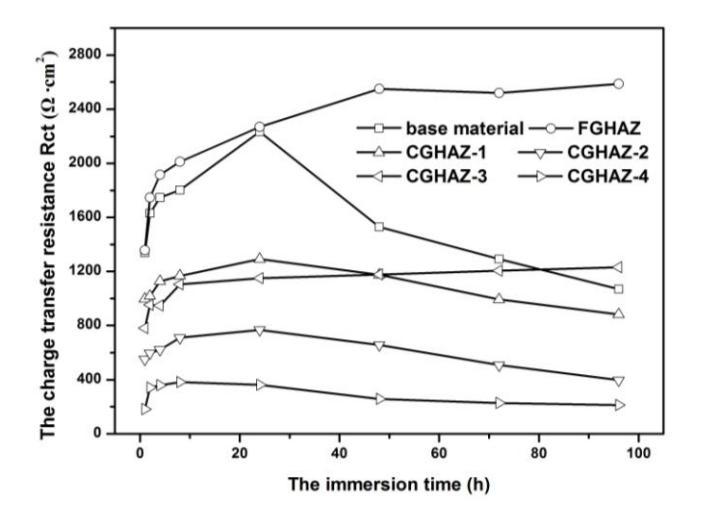
**Figure 7.** The fitted results of charge transfer resistance R<sub>ct</sub> of different electrodes under different immersion time

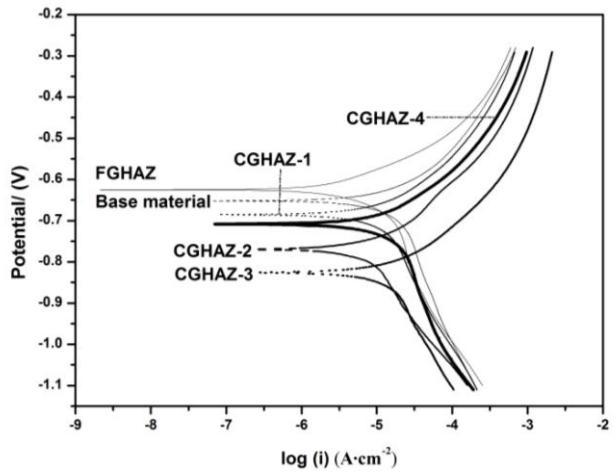
**Figure 8.** The potentiodynamic polarization curves of the base material and HAZs in the studied solution with the applied stress of 500MPa

Fig.8 shows the results of potentialdynamic polarization measurements of different electrodes in the studied condition. It is apparent that all electrodes are in active state and the anodic processes are controlled by charge-transfer processes indicating that all electrodes are unable to be passivated in the measured corrosion condition and potential range. The plots were simulated by Tafel Curve Fitting methods to get the anodic and cathodic Tafel slopes ( $b_a$  and  $b_c$ ), corrosion potential ( $E_{corr}$ ) and corrosion current density ( $i_{corr}$ ). The fitting results are shown in Table 2. It is seen that the values series of the corrosion potential ( $E_{corr}$ ) are in accordance with OCP. However, it can be seen that the difference in anodic and cathodic Tafel slopes can be negligible indicating that the minor effect of microstructure evolution on the corrosion kinetics. In addition, it is shown that the corrosion current densities for different electrodes are in the same orders of magnitude and the differences among them can be ignored.

**Table 2.** The corrosion potential  $(E_{corr})$  and corrosion current density  $(i_{corr})$  obtained from Fig.8 by Tafel Curve Fitting methods

It is indicated that no correlation between the microstructure evolution and the corrosion rate of different electrodes at corrosion potential can be seen when the electrodes were immersed into the solution individually which is in accordance with the previous study [24]. But there are obviously differences in the current densities in anodic polarization zones can be seen, the series are FGHAZ<br/>base material <CGHAZ-1<CGHAZ<4<CGHAZ<2<CGHAZ-3.

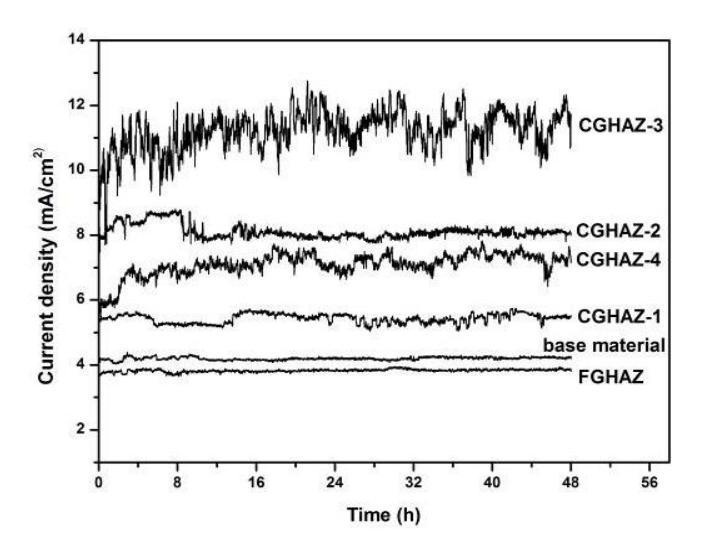
Figure 9. The anodic current density of different electrodes potentiostatically polarized at -0.3V (SCE)

Fig.9 shows the time dependence of anodic dissolution current density of the base material and HAZs potentiostatically polarized at -0.3V (SCE). It is seen that the anodic dissolution current density series are in accordance of anodic zone of potentiodynamic polarization curves. It is shown that the anodic dissolution current density of FGHAZ is lower than base material and the anodic dissolution current density of CGHAZ is higher than base material. The anodic dissolution current density of CGHAZ-1 is lower than CGHAZ-2 indicating that the higher the peak temperature, the anodic dissolution current density. In addition, it is evident that the lower the heat input for those CGHAZs with the same peak temperature, the higher the anodic dissolution current density.

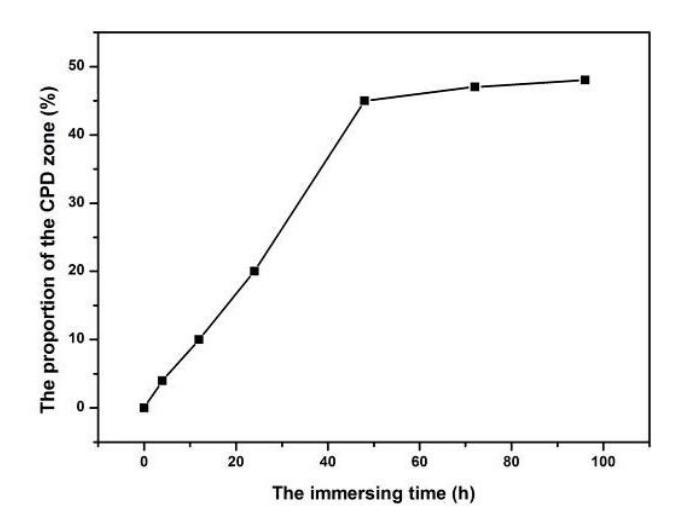
Figure 10. The effects of immersion time on the proportion of the CPD zone

It can be seen clearly by naked eyes that the surface of the specimen after immersion in the studied solution can be divided into two obvious different parts. In one part, the surface of the specimen is bright and the corrosion products have fallen off the surface when the specimen was taken out from the solution so that it can be called "corrosion product desquamate" (CPD) zone. However, in the other part, the corrosion product is adhered to the dark and dim surface of the specimen strongly in which the corrosion products can not be divided by ultrasonic cleaning with alcohol so that it can be called "corrosion rates. The surface of the CPD zone is lower than the CPA zone indicating that the corrosion rate of the former is higher. It is indicated from Fig.10 that the proportion of the CPD increases linearly at first and then it will stabilize at about 50% after 2days.

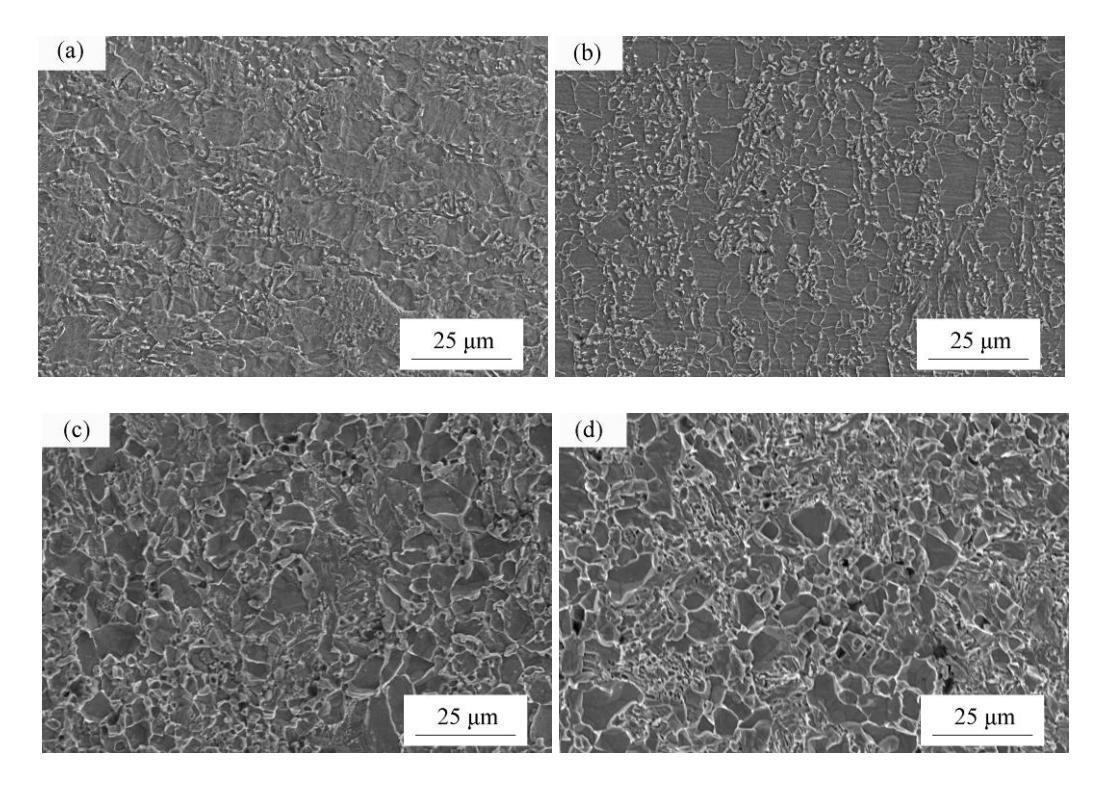
Figure 11. The corrosion morphology of X80 in NS4 solution (a) 4h (b) 1 day (c) 2 days (d) 4days

The corrosion morphologies of base material in the CPD zone under different immersion time are shown in Fig.11. As is shown in Fig.10 (a), the surface of the sample becomes rough and asperous after immersion for 4h. The scratches left in the electrodes preparation processing can't be seen indicating that the corrosion depth is bigger than the depth of the scratches at least. However, the microstructure can not be identified clearly and no obvious pitting holes can be seen. In Fig.10 (b), it can be seen that the microstructure of polygonal ferrite and granular bainite has been clearly identified after immersion for 1 day. In addition, some small pitting holes can be seen in granular bainite zones. Fig.10 (c) shows that many big pitting holes can be seen clearly in the grain boundaries are prominent and the grain sags from the grain boundaries is better than the inner grain which can be attributed to the collection of alloying elements, such as Cu, in the grain boundaries. What's more, the similar corrosion morphologies can be seen after immersion for 4 days.

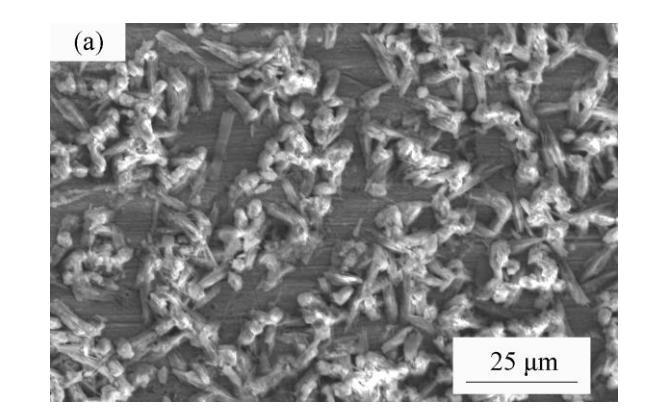
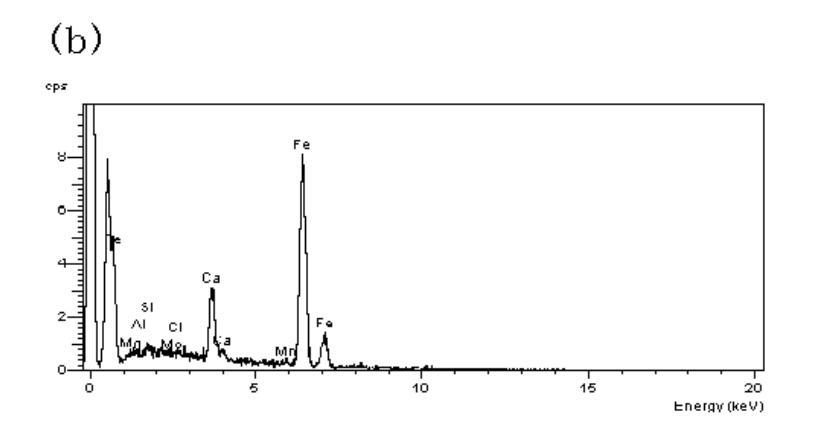
**Figure 12.** The SEM micrograph and EDS result of corrosion product layer generated in the CPA zone (a) the SEM micrograph (b) The corresponding EDS result

The SEM micrographs of the corrosion product film that adhered in the CPA zone after immersion for 4 days in the NS4 solution are shown in Fig.12(a). It is indicated that the bright beam-shaped corrosion products didn't cover the whole surface and the scratches left in the sample preparation processing can be seen clearly in the exposed part indicating that the corrosion is not serious compared to the CPD zone. From the EDS of the CPA zone, it is indicated that the corrosion product is rich in Ca and Fe.

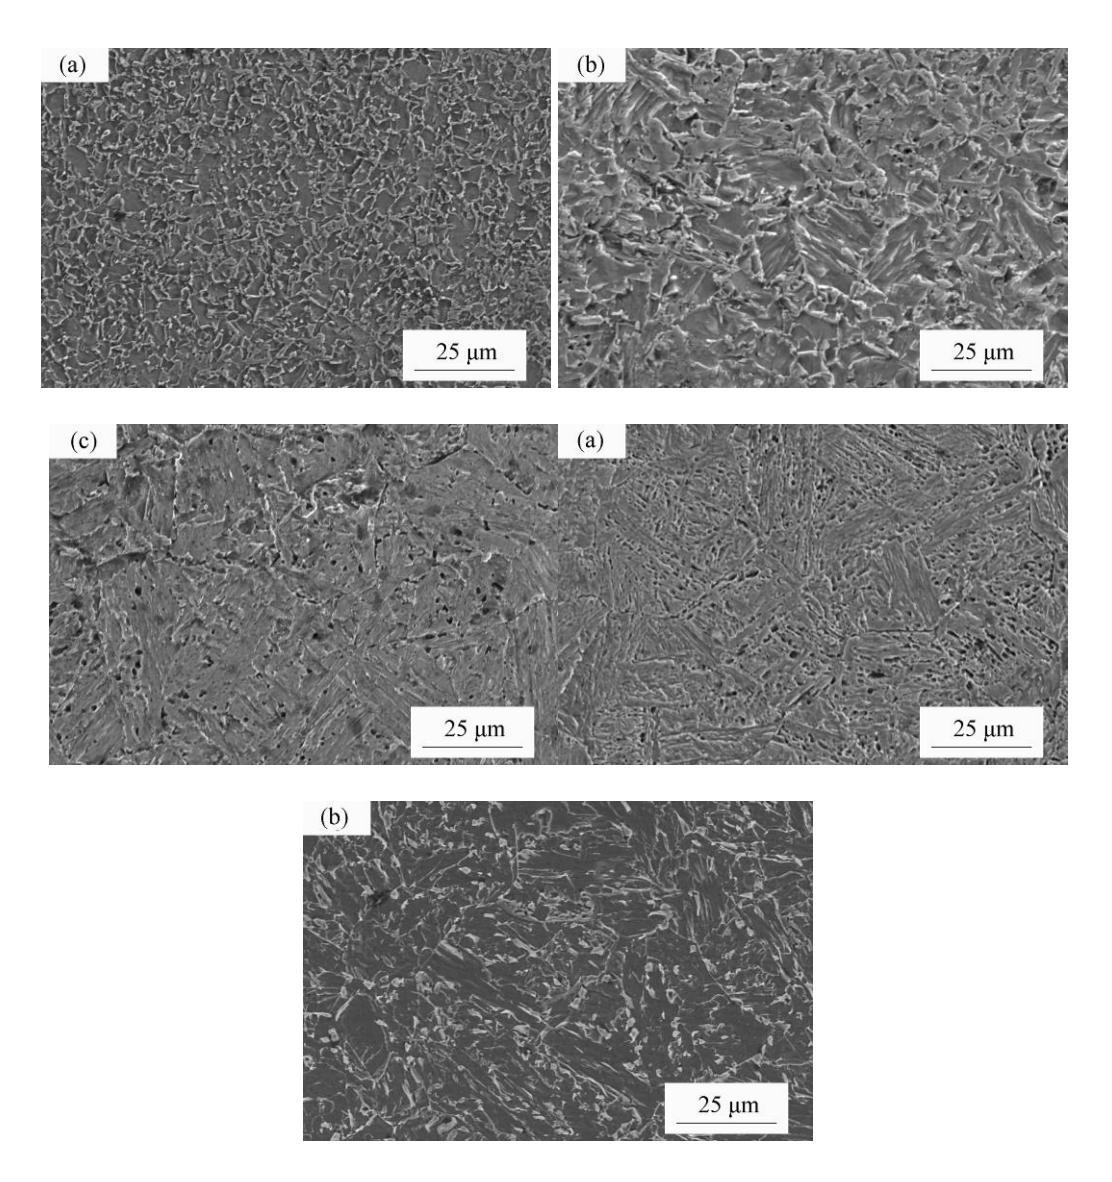
**Figure 13.** SEM of corrosion morphologies in CPA zone of HAZs after immersion for 2 days (a) FGHAZ (b) CGHAZ-1 (c) CGHAZ-2 (d) CGHAZ-3 (e) CGHAZ-4

The corrosion morphologies in CPD zones of HAZs after immersion for 2 days are shown in Fig.13. Fig.13 (a) shows that there is almost no pitting hole can be seen in FGHAZ surface in this magnification after immersion for 4 days.

Fig.13 (b) shows that the corrosion morphologies of CGHAZ-1 present river-like shape and some pitting holes can be seen. However, it seems difficult to identify where the pitting holes locate. Fig.13 (c) shows that many big pitting holes can be produced along the prior-austenite grain boundaries or inner of the prior austenite on CGHAZ-2 surface. In addition, some close pitting holes grow up to connect with each other resulting that some cracks are generated. In Fig.13 (d), it is shown that many dense and favaginous pitting holes can be seen and many holes have grown up to connect with others on CGHAZ-3 surface. The density of pitting holes is much higher than CGHAZ-2 although the size is smaller. Furthermore, it is interesting that the pitting holes line is parallel to the M/A islands and bainite lath in one austenite grain. However, the pitting corrosion of CGHAZ-4 is not seriously which is shown in Fig.13 (e). It is shown that there is only a little sum of pitting holes which locate on coarse M/A islands.
