# Electrochemical Corrosion Behavior of X70 Steel in Sand Soil Contaminated by Copper(II)

X70 steel, a common pipeline material for the long distance transport, has been extensively used in many domestic and overseas underground projects, for example "West-East" project of P. R. China. In order to study the effect of heavy metal copper(II) on the corrosion performance of X70 steel, electrochemical corrosion tests were conducted on X70 steel in sand soil for 35 d. The macro-/micromorphology, surface composition, polarization curve, electrochemical impedance spectroscopy (EIS)of X70 steel were characterized by scanning electron microscope (SEM), energy dispersive spectrometer (EDS), and electrochemical workstation, respectively. Five different concentrations of copper(II) were added into the sand soil simulated medium. The macro-/micro- morphology acquired by Canon 6D SLR cameras and SEM. The testing results showed that the copper(II) significantly affected the corrosion performance of X70 steel in sand soil. And corrosion products of X70 steel in sand soil contaminated by copper(II) exhibited colors such as yellow, red-brown, brown, black etc. It was the mixture of compound with Fe

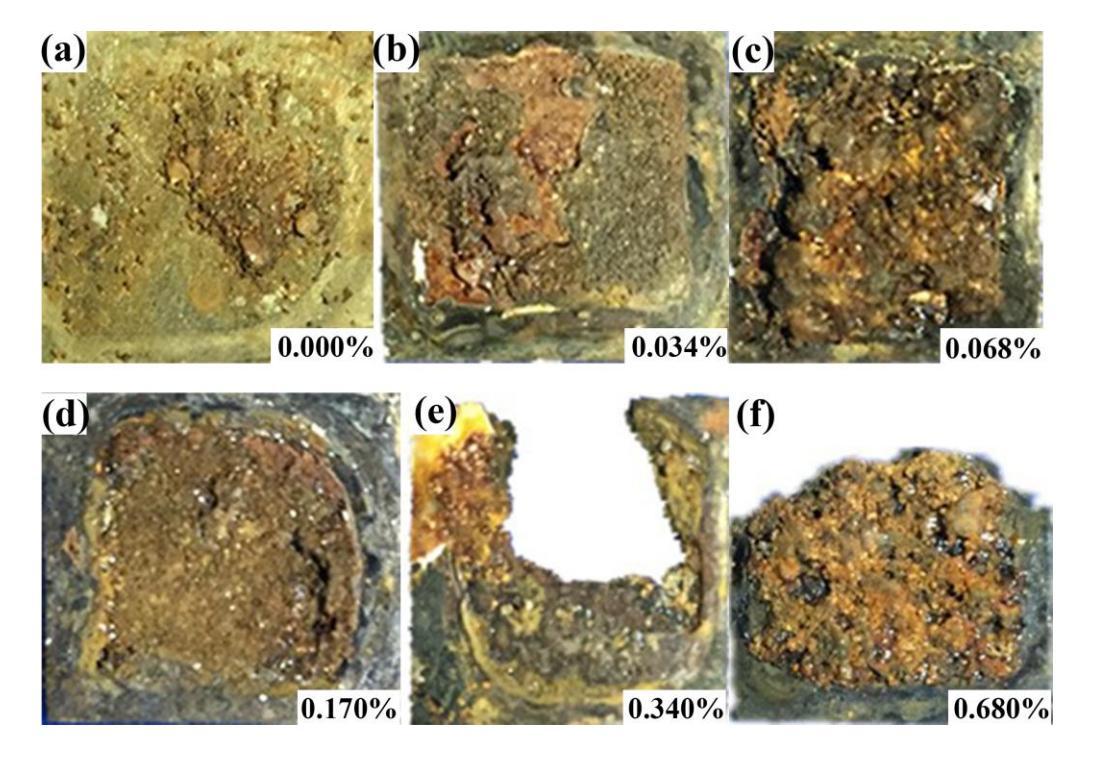
Figure 1 and Figure 2 are the macro corrosion morphology of X70 embedded in contaminated sand soil with different copper(II) (for 35 d) after cleaning the loose sand and rust cleaning. Obviously, the corrosion degree of X70 steel in copper(II) contaminated sand soil is larger than that in sand soil without contamination and it increase with the increase of copper(II) content. While the corrosion degree of X70 in soil contaminated by copper(II) for 35 d generally is more serious than that in soil contaminated by NaCl, NaOH for nearly the same time (28 d). And with the increase of contaminated by copper(II) are consistent with that in soil contaminated by NaCl and H<sub>2</sub>SO<sub>4</sub>, but contrast to that in soil contaminated by NaOH [19-21]. Overall invagination at 0.170% and even partial deletion at 0.340%, 0.680% appeared on the X70 samples. In addition, the hard compound of corrosion products and sand exhibited various colors such as yellow, red brown, brown, black etc. and was closely combined with the substrates. In terms of the sand soil, the sand particles in the vicinity of sample (range of a few centimeters) presented red-brown and the color of them became darker with the decrease of distance to sample and the increase of copper(II) content. And with the increased.

Figure 1. Macro corrosion morphology of X70 steel in sand soil contaminated by different concentration of copper(II) for 35d (Before rust cleaning):(a)0.000%, (b)0.034%, (c)0.068%, (d)0.170%, (e)0.340%, (f)0.680%.

These colorized corrosion products (Figure 1) adhered to the sample can be inferred as iron oxides and pure copper simple substance. On the one hand, the adhesive effect of corrosion products on loose sand lead to the formation of compound firmly stuck on the surface of the specimen. On the another hand, the various ions generated through electrode reaction spread into the depths of sand medium by diffusion, thus there were  $Fe^{2+}$  and  $Fe^{3+}$  even at the depths away from the electrodes. The corrosion products formed by the reaction of ions deposited on the surface of sand particles and hydroxide also covered on the sand particles. All of the above affect the formation of color sand products which is different from that of X70 steel formed in soil without copper(II) contamination and contaminated by NaCl and H<sub>2</sub>SO<sub>4</sub>[20,21]. And the corrosion products with different colors are difficultly removed from the substrate by mechanical means. While small amount of sand particles adhesion to the samples was very easy to remove and the sand nearby the samples presents the original pale yellow. That also show that the corrosion degree of the X70 steel in sand soil without copper(II) contamination was light and the corrosion products were less. In contrast, the corrosion products of X70 steel formed in soil contaminated by H<sub>2</sub>SO<sub>4</sub> of low contents were difficultly removed from substrate by cotton swab, while the corrosion products of X70 steel formed in soil contaminated by H<sub>2</sub>SO<sub>4</sub> of high contents fall off automatically[21].

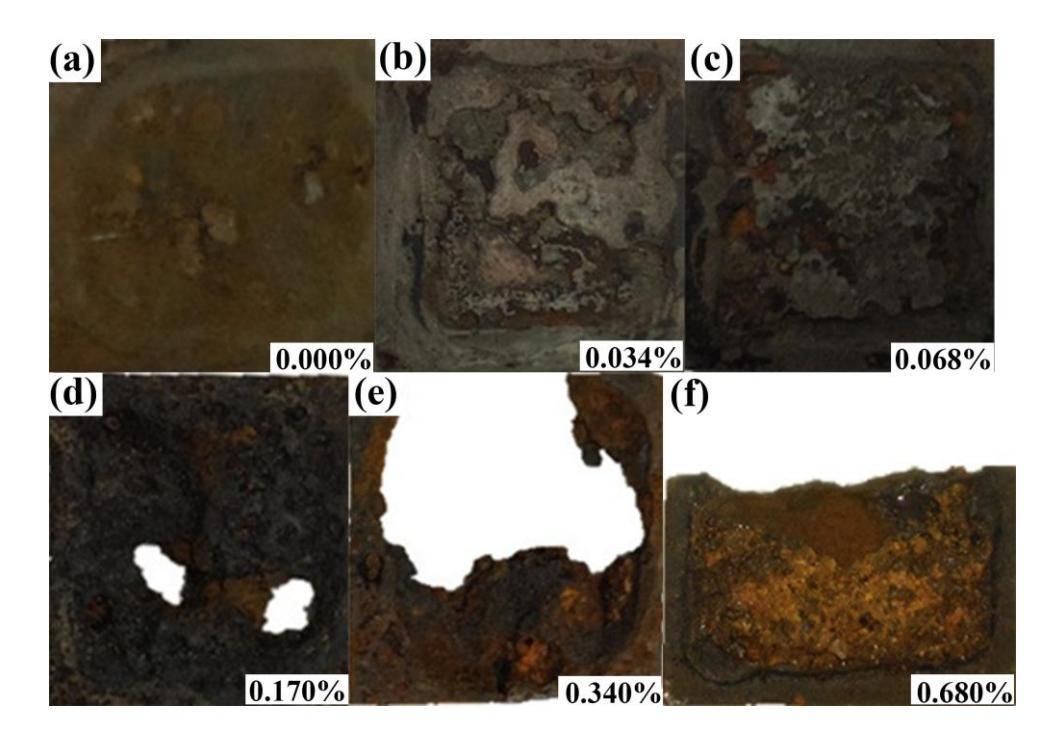
As shown in Figure 2, there were only some small localized corrosion pits and tiny loosen of original metallic luster on the steel samples in the sand soil without copper(II) contamination. When the content of copper(II) was 0.034% and 0.068%, the corrosion degree of samples significantly increased and showed typical localized corrosion. Etch pits mainly distributed at the edges of sample, while the pits of 0.068% were deeper than that of 0.034% and a long around "tunnel" formed. Besides, in the central part there was large un-corroded areas at 0.034%, but only many tiny corrosion pits, not as a whole, existed in the central part at 0.068%. When the content of copper(II) was 0.170%, the corrosion of samples was further increased. Dull surface, integrally collapsed corrosion pits with uneven interior and even two penetrated regions of  $2 \text{ mm}^2$  formed on the samples. This phenomenon was caused by the increasingly large and connection of corrosion pits and the growing increase of anode dissolution caused by the autocatalytic effect in individual region. When the content of copper( II) was 0.340% and 0.680%, the corrosion is considerably serious. The perforated regions connected into a whole and there were a large area and more than half deletion appeared at 0.340% and 0.680% respectively. Compared to the corrosion of X70 in other contaminated soil, pitting is the mainly corrosion form of X70 in soil contaminated by NaCl of 18.0 g/kg and all concentration of NaOH. Comprehensive non-uniform corrosion is the corrosion form of X70 in soil contaminated by low concentration of H<sub>2</sub>SO<sub>4</sub> (1.5, 4.5 g/kg) and non-uniform corrosion is that in soil contaminated by high concentration of H<sub>2</sub>SO<sub>4</sub> (9.0, 18.0 g/kg) for 112 d[19-21].

Figure 2. Macro corrosion morphology of X70 steel in sand soil contaminated by different concentration of copper(II) for 35d (After rust cleaning):(a)0.000%, (b)0.034%, (c)0.068%, (d)0.170%, (e)0.340%, (f)0.680%.

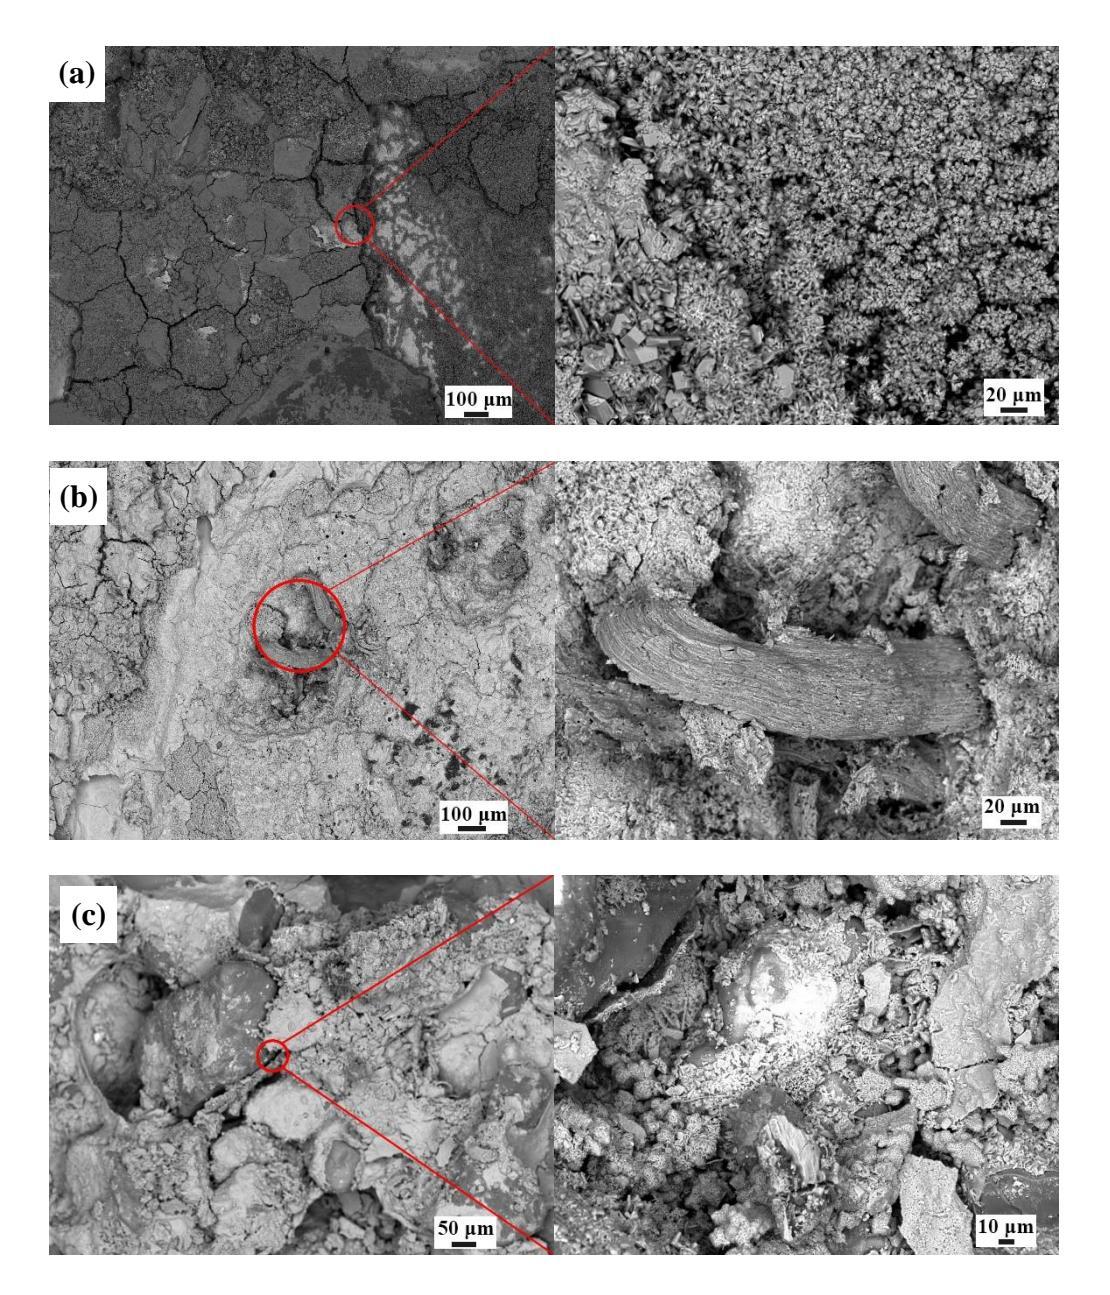
Low and high magnification ( $\times 30 \sim \times 1000$ ) of microscopic corrosion morphology of the samples in contaminated sand soil with different copper(II) before and after the rust cleaning were as shown in Figure 3 and Figure 4. Seen from the low magnification morphology, the corrosion product layers present different degrees of cracking. This will be the diffusion channel of corrosive media to the under of corrosion product layer and the effect of "blocking corrosion battery" further promoted the pitting. In addition, microcracks in pitting pits connected to each other and extended to the internal of metal. And then stress corrosion cracking (SCC) appeared on the surface of X70 steel in a large scale[25]. Many corrosion products deposited on the sand particles and there were also thin layer of corrosion products on the samples as see in Figure 3. In addition, local cracks and peeling of the products layer appeared. And the forms of corrosion products, such as grainy, coral, irregular polyhedral, flaky etc., became increasingly complex with the increase of copper(II) concentration.

**Figure 3.** Typical micro corrosion morphology of X70 steel in different copper(II) contaminated sand: (a)0.034%, (b)0.170%, (c)0.680%. (Before rust cleaning)

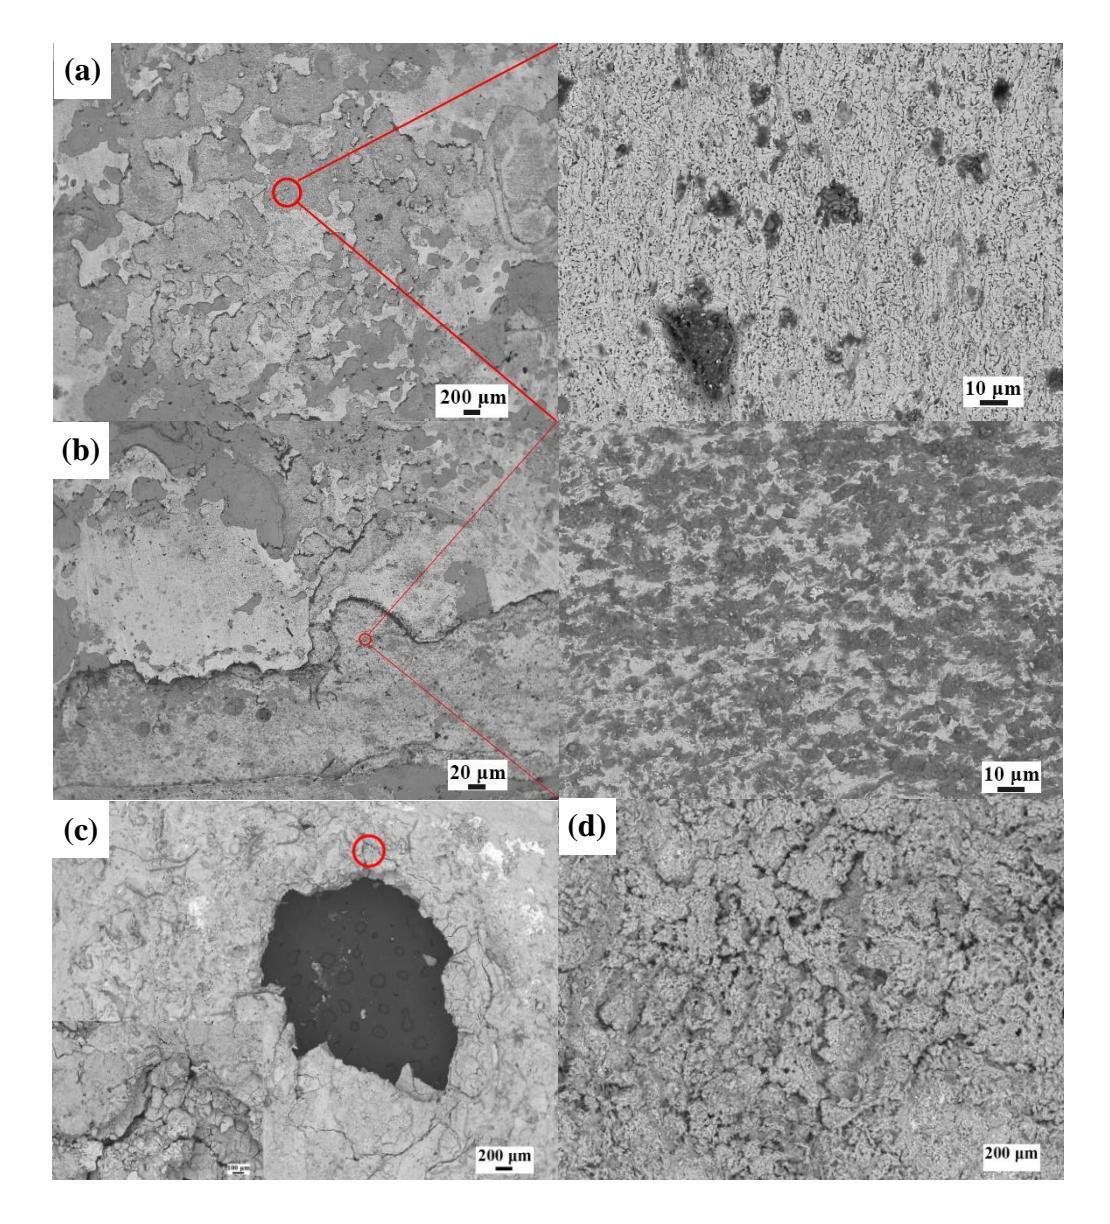
And seen from Figure 4, there was a large area of thin peeling layer on the samples when the content of copper(II) was 0.034%. And the corrosion morphology was uneven and layered, but the organization characteristics of surface substrate still retained as a whole. When the content of copper(II) in soil medium was 0.068%, the peeling layer is thick. And a large number of small dissolved pits and big etch pits formed by the connection of small dissolved pits both appeared on the surface of samples. In addition, organization characteristics of surface substrate stufface substrate had changed but still shown a certain regularity. When the content of copper(II) in soil medium was 0.170%, corrosion perforation emerged and many particulate matter, cracks and porous structure formed nearby it which will constantly accelerate corrosion process.

When the content of copper(II) in soil medium increased to 0.680%, the structure of unmissing part with large of pore is more loose and the surface structure presented worm-like, which was related to the formation of more and more oxide layer with loose structure. In contrast, the corrosion forms of X70 steel in soil contaminated by NaCl and  $H_2SO_4$  is mainly lacal pitting with irregular round or oval[20,21]. This is consistent with the results of macro corrosion morphology. With the increase of copper(II) in sand soil medium, the corrosion degree of X70 steel increased significantly.

Figure 4. Micro corrosion morphology of X70 steel in different copper(II) contaminated sand: (a)0.034%, (b)0.068%, (c)0.170%, (d)0.680%. (After rust cleaning)

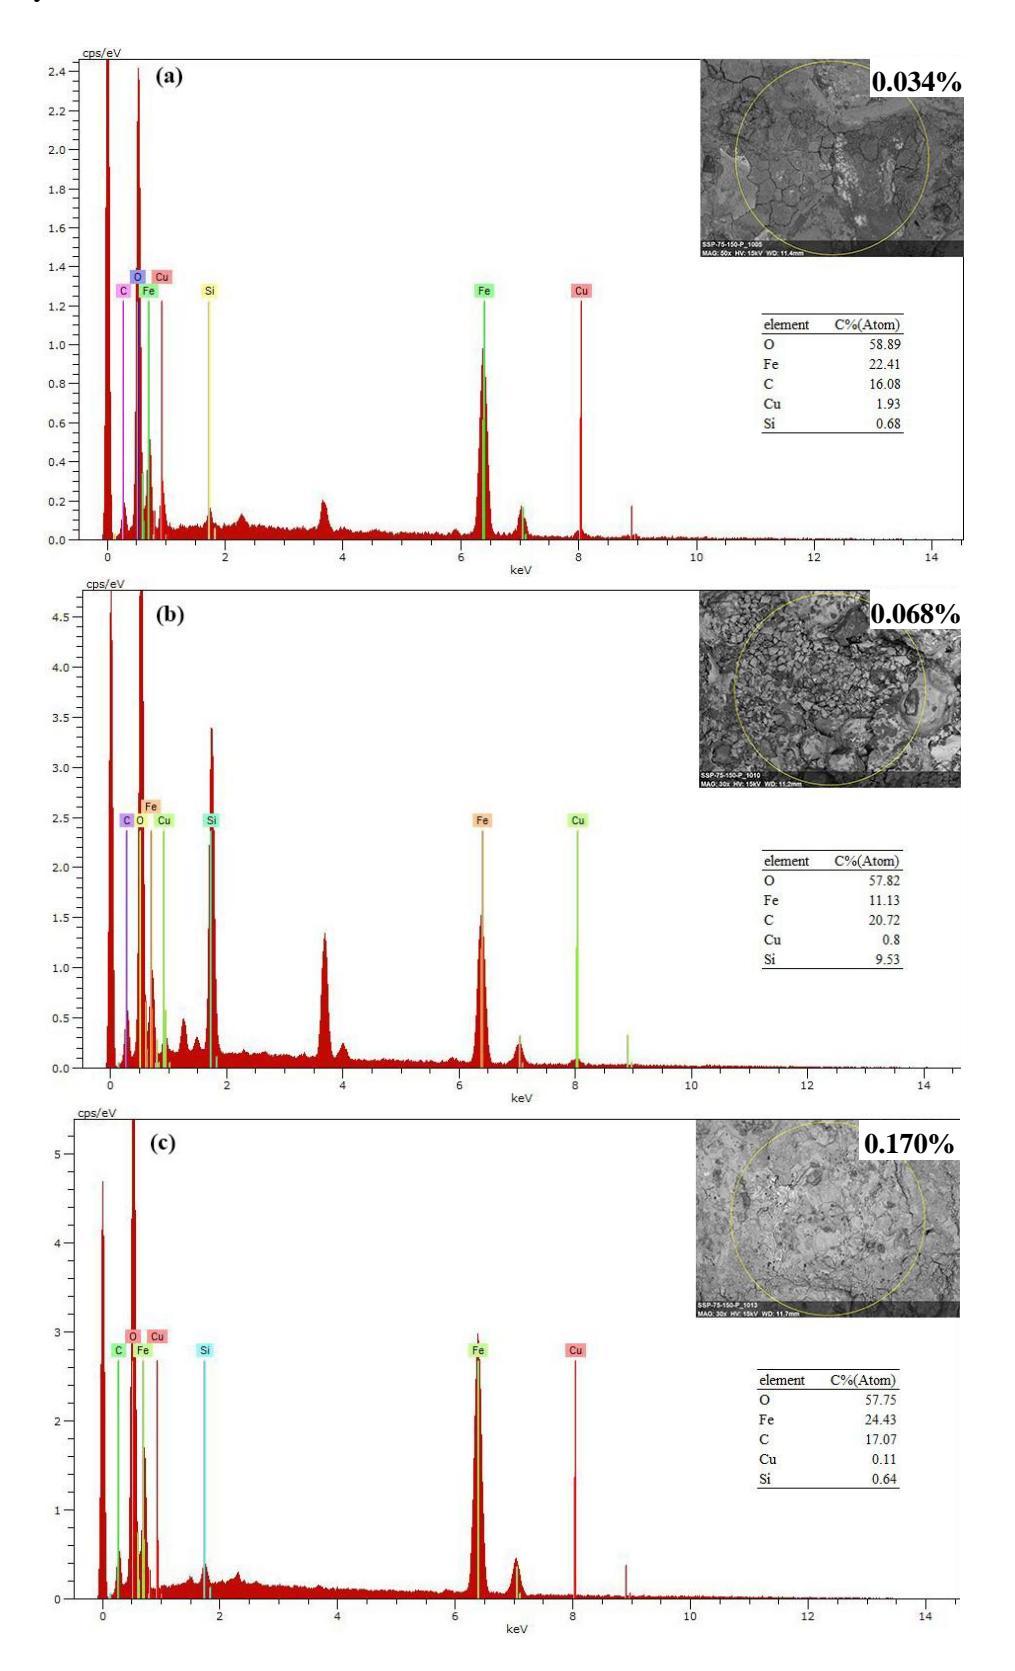
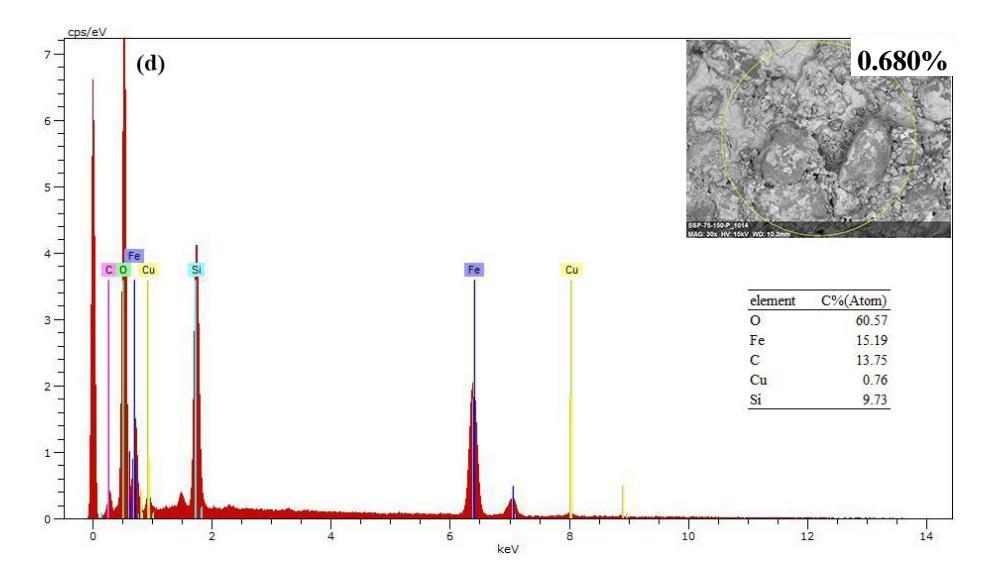
EDS test results of X70 steel in different copper(II) (0.034%, 0.068%, 0.170%, 0.680%) contaminated sand for 35d were shown in Figure 5. Obviously the corrosion product layer is mainly composed of Fe, C, O, Cu, Si. Wherein, Fe mainly existed in the form of oxide. While in terms of O, except for the amount contained in the compound, it also remained in cracks and porous, loose surface structure. Besides, with the increase of copper(II) content in the soil medium, the atomic concentration ratio of Fe/O presented the trend of decrease. Namely, there was the transition trend from low valence to high valence for Fe, which is consist with the deepening of color for the corrosion products. Results show that the cation (Na<sup>+</sup>) in solution can penetrate the corrosion product layer in sandy soil corrosive environments[26]. Similarly, the cation (Cu<sup>2+</sup>) in solution can also penetrate the

corrosion product layer reach to the metal surface in sandy soil corrosive environments. Thus less amount of solid pure Cu and copper oxide formed on the surface of sample electrode spread difficultly into the depths of soil medium, while the Fe ions generated on the sample surface can be dissolved in water and easily diffused into the soil medium.

Figure 5. Atom percent of the X70 steel surface in sand soil contaminated by different copper(II): (a)0.034%, (b)0.068%, (c)0.170%, (d)0.680%.

Thus surface layered structure of corrosion products on samples was formed and it included inner layer of pure Cu and outer layer of compound contained Fe and copper oxide. In addition, Si is mainly from quartz sand and X70 steel and C with atomic concentration of substantially 20% was also mainly from X70 steel, which is similar to that of soil contaminated by NaCl[26,27].

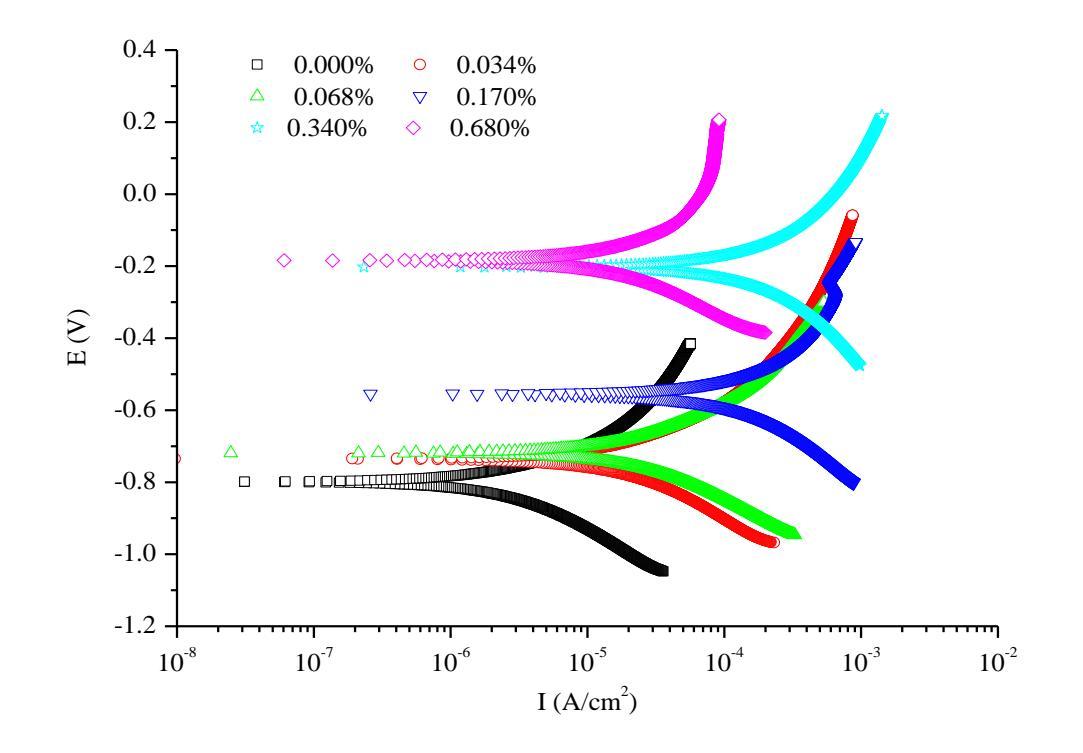
Figure 6 is the polarization curves and Table 3 is the fitted results of the polarization curves for X70 steel embedded in different sand soil with copper(II) for 35 d through Tafel extrapolation. Similar to that in NaCl contaminated soil with the same water content of 15%, the anodic polarization of X70 steel in sand soil with copper(II) is large[26,27]. It can be concluded the copper(II) in sand medium affected significantly the corrosion property of X70 and with the increase of copper(II) content, the polarization curves presented a certain regularity. Generally speaking, the addition of copper(II) in sand soil made the corrosion potential shift positively and the shift amount increased with the increase of copper(II) content. Compared to the corrosion potential of X70 steel in sand soil without copper(II) (799 mV), the shift amount was small(0.034% of 64 mV, 0.068% of 80 mV) when the concentration of copper(II) is 0.034%, 0.068%. The shift amount drastically increased to 244 mV, 597 mV at copper(II) of 0.170%, 0.340% respectively. And the shift amount slowly increased to maximum value of 615 mV at copper(II) of 2%. In contrast, the corrosion potential of X70 steel in soil contaminated by NaCl present continuously positive shift with the increase of NaCl in sand soil and the effect is not significant[26,27].

**Figure 6.** Polarization curves of X70 steel in contaminated sand with different copper(II) content (35 d) of 0.000%, 0.034%, 0.068%, 0.170%, 0.340%, 0.680%.

Besides, the addition of copper(II) in sand soil also significantly impact the corrosion current density and made the corrosion current density move positively compared to the X70 in sand soil without copper(II) (2.774  $\mu$ A/cm<sup>2</sup>). When the addition of copper(II) in soil medium was 0.034%, 0.068%, the corrosion current density dramatically increased by nearly 7, 9 times respectively. When the addition of copper(II) in soil medium reached to 0.170%, the corrosion current density(261.47  $\mu$ A/cm<sup>2</sup>) of X70 steel even increased by two orders of magnitude compared to that in sand soil without copper(II). When the addition of copper(II) in soil medium increased to 0.340%, corrosion current density of X70 steel further increased to the maximum value of 309.67  $\mu$ A/cm<sup>2</sup>. While when the addition of copper(II) in soil medium was 0.680%, the corrosion current density sharply decreased by

nearly 10 times compared to that at 0.340%, but it still above that at 0.034%. According to the standard, the addition of changed the corrosion grade of X70 steel from slight corrosion (I) into serious (III) and severe corrosion (IV)[28,29]. In terms of instantaneous corrosion rate, it increased firstly and then decreased with the increase of copper(II) concentration and the maximum value(3.642 mm/a) acquired at  $Cu^{2+}$  of 0.340%. The decrease of corrosion rate under  $Cu^{2+}$  of 0.680% is caused by the increase of anodic polarization resistance. And that may been explained by that during the anodic process, cohesive composite layer of corrosion products and sands particles formed quickly on the surface of electrode under high concentration of copper(II) blocked the transmission channel of matter between samples and soil medium[28,29]. That is to say the corrosion product layer plays protective effect, which is similar to that in soil leachate[30].

In general, the formation of numerous corrosion micro-cell caused by the precipitation of pure Cu on sample increased corrosion degree. In short, the corrosion resistance of X70 steel reduced firstly and then increased with the increase of copper(II) in soil. While the corrosion rate of X70 in soil contaminated by NaCl continuously increase with the increase of NaCl in soil and the decrease of soil resistivity[26,27].

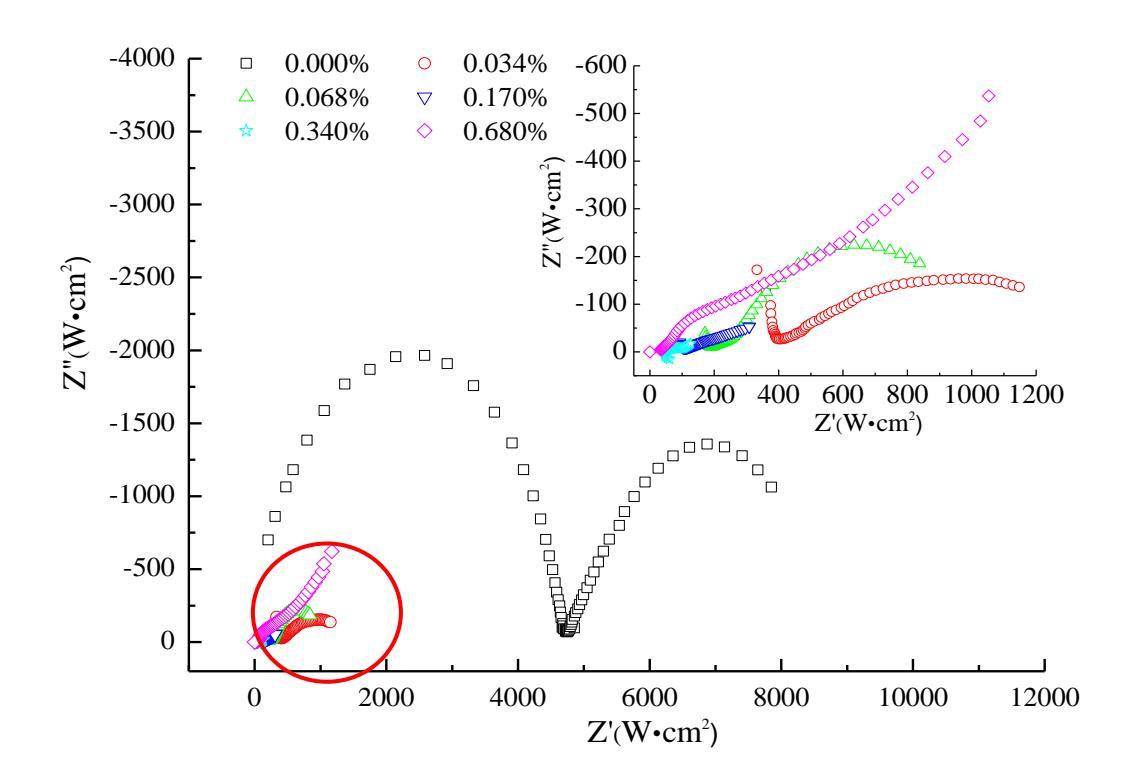
**Figure 7.** EIS of X70 steel in contaminated sand with different copper(II) content (35d) of 0.000%, 0.034%, 0.068%, 0.170%, 0.340%, 0.680%.

EIS of X70 steel corroded in copper(II) contaminated sand soil for 35 d was also tested and the results shown in Figure 7. Evidently, the effect of copper(II) on the EIS of X70 steel is significant. The EIS in uncontaminated sand contains two distinct capacitive arc and the sum of polarization

resistance and solution resistance is large more than that in contaminated sand soil. It is a process jointly controlled by the charge transfer and particle adsorption on electrode surface and the main reaction is the depolarization of oxygen. While the EIS of X70 steel in contaminated soil with copper(II) of 0.034% and 0.068% consist of the smaller incomplete capacitive arc in high frequency and the flat capacitive arcs in low frequency, which is similar to that of X70 steel in salinized sandy soil at the initial stage of corrosion[26]. This shows that electrochemical polarization and concentration polarization exist simultaneously in the cathode process of metal electrode[28,29]. And with the increase of copper(II), concentration polarization enhanced and electrochemical polarization weakened. When the content of copper(II) increased sequentially, the smaller incomplete capacitive arc in high frequency disappeared gradually and the diffusion phenomenon also emerged.

The addition of copper(II) made the charge transfer resistance (Rt) present significant decrease first and then increase and the minimum value (98.6  $\Omega$ ) acquired at copper(II) of 0.340%. And it is similar to the variation of charge transfer resistance to time for the short-term corrosion of X70 steel in sandy soils[26]. While the double electric layer capacitor (QPE<sub>1</sub>) change inversely with the increase of copper(II) content and the maximum value also acquired at copper(II) of 0.340%. However, the medium resistance (R<sub>s</sub>) constantly decreased with the increase of copper(II) content, which is related to gradual decreasing of the soil resistivity (Table 2) caused by the increase of ions. And the high concentrations of copper(II) decreased the outer corrosion while increased the inner corrosion. Overall, the sum of Rs, Rt and W decreased first and then increased and the minimum value(267.6  $\Omega$ ) acquired at copper(II) of 0.340%, which is consist with above results. Generally speaking, the corrosion degree of X70 increased with the increase of copper(II) concentration. In contrast, the corrosion behavior of X70 steel in sandy soils is controlled by charge transfer processes[26].

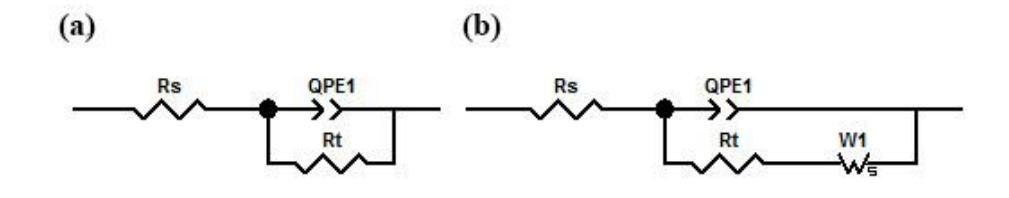
Furthermore, for the X70 steel in contaminated soil, only the low frequency regions were simulated through equivalent circuit due to the too small "capacitance tail" of EIS in high frequency region. EIS of 0.034% and 0.068% simulated by equivalent circuit Figure 8a and that of 0.170%, 0.340%, 0.680% were simulated by equivalent circuit Figure 8b and the results were listed in Table 4. Four components were included in Figure 8a and Figure 8b: Rs- medium resistance,  $QPE_1$  (element with constant phase angle)-capacitor of double electric layer on the interface of samples/soil medium, Rt resistance of charge transfer and W-Warburg impedance. Besides, n represent the deviation between C and the ideal capacitance and the smaller n, the deviation of C greater.

Figure 8. Equivalent electrical circuit model used to analyze the EIS date of X70 steel in sand soil for 35 d.
