Influence of the Marine Environment on Reinforced Concrete Degradation Depending on Exposure Conditions

Chloride ion, present in marine breeze and seawater is considered the main external agent to damage reinforced concrete in marine environments. It affects the passivity of steel film and provokes the initiation of corrosion. This study analyzes the changes in concrete contour and interface steel-concrete on samples exposed to continuous immersed seawater, alternated wet in seawater/dry at atmosphere and continuous weathering at atmosphere. The next elements: chloride, calcium, iron, oxygen and magnesium were determinate by using SEM/EDX analysis. Immersed concrete specimens show high amount of chloride at the steel-concrete interface, followed by those exposes to alternated wet-dry cycles, while atmospheric samples practically do not present this ion. Similar sequence of chloride concentration was obtained for the contour of specimens. The noticeable presence of high quantity of magnesium at contour evidence the formation of particular compounds such as brucite and dolomite in those samples exposed to total immersion and alternated wet-dry alternated cycles. Monitoring of electr

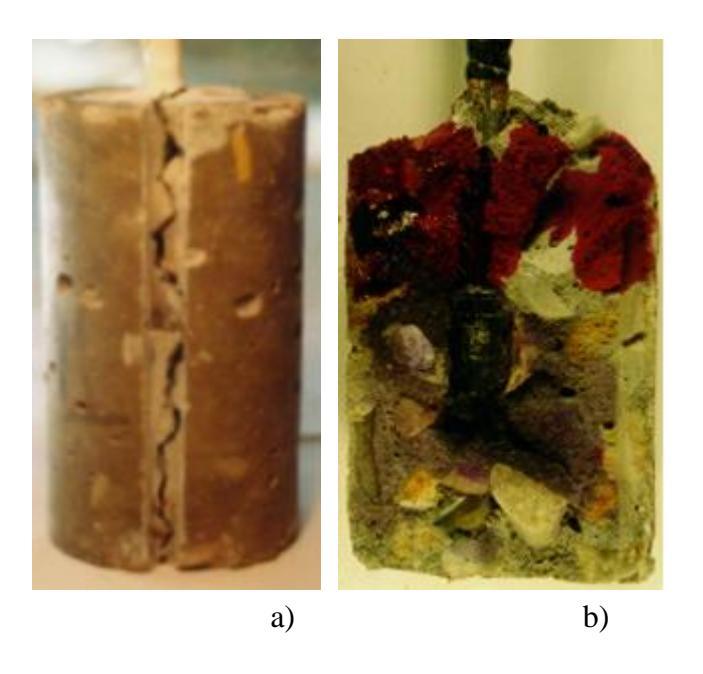
Figure 1. Carbonation test. a) Cut of cylinder. b) Acid-base indicator application.

Carbonation depth was determined using an acid-base indicator [14]. From each set of samples, one was selected for carbonation test. The sample was cut in axial direction to the bar using an electric emery machine. This cut was used as a guide for the application of pressure and fracture the sample in two pieces (see Figure 1). The reinforced bar remain in one of the two pieces obtained. The part having no reinforced bar was selected to determine the carbonation front. Acid base indicator was applied by spray on the surface. After application, the long of the uncolored zone was measured by using a ruler.

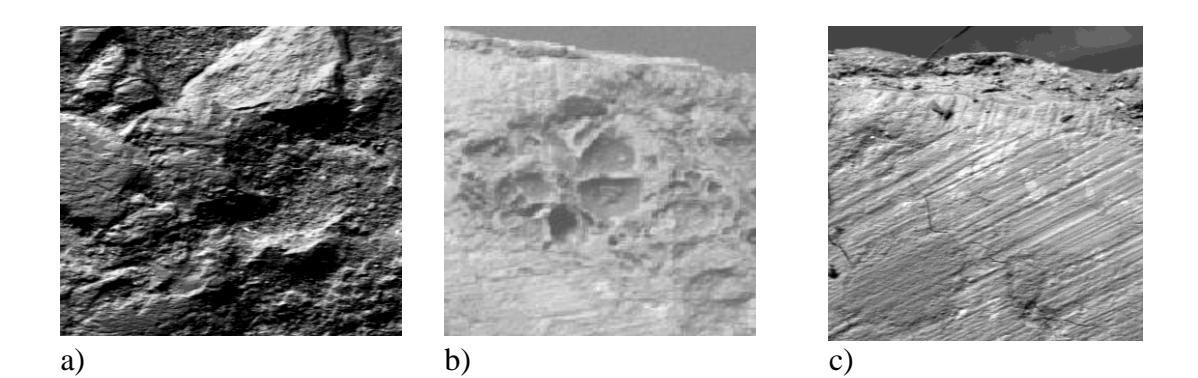
Figure 2. Concrete samples borders. a) ATM (130x), b)ALT (250x), c) IMM (1500x).

Figure 2 shows the images of concrete samples exposed to each test media during the study. On the other hand, a comparative mapping about the elemental distribution in concrete samples is presented in Figures 3 (Ca), 4 (O), 5 (Cl), and 6 (Mg).

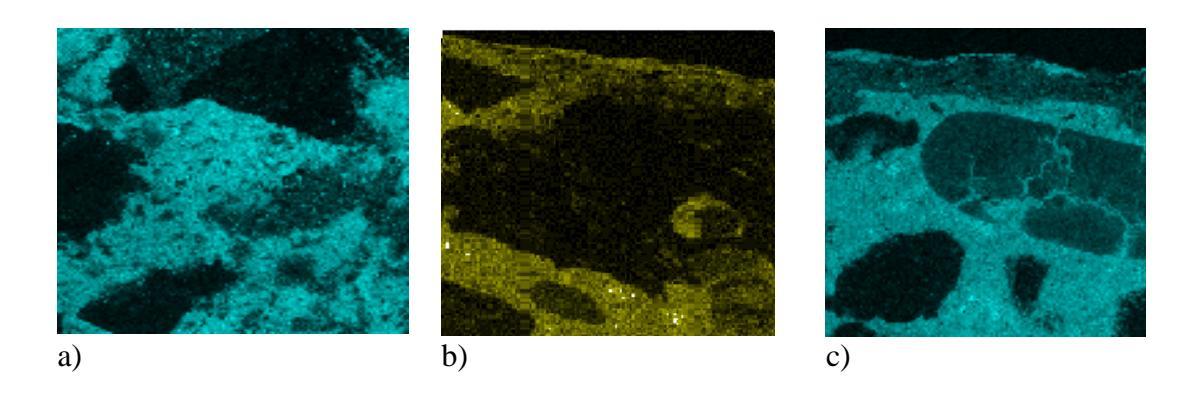
Figure 3. (Ca). Calcium distribution at the borders. a) ATM (130x), b)ALT (250x), c) IMM (1500x).

Ca (Figure 3) is distributed on concrete paste on the surface of the samples exposed in the three different conditions. Dark zones should correspond to fragments of aggregates, mainly composed by Si. Oxygen distribution (Figure 4) should be mainly due to the presence of $Ca(OH)_2$, silicates and other hydrated compounds in the concrete paste.

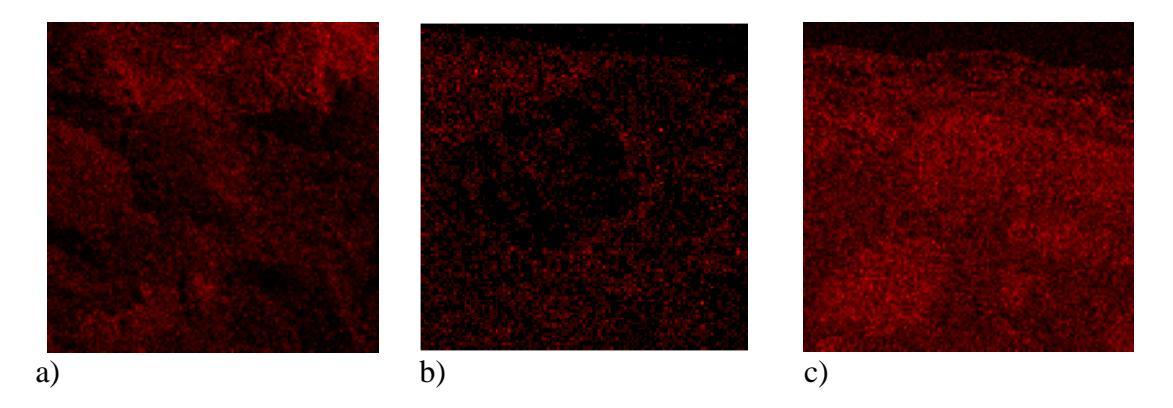
Figure 4. (O). Oxygen distribution at the borders. a) ATM (130x), b)ALT (250x), c) IMM (1500x).

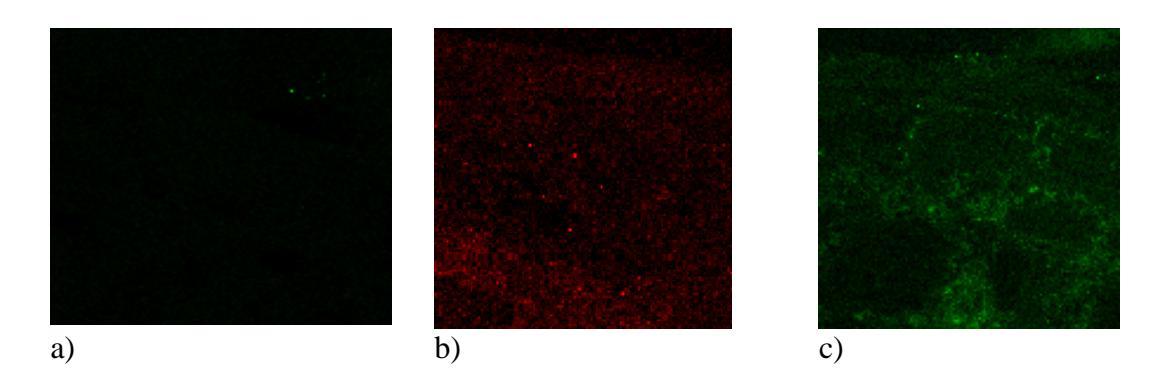
Figure 5. (Cl). Chlorine distribution at the borders. a) ATM (130x), b)ALT (250x), c) IMM (1500x).

The presence of Cl (Figure 5) is not observed on the surface of samples exposed in atmospheric conditions (ATM). Since these samples were exposed to natural weathering, perhaps chloride ions were dissolved and washed by rain. Also, chloride ions could have migrated inside the concrete

through the porous structure, because the test zone is submitted to wet-dry cycles. It should be also considered that chloride deposition rate is not high in Campeche, so the amount of deposited Cl could be low [16], ALT and IMM samples show the presence of Cl at the entire surface. In these cases, they were immersed in sea water, so the presence of Cl is warranted.

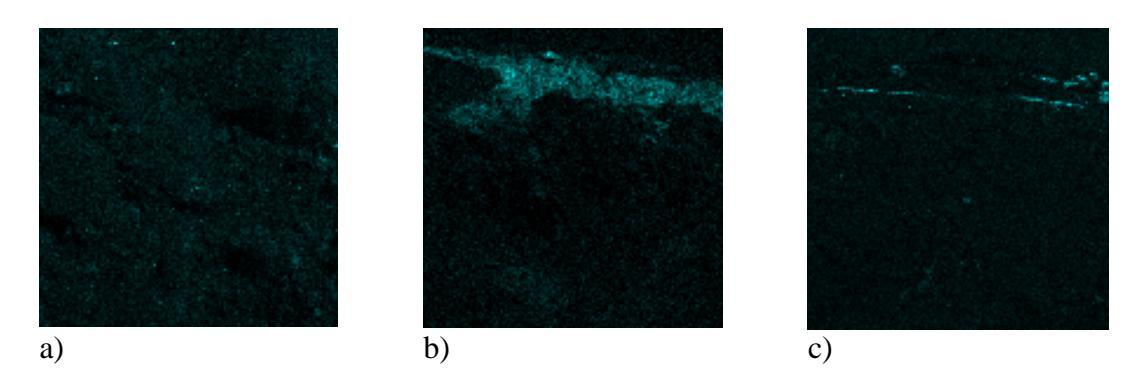
Figure 6. (Mg). Magnesium distribution at the borders. a) ATM (130x), b)ALT (250x), c) IMM (1500x).

Mg is present in the three types of exposure conditions, Figure 6. This element is a constituent of cement as MgO. Also it is present in sea water and sea aerosol. Maximum content of Mg allowed for Portland cement according to[17] is 6%. It is reported an expansive effect of Mg[18]. Under atmospheric exposure (ATM), only scattered points of Mg are observed in the surface, whose probably source is the cement. Under ALT and IMM conditions, higher accumulation of Mg was observed. This accumulation is attributed to the calcareous layer formed in the concrete surface known as "skin" [4] as a consequence of the exposure to sea water. This layer acts as a barrier and plays an important role since slows down the migration of chloride ions inside the sample. Its effect should be considered for the surface concentration calculation and modeling of chloride ion diffusion.

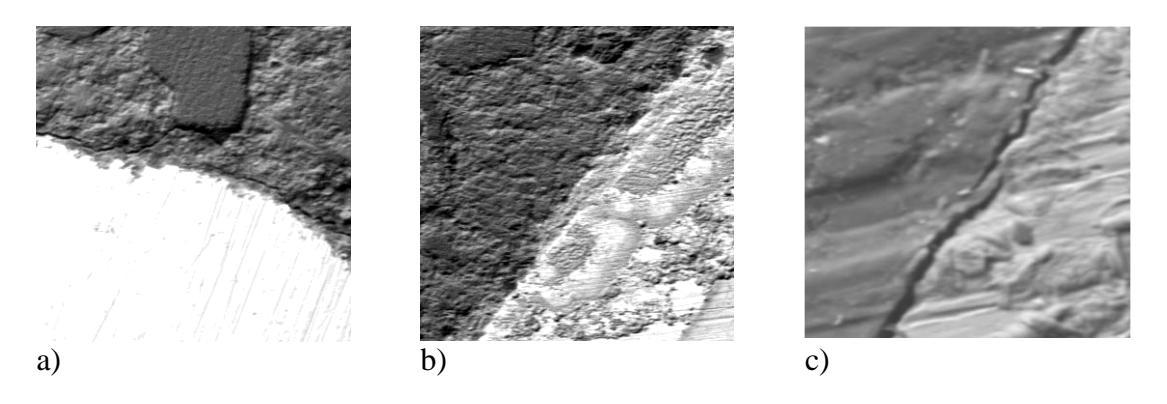
Figure 7. Concrete-steel interface. a) ATM (130x), b)ALT (110x), c) IMM (130x).

Concrete-steel reinforced interface image is presented in Figure 7. Comparative mapping of the surface elements distribution at the interface concrete-steel reinforced in samples exposed under three different exposure conditions is presented on Figures 8 (Ca), 9 (O), 10 (Cl), and 11 (Fe).

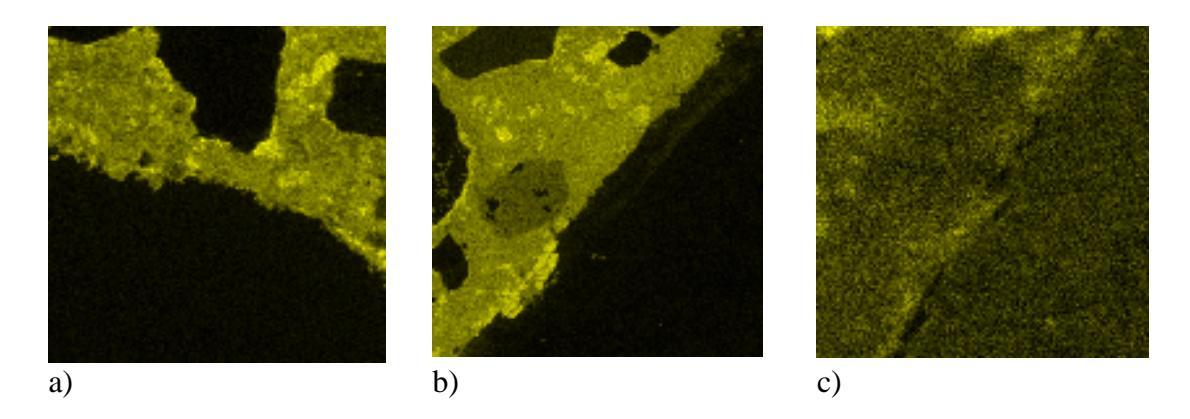
Figure 8. (Ca). Calcium distribution at concrete-steel interface. a) ATM (130x), b)ALT (110x), c) IMM (130x).

According Figure 8, Ca distribution seems to be similar to that observed at the borders of the concrete paste. Ca(OH)₂ produces an alkaline pH that induce passive conditions allowing the protection of steel rebar against corrosion. Oxygen is an element included in the composition of cement, aggregates, and corrosion products of steel. A lower distribution of oxygen is present on steel bar surface of ATM samples (Figure 9). It could indicate the absence of corrosion products in this surface; however, oxygen is observed in the surface of steel in samples submitted to immersion (IMM) and humid/dry cycles (ALT). It indicates the presence of corrosion products on these surfaces and, consequently, corrosion of the steel bar. The corrosion over the iron surface could probably be caused by contamination during the polishing process.

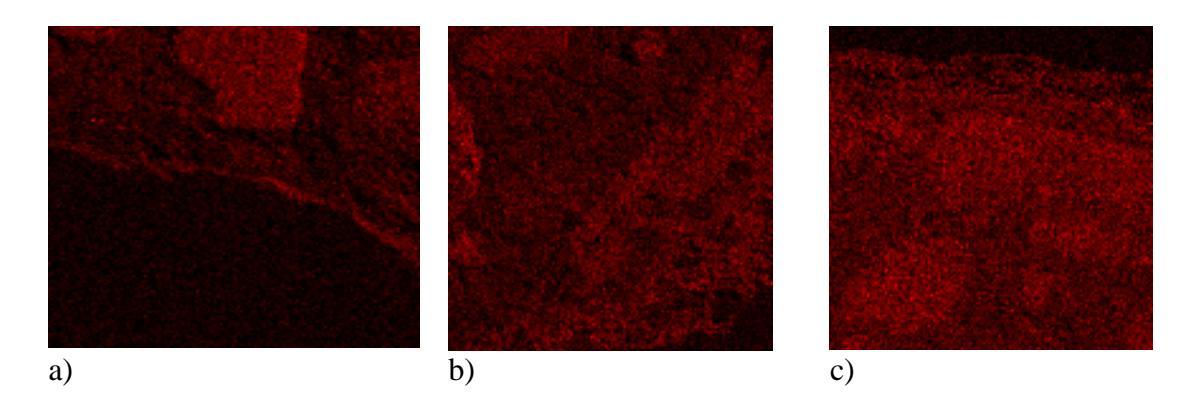
Figure 9. (O). Oxygen distribution at concrete-steel interface. a) ATM (130x), b)ALT (110x), c) IMM (130x).

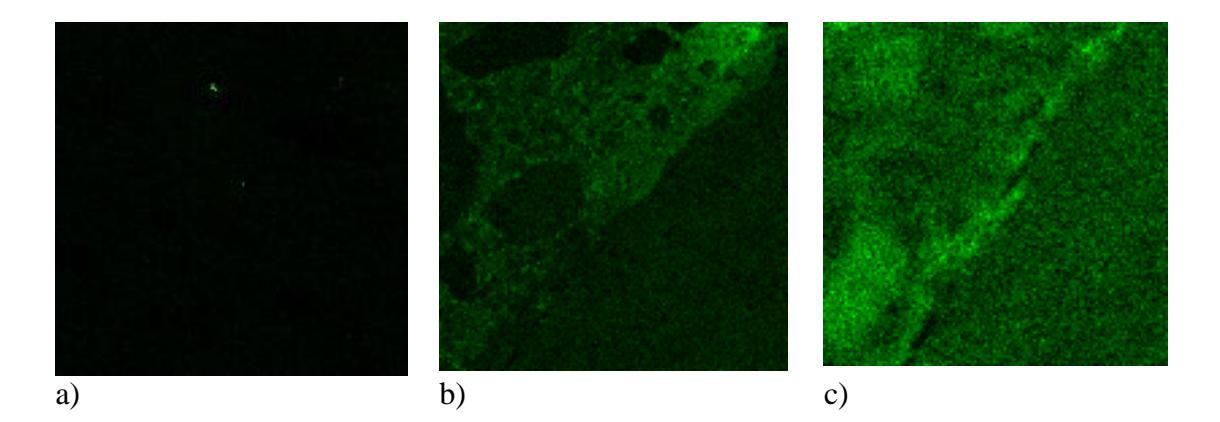
Figure 10. (Cl). Chlorine distribution at concrete-steel interface. a) ATM (130x), b)ALT (110x), c) IMM (130x).

Figure 10 shows the distribution of Cl in the interface concrete-reinforced bar. It is important to highlight that Cl it is not detected in the sample corresponding to atmospheric exposure. Respecting samples exposed under ALT and IMM conditions, it was observed the presence of Cl in the interface concrete-rebar. The presence of Cl over the rebar surface could be due to contamination during polishing process.

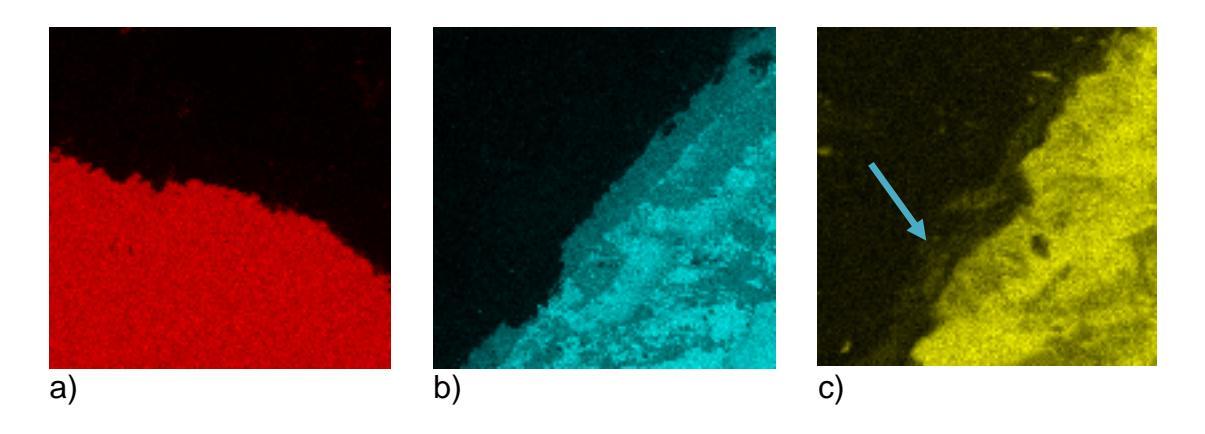
Figure 11 (Fe). Iron distribution at concrete-steel interface. a) ATM (130x), b)ALT (110x), c) IMM (130x).

Samples exposed under ALT and IMM conditions shown presence of iron at the concrete-steel interface (Figure 11). It was not the case of the ATM samples. In the case of IMM conditions, a diffuse and disperse iron layer was detected closer to the interface; perhaps it indicates that corrosion products are migrating towards the concrete external surface (indicated by arrow).

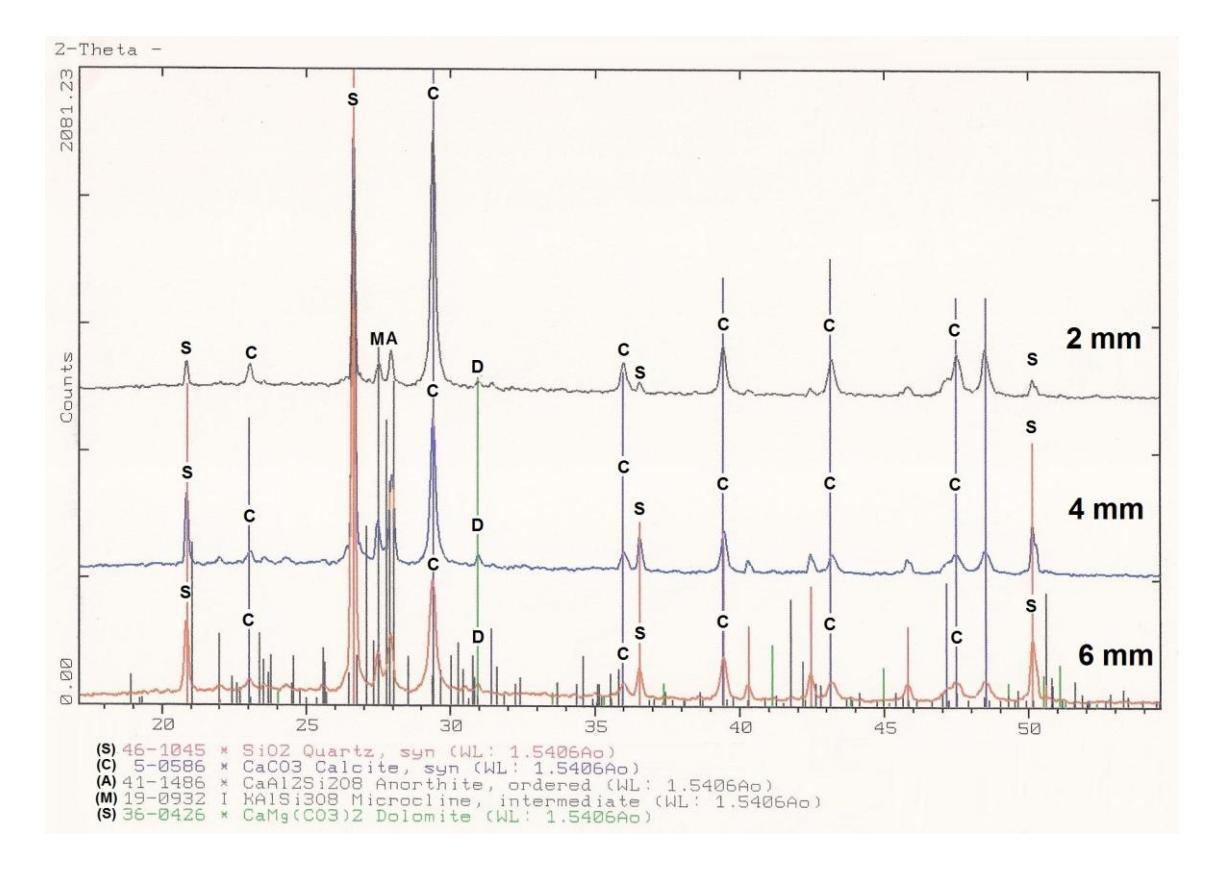
Figure 12. DRX diffractograms corresponding to samples exposed to ATM conditions.

Figures 12-14 shows the XRD diffractograms obtained from powder of concrete samples obtained at 2, 4 and 6 mm depth. A comparative analysis of their mineral phases is presented on this

section. Ratios were obtained based on the measurement of the main peak from the net area of principal reflection in arbitrary units, (A. U.).

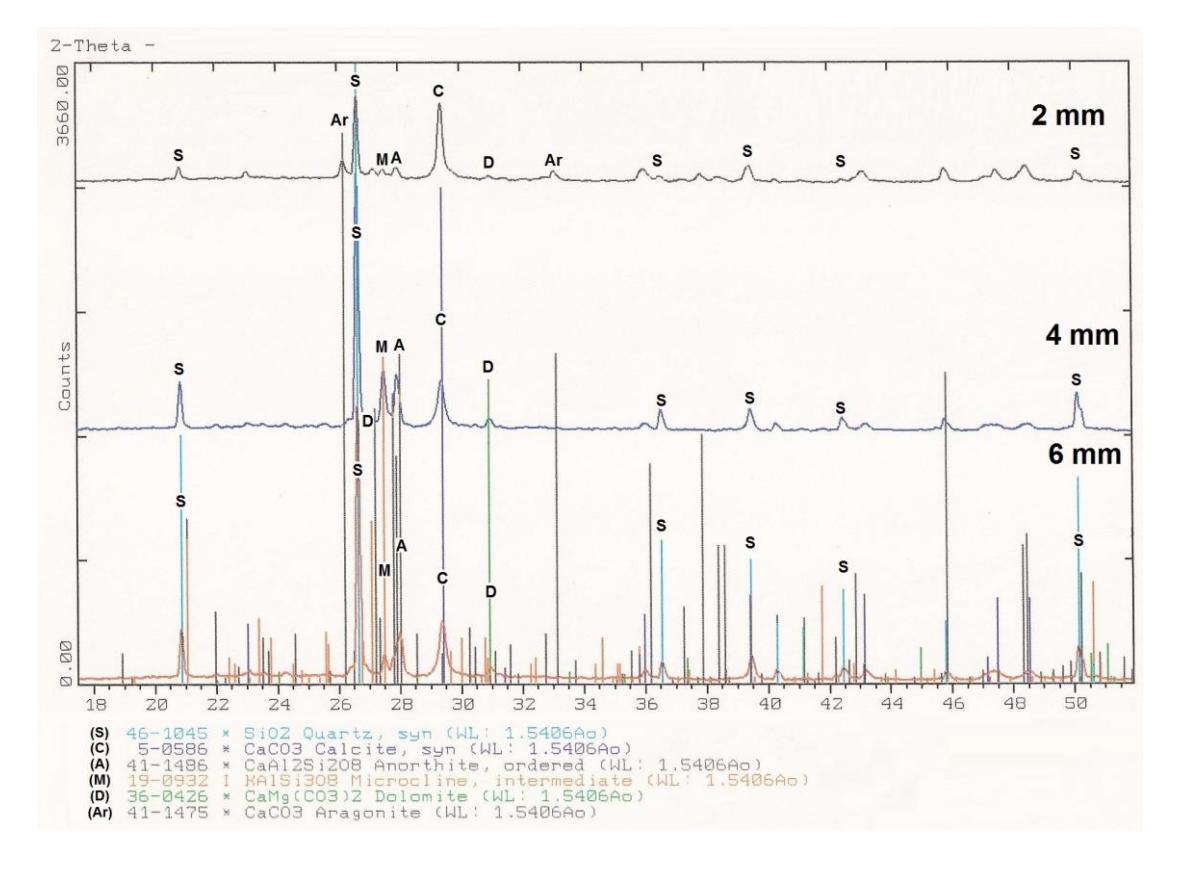
Figure 13. DRX diffractograms corresponding to samples exposed to ALT conditions.

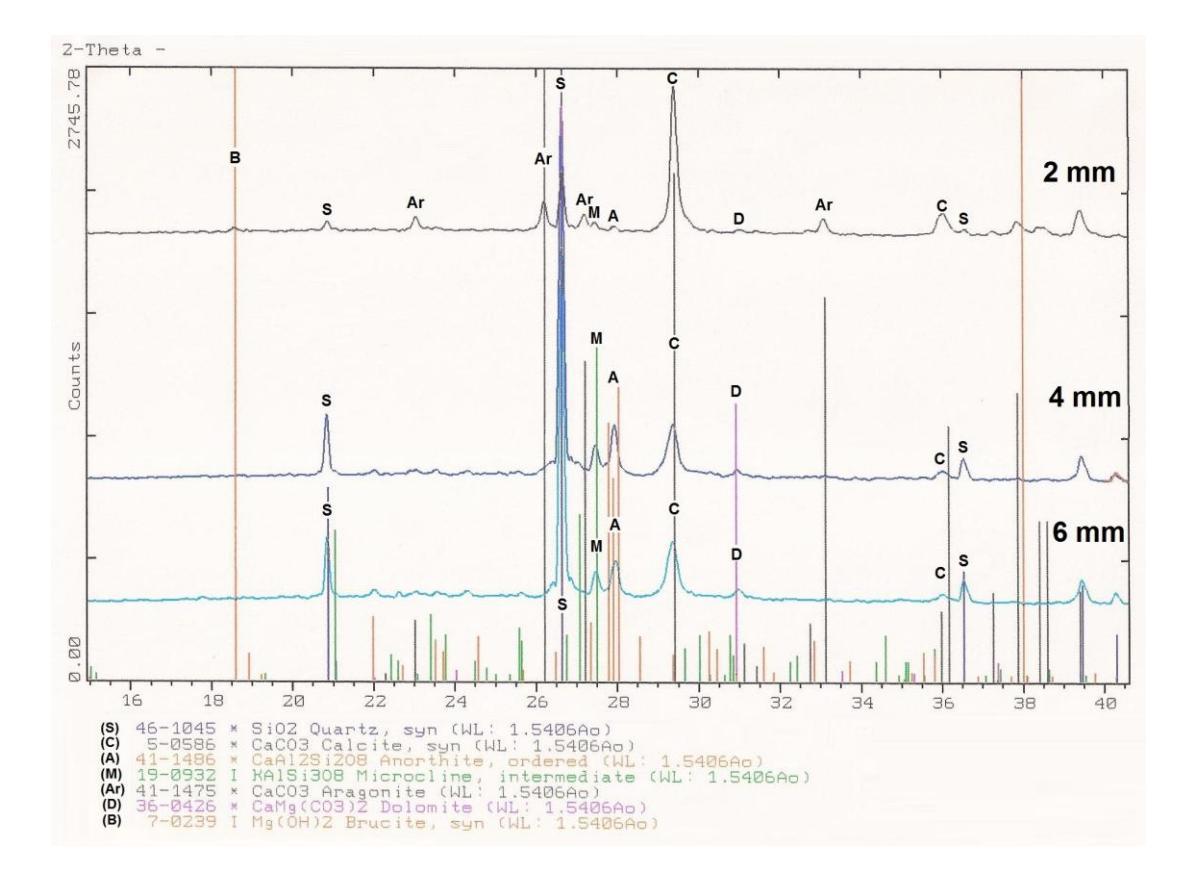
Figure 14. DRX diffractograms corresponding to samples exposed to IMM conditions.

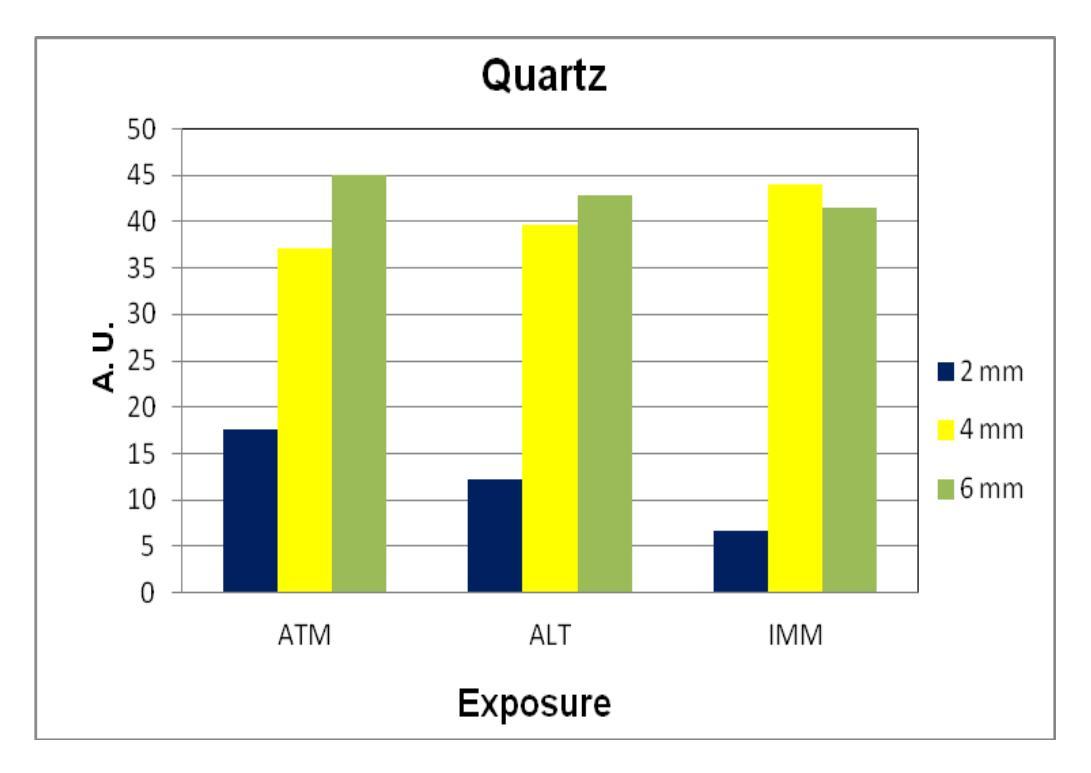
Figure 15. Quartz content at the contours of concrete samples.

Quartz - The profile of SiO₂ content in the samples was determined considering three penetration depths for each exposure conditions. Its concentration is presented at Figure 15. The three types of samples showed a similar behavior. The external layer (2 mm) shows lower quartz content, indicating that quartz content decreases due to the influence of the external environment. The sample corresponding to atmospheric exposure (ATM) shows the higher quartz content, followed by the sample ALT and finally the lower content corresponds to IMM sample. Quartz is one of the main components of concrete and is responsible of mechanical resistance. If the environment aggressiveness increases, a higher lost of quartz could occur in the surface.

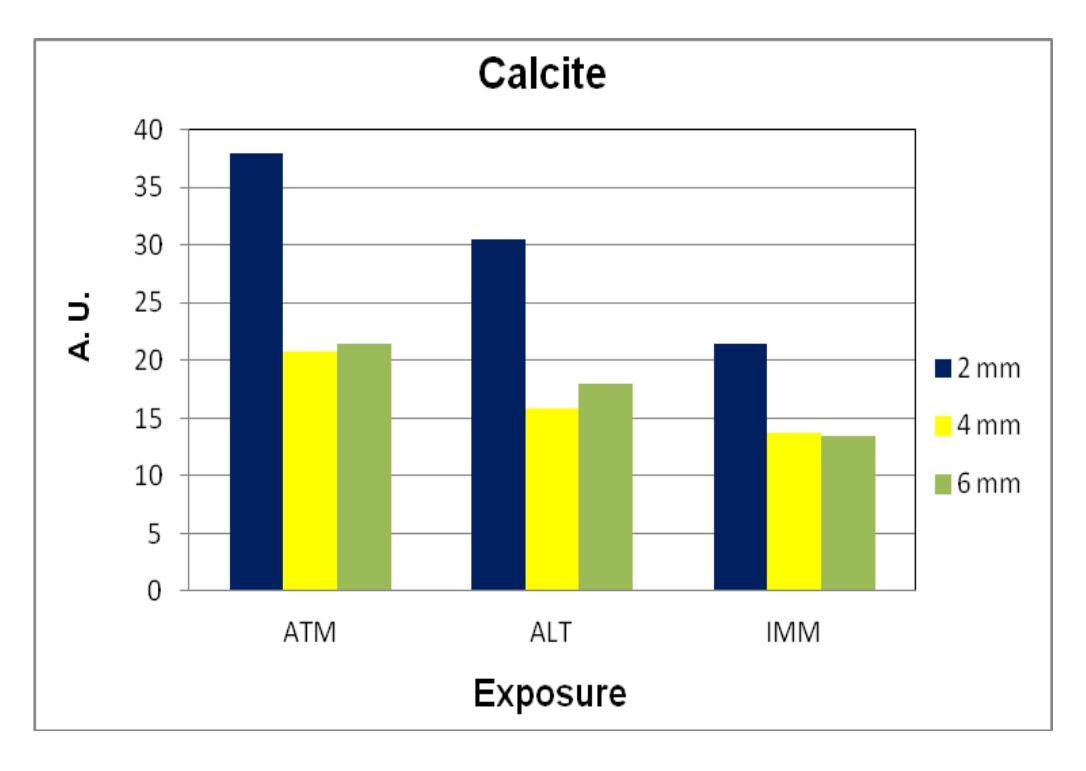
Figure 16. Calcite content at the contours of concrete samples.

Calcite - The higher calcite content was determined in the concrete external layer under atmospheric exposure. Calcite is considered a reaction product between hydrated cement components and CO_2 . The reaction with CO_2 is facilitated in the external layer. Calcite content increases when penetration depth decreases.

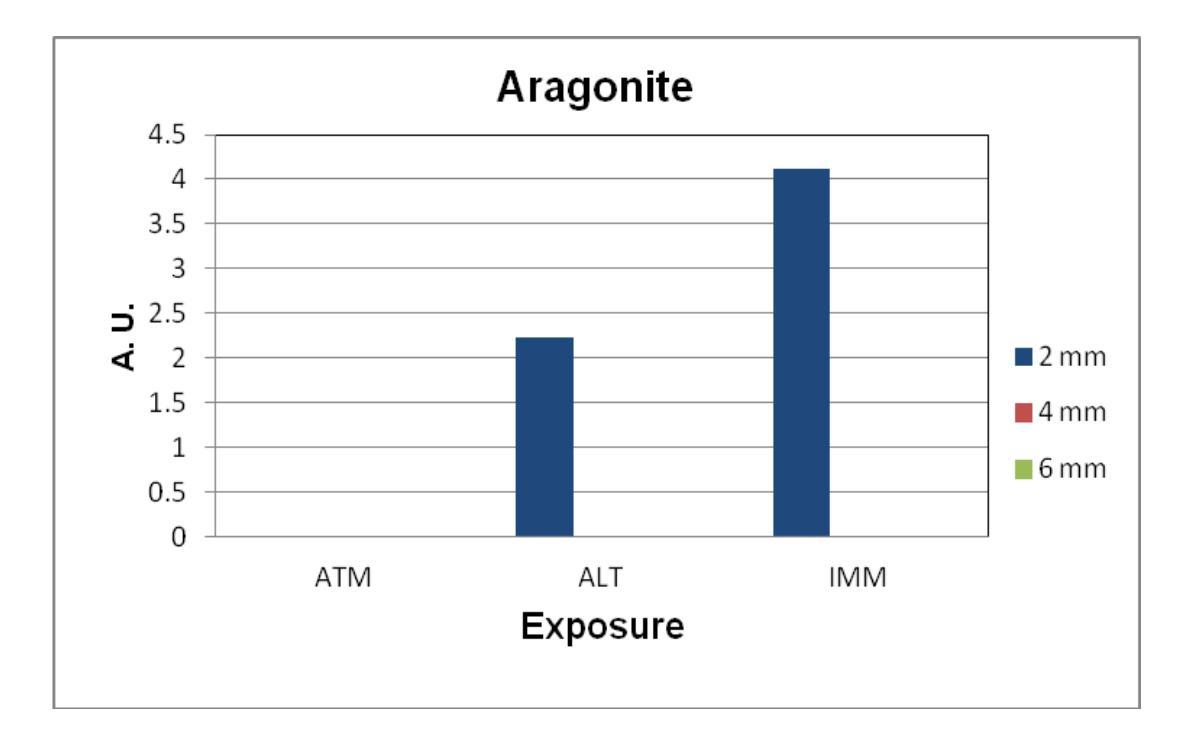
Figure 17. Aragonite content at the contours of concrete samples.

Aragonite - Aragonite was observed at the external layer of ALT and IMM samples, but in opposite tendency to calcite. The higher content is reported for IMM samples. It is reported that aragonite is stable in seawater[11]. Transformation of aragonite into calcite is possible in an aqueous environment. Calcite is more stable on ATM samples, while in presence of sea water, the probability of calcite transformation into aragonite increases.

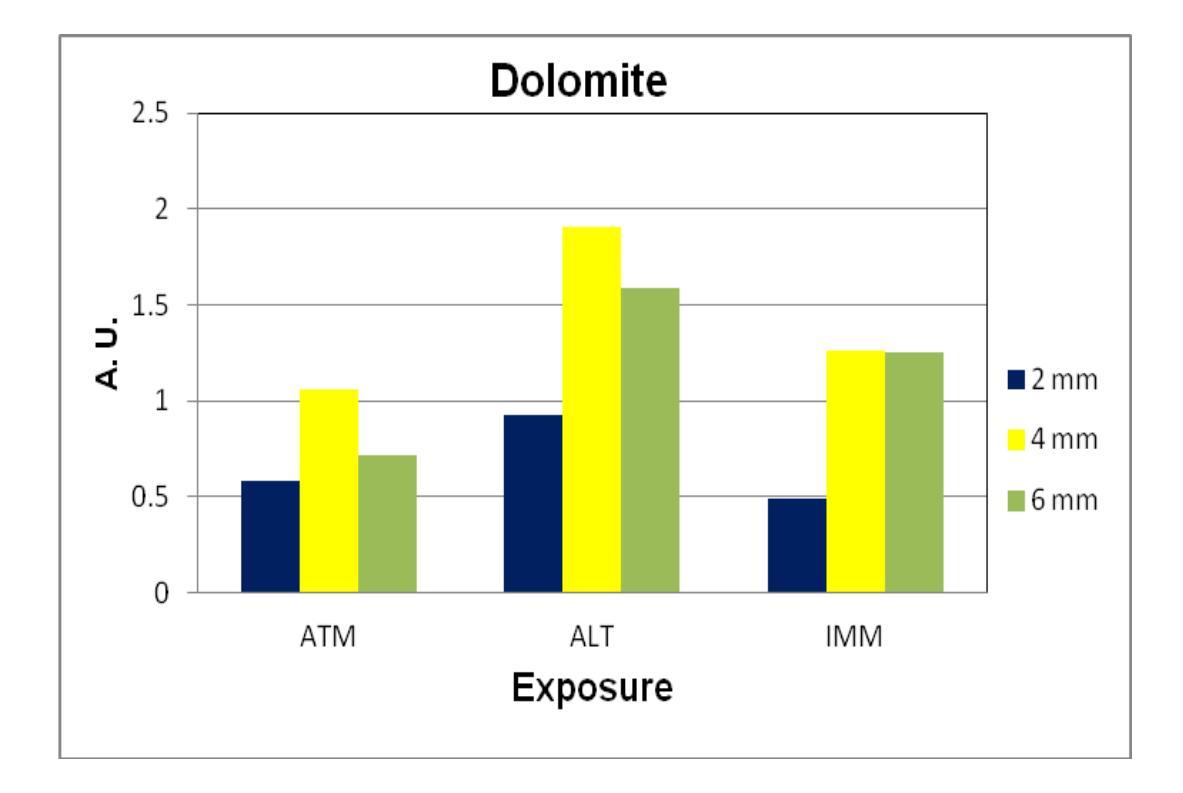
Figure 18. Dolomite content at the contours of concrete samples.

Dolomite - This phase should be present in the samples since the cylinder fabrication. The higher content is reported for ALT samples. In this case, the drying process could contribute to stabilize the presence of dolomite.

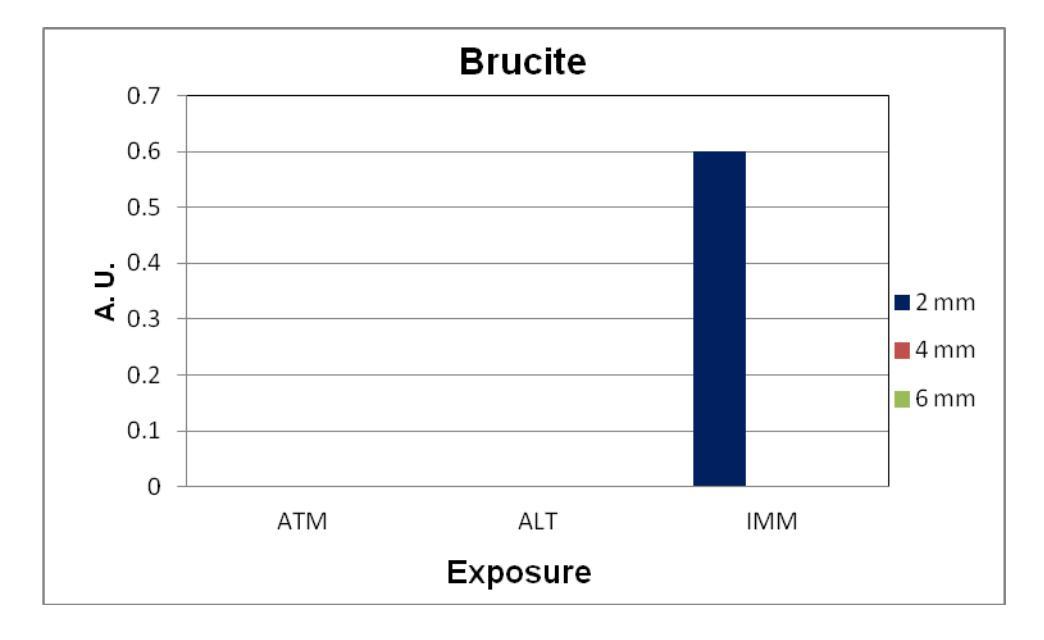
Figure 19. Brucite content at the contours of concrete samples.

Brucite - It is reported that in an alkaline solution, $Mg(OH)_2$ is more stable than MgO. Aragonite and brucite precipitate when the solution is saturated in calcium carbonate and magnesium hydroxide.

The samples submitted to complete immersion (IMM) and in lower proportion ALT could suffer the influence of magnesium chloride and magnesium sulfate presents in sea water according to the following chemicals reactions [19, 20]:

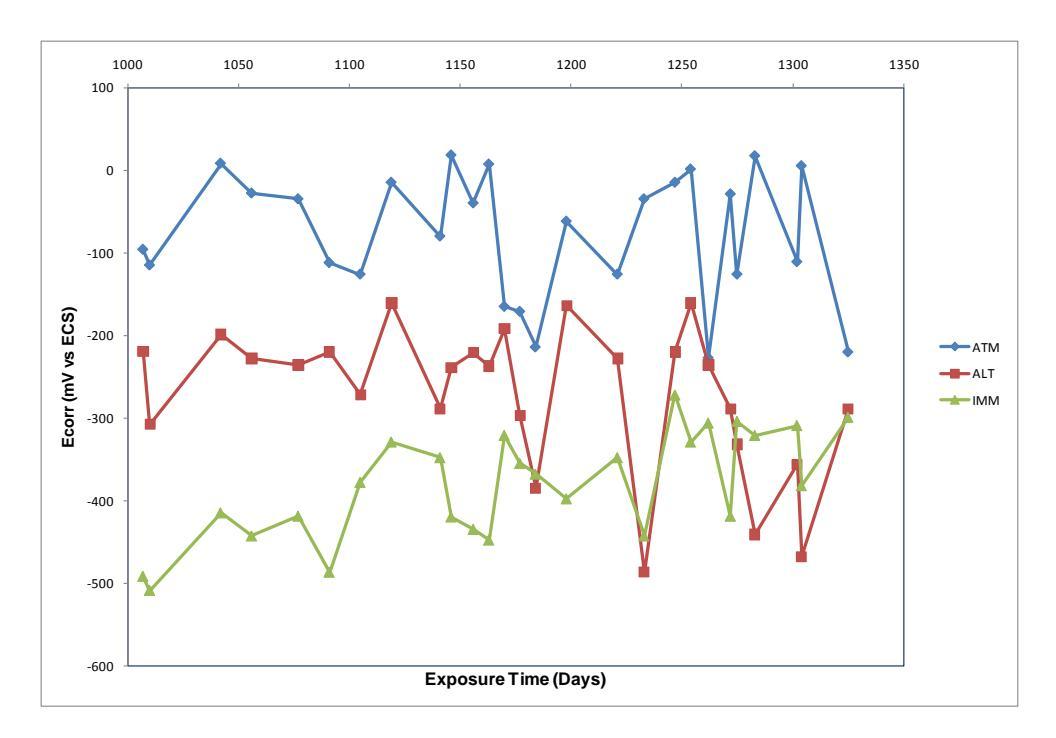
Figure 20. Half cell potential vs time.

Half cell potential (Ecorr).- Changes in Ecorr of steel rebar on samples exposed at the three different exposure conditions vs exposure time is presented on Figure 20. Ecorr of steel rebar corresponding to ATM samples lie always in the passive zone according to [15]. It means that no corrosion process was not detected in these samples. On samples exposed under ALT conditions, the probability of corrosion of rebar is higher because corrosion potential shows more negative values in comparison to ATM samples. It is important to note that from the exposure of 1238 day, the corrosion potential reach values indicating high corrosion probability. For IMM samples, corrosion potential values oscillate in the zone of high corrosion probability. According to these results we can have information about corrosion probability, but not related to the corrosion intensity.

The order of corrosion probability, according to corrosion potential measurement was IMM>ALT>ATM.

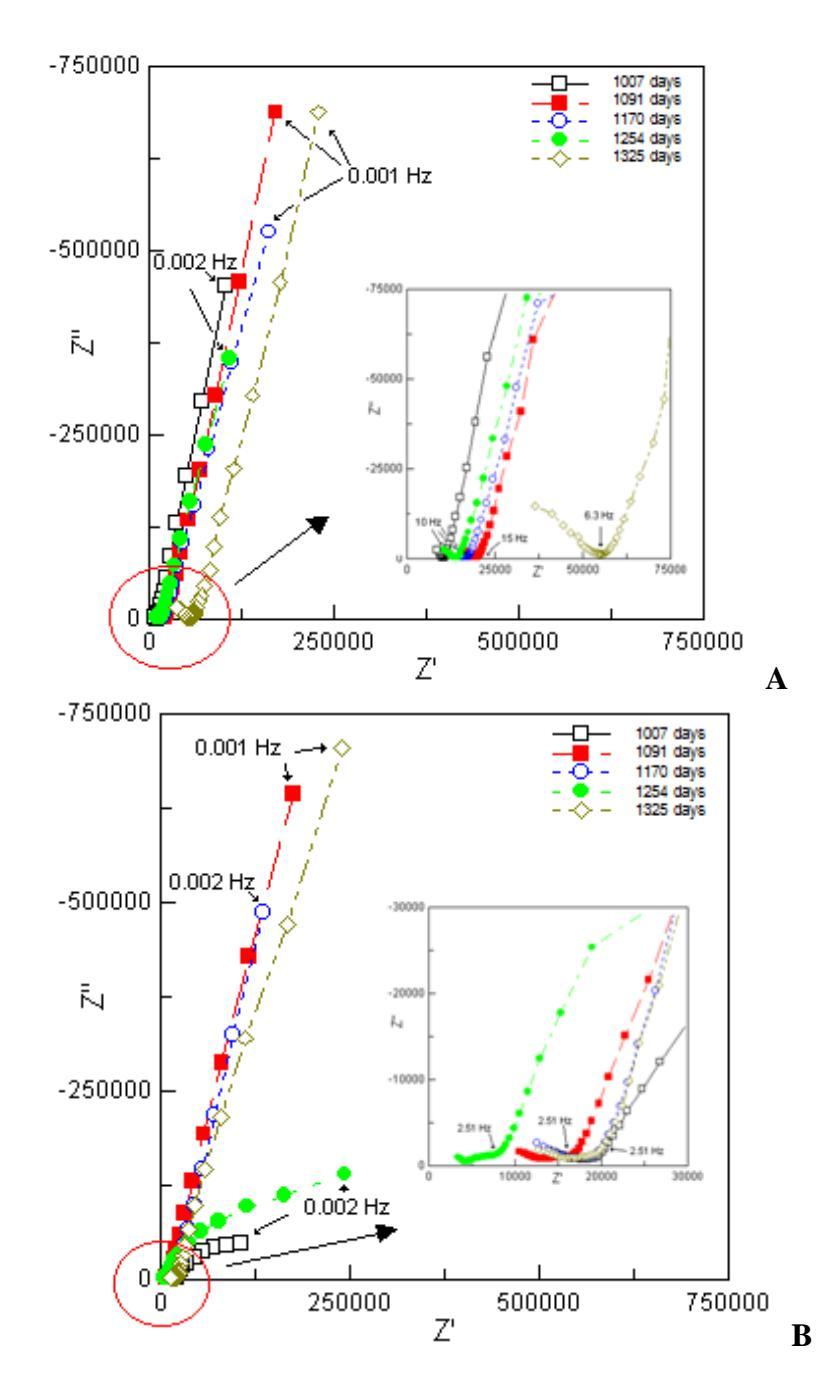
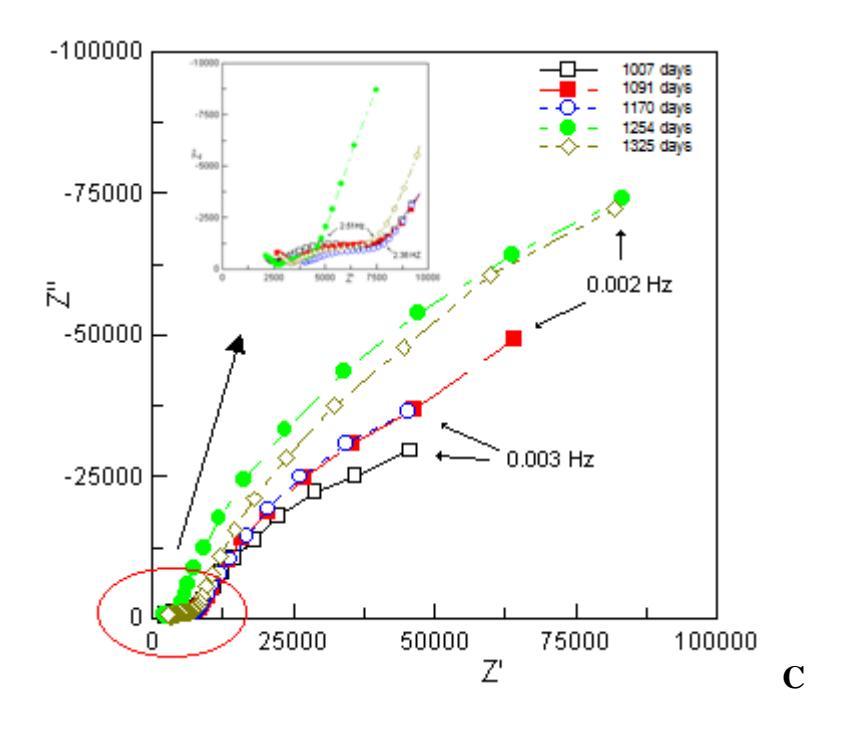
Figure 21. EIS diagrams vs time.

Nyquist diagrams of EIS show clear differences respect to condition of steel rebar, Figure 21. At ATM exposed samples, capacitive response was predominant over the resistive, an arc with high resistance value is evidence of passive rebar as can be observed at Figure 21a. ALT exposure (Figure 21b) show changes in the capacitive arc behavior from high resistance with a tendency to less resistance than 500,000 Ω cm². This represents a transition active-passive at concrete-steel interphase and consequently an increase of corrosion rate. The importance of these changes is the evidence of the starting of corrosion process. Figure 21c shows arcs with a less magnitude order in resistance, undoubtedly is signal of an active interphase concrete-rebar [21-24].

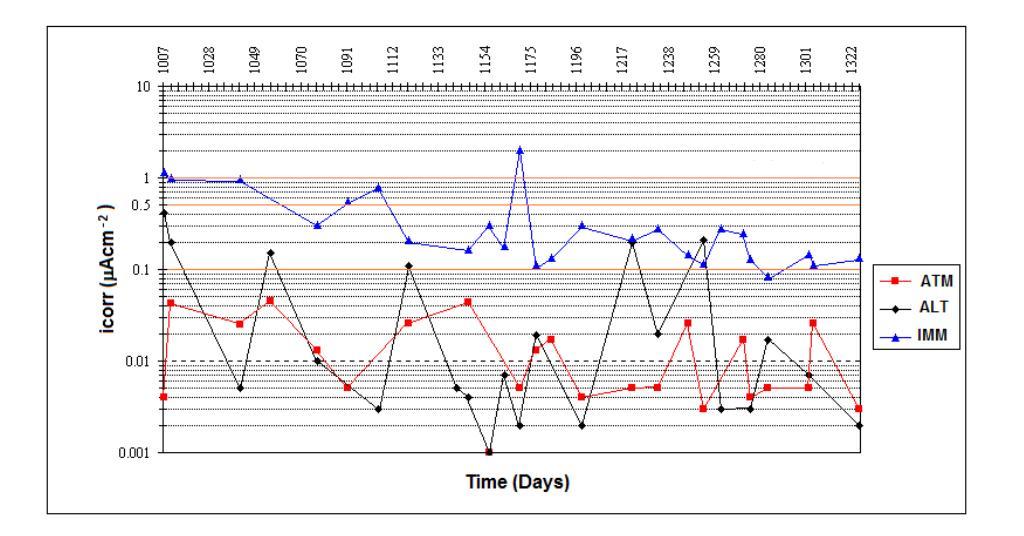
Figure 22. icorr vs time.

The behavior of corrosion current vs time for samples exposed at different exposure conditions is presented on Figure 22. Values corresponding to ATM samples are lower than 0.1 μ A/cm² (passive conditions). In the case of ALT samples, corrosion current values are also low, but sometimes are over 0.1 μ A/cm² (active-passive conditions). Data corresponding to IMM samples are higher (active zone), showing a higher corrosion in this exposure conditions. Similar tendency with the ones results of corrosion potential was obtained. The order of corrosion current corresponds with the corrosion probability.Half cell potential (Ecorr) vs corrosion current (icorr) determined by EIS is presented on Figure 23. The points corresponding to ATM samples are located in a zone that corresponds to the corrosion probability, but in general has a low corrosion current (active-passive conditions). Points for IMM samples show the most negative values of Ecorr and higher values of corrosion rate. The results show that the most aggressive conditions correspond to IMM samples, followed by ALT samples. No significant corrosion of rebar is detected for ATM samples.

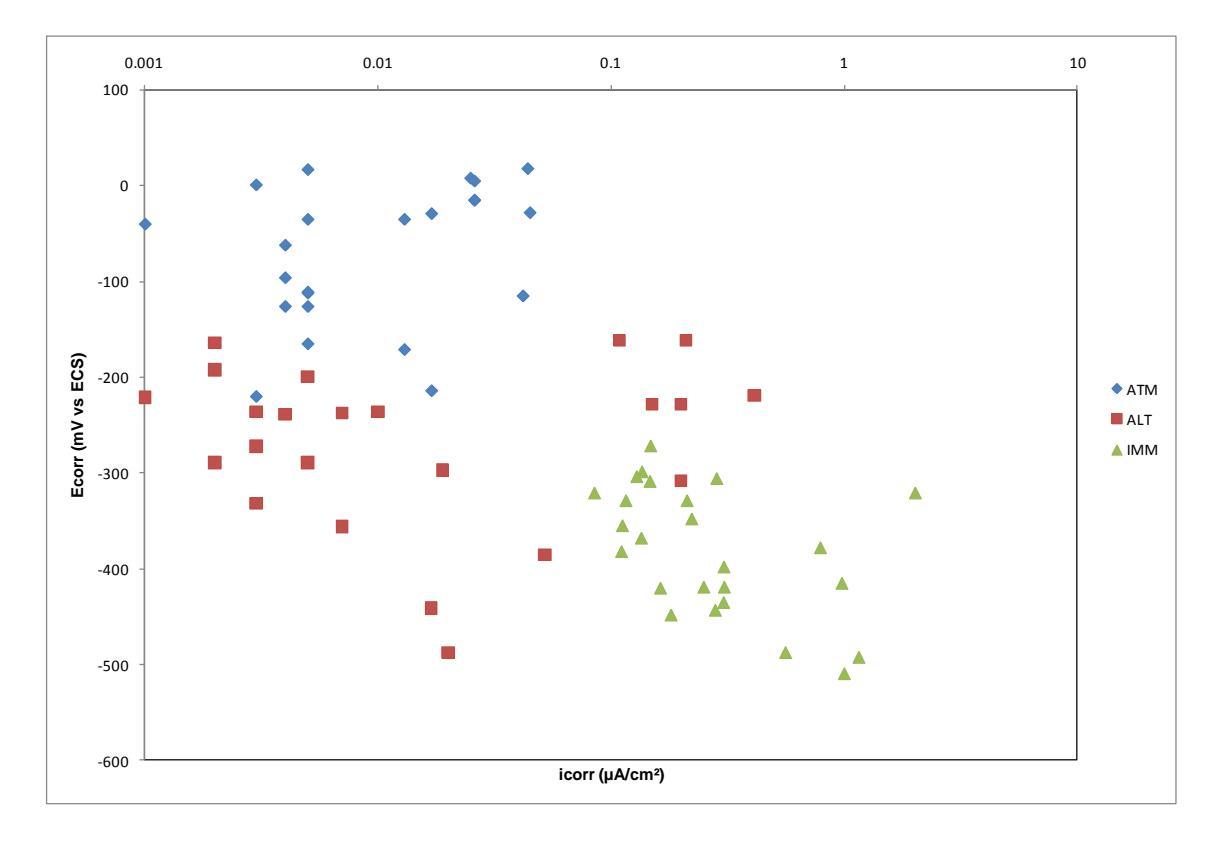
Figure 23. Ecorr vs icorr distribution.

Electrochemical results obtained are in accordance with the chloride distribution at interphase concrete-steel reinforced. ATM has the lower chloride concentration (almost insignificant), by this reason the reinforced steel remains passive, as indicate by the values of Ecorr and icorr. Chloride is higher for ALT samples than ATM, however by its exposure condition, when were located to atmosphere the chloride migrates inside the sample and the corrosion process diminishes. Since the samples were continuously immersed in IMM, the chloride ions migration was faster than of ATM and
