Effect of tropical marine microclimates on depassivation and corrosion-induced cracking of reinforced concrete

The objective of the present work is to discuss the electrochemical monitoring and corrosion-induced cracking propagation obtained from small reinforced concrete cylinders exposed to three natural tropical marine microclimates. Tests were performed with reinforced concrete cylinders (7.5 x 15 cm) exposed for 16 years at three different tropical marine microclimates (50, 100 and 780 m from the seashore) in the city of Progreso, Yucatan, Mexico. The concrete used in these cylindrical specimens was fabricated with four different water/cement ratios (0.50, 0.53, 0.70, and 0.76), and three different curing periods (1, 3, and 7 days). Electrochemical techniques were used to monitor the corrosion performance of the reinforcing bar during the exposure time (16 years). After corrosion damage was achieved by the appearance of surface cracks, the morphology of such cracks were surveyed and recorded. The results observed indicate a direct effect of distance from the seashore on the depassivation time of the reinforcing steel: the higher the distance from seashore, the longer is the c

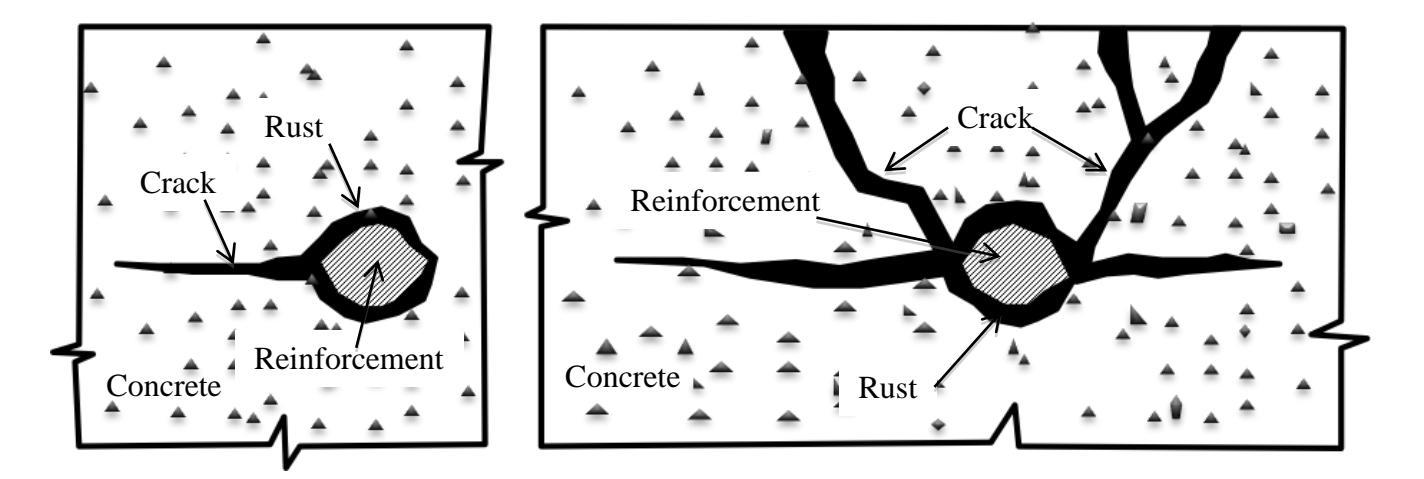
Figure 1. Scheme of concrete cover cracking.

Such relationships between structural distress and corrosion from accelerated corrosion tests performed in laboratory have been presented [10-16], while natural corrosion investigations are scant due to its complexity on data analysis, which may include various parameters involved in this corrosion phenomenon [16]. In the case of structures exposed in a marine environment, chloride ions are deposited on the surface of the concrete and penetrate until they reach the surface of the reinforcing steel, causing the breakdown of the passive layer [17-19]. Once reinforcing bar corrosion starts, corrosion products starts to build up around the reinforcing bar, causing volumetric expansions that will result in concrete cover cracking (Figure 1) [20].

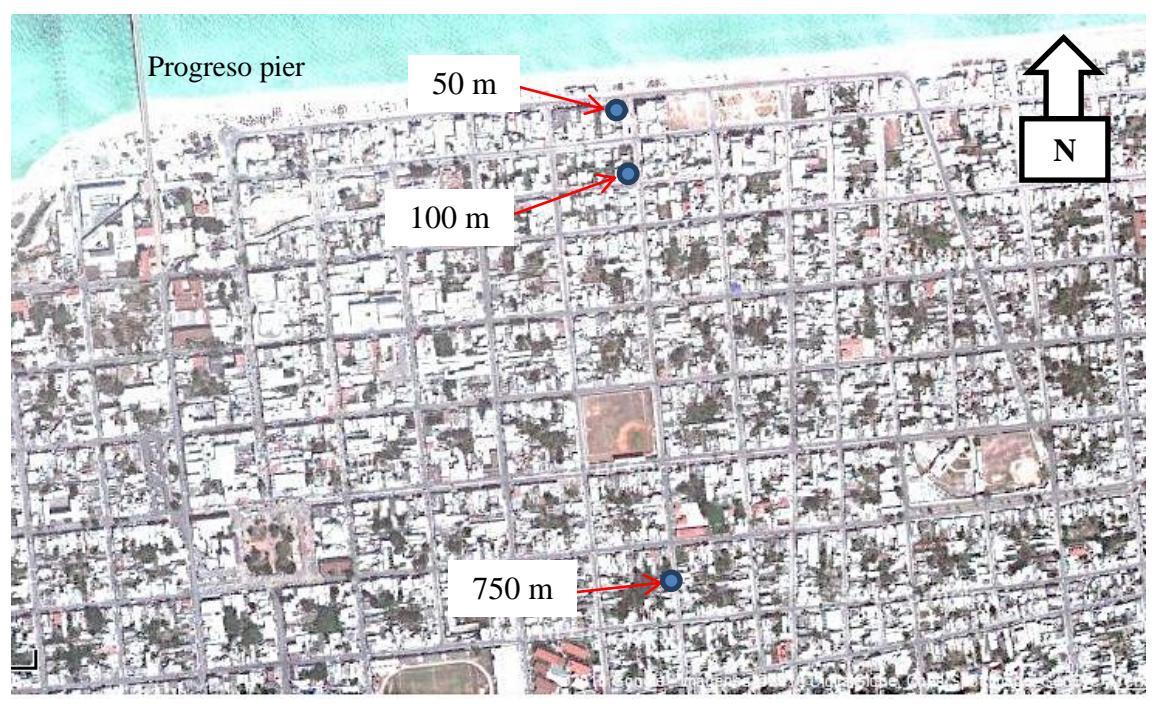
Figure 2. Distribution and location of the concrete specimens

different microclimates (Figure 2, main variable was the distance to the seashore: 50, 100 and 780 m), the time of steel reinforcement depassivation (corrosion initiation stage), and cover concrete crack propagation.

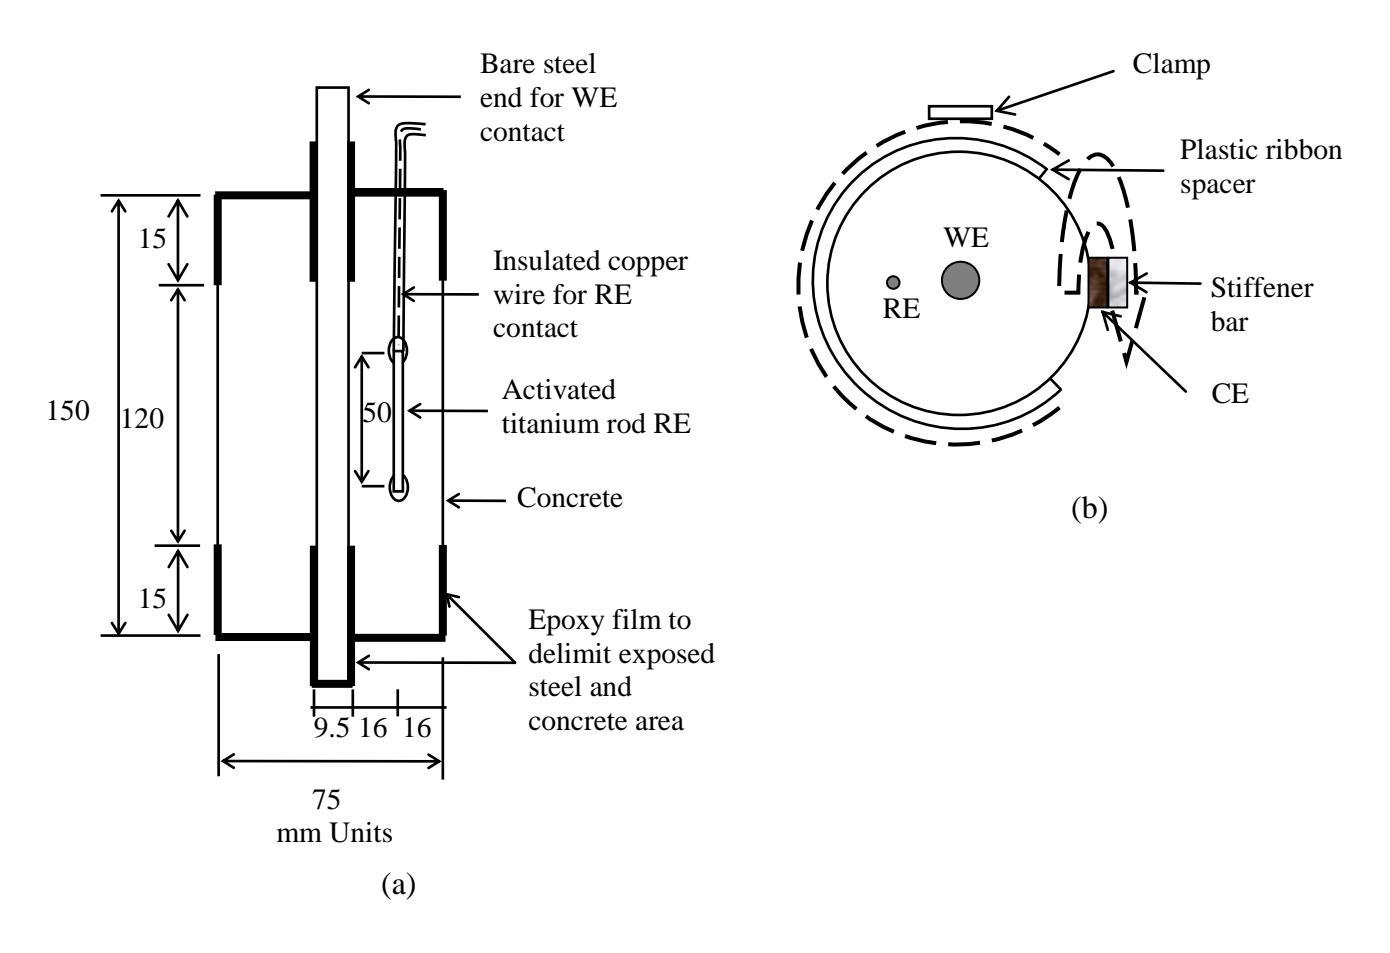
Figure 3. Schematic representation showing (a) dimensions and assembly of the specimens, (b) the cell configuration.

90 reinforced concrete cylinders, 7.5 cm in diameter by 15.0 cm in length, with a deformed reinforcing steel bar (9.5 mm nominal diameter and 20.0 cm long), placed in the center of the cylinder were evaluated (Figure 3a). Cylinders and the reinforcing bars (also called working electrode or WE)

Two were the electrochemical techniques used to determine the corrosion performance of the reinforcement steel inside the concrete cylinders: corrosion potential measurements (E_{corr}) and linear polarization resistance (Rp) [29, 30]. Electrochemical measurements were performed using the cell configuration as shown in figure 3b, which has been characterized and calibrated in previous studies [31].

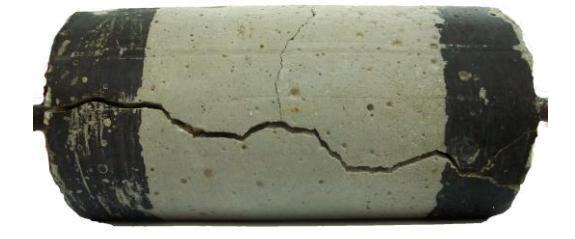
Figure 4. Typical concrete cracking after exposure to tropical marine environment.

During the experimental period, all cylinders surfaces were inspected to observe possible corrosion-induced crack formations. When corrosion crack appeared at the concrete cylinder surface, the date was recorded and the cylinder was retrieved from the test station for crack survey and returned afterwards to the test station. For the registry of the crack's shape and size, special crack comparators were used (transparent plastic card of 5.0 cm x 8.0 cm, from Construction Technology Laboratories, Inc. CTL reference card). Also, transparent acetate sheets were used to draw the crack configuration and morphology with respect to the cylindrical specimen geometry. Figure 4 shows a concrete cylinder with the presence of typical concrete cover cracking (corresponds to a 0.53 water/cement ratio, 1-day curing, and exposed to 100 m from the seashore).

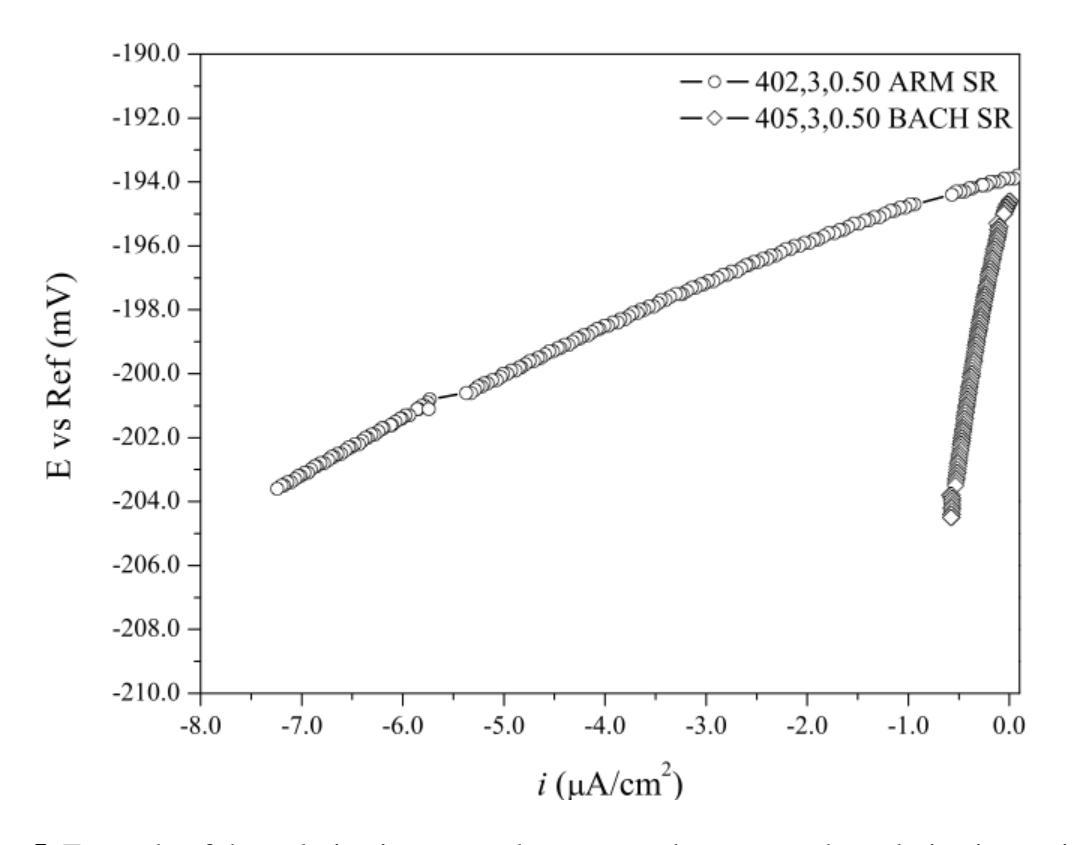
Figure 5. Example of the polarization curve that was used to extract the polarization resistance.

Figure 5 shows two typical examples of the polarization curve that were used to extract the polarization resistance, which was used to obtain the corrosion rate from the equation (1). The examples correspond to both microclimates, Armada (ARM SR) and Bachilleres (BACH SR) which are exposed at 100 m and 780 m from de seashore respectively.

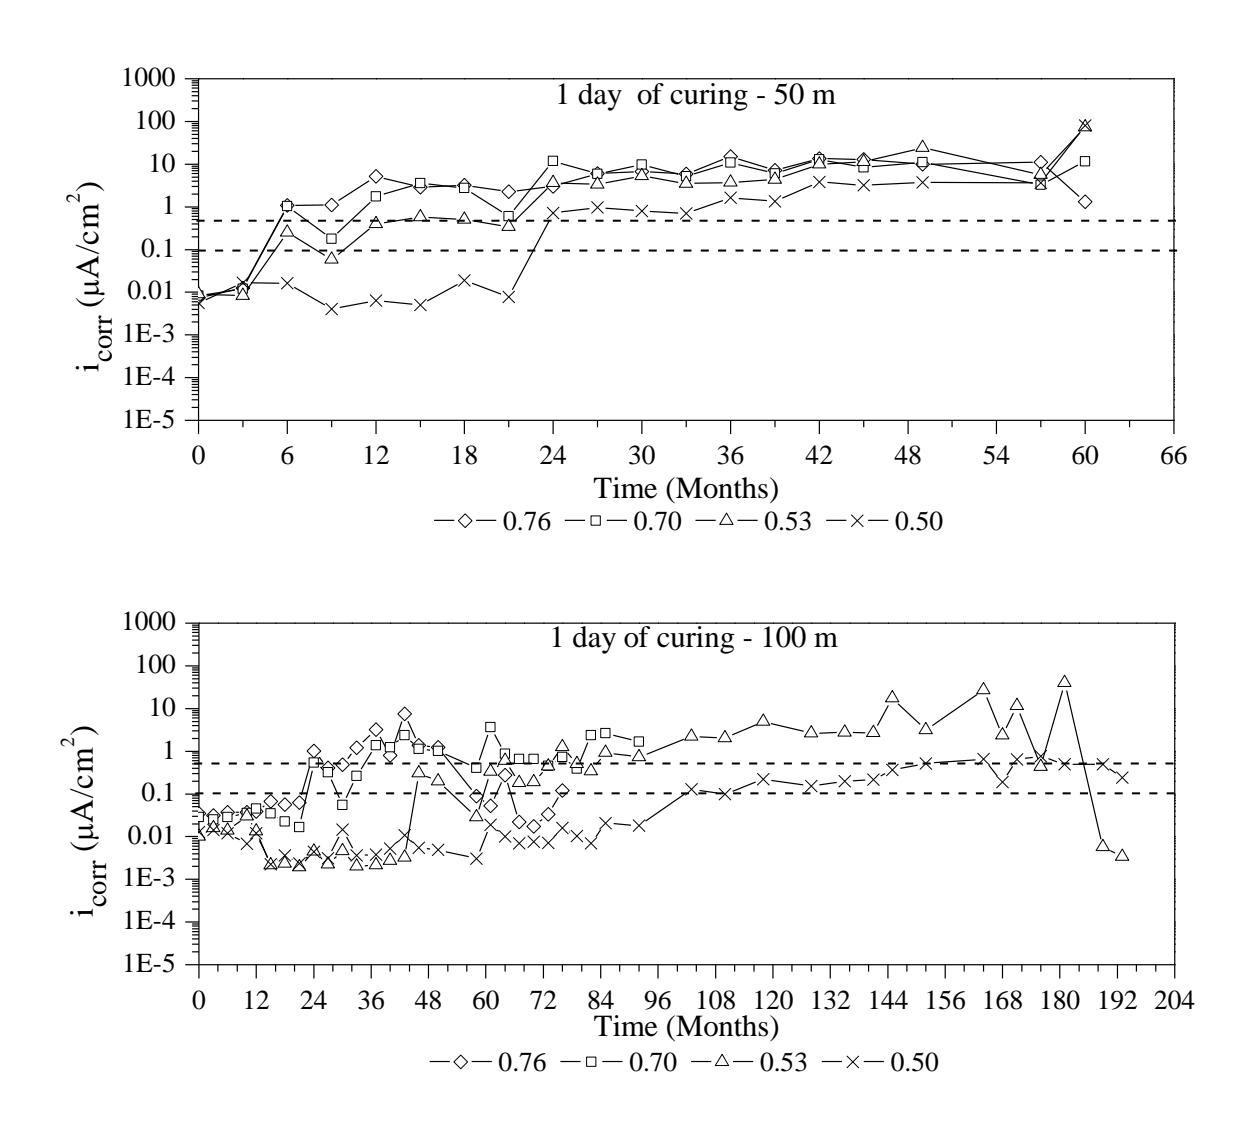
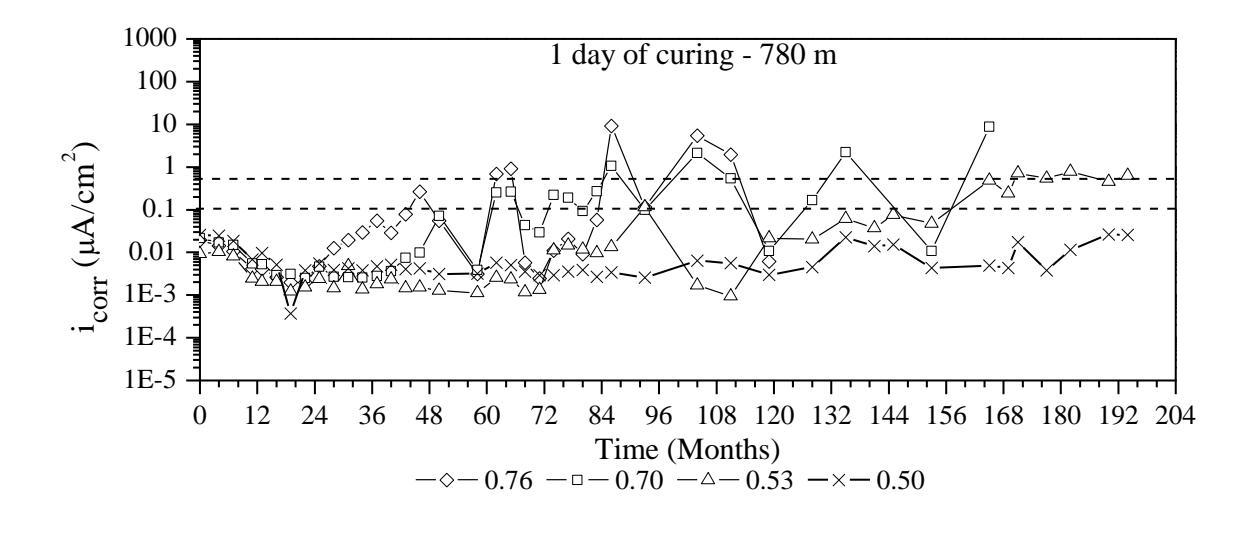
Figure 6. Corrosion rate to determine T1, 1-day curing concrete.

The corrosion initiation stage (T₁) was considered as the time between the concrete cylinders were placed at the test station and time which reinforcing steel depassivation occurred. In this investigation, depassivation is reached when i_{corr} values measured is $\geq 0.1 \ \mu\text{A/cm}^2$ [34]. Figure 6 shows typical performance of all w/c ratio concretes, 1-day curing (TC), and exposed to 50, 100, and 780 m test sites. This figure displays i_{corr} measurements vs. time of exposure (in months). It also shows two horizontal dotted lines (at 0.1 and 0.5 $\mu\text{A/cm}^2$), which correspond to the corrosion activation range. Therefore, the time estimate of active corrosion is reached when i_{corr} values were higher than this two horizontal threshold. Using these activation values, Figure 6 was built, showing the results (average of three cylinders per mixture) of corrosion initiation stage for all mixtures and exposure sites.

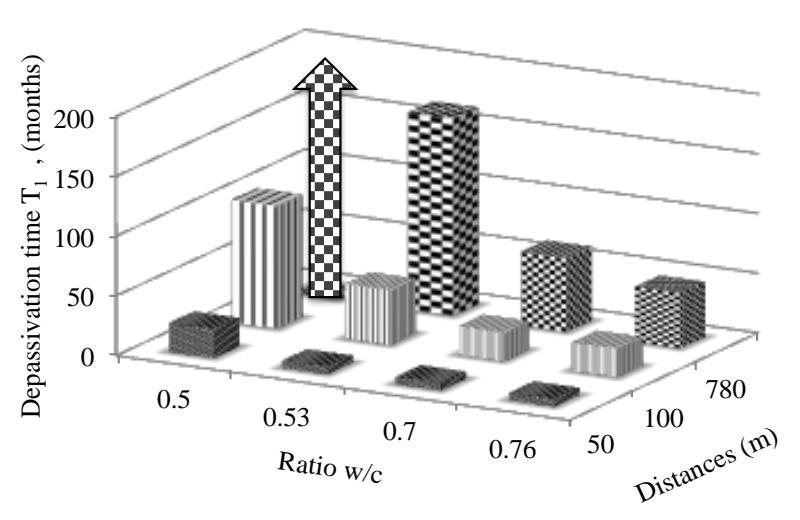
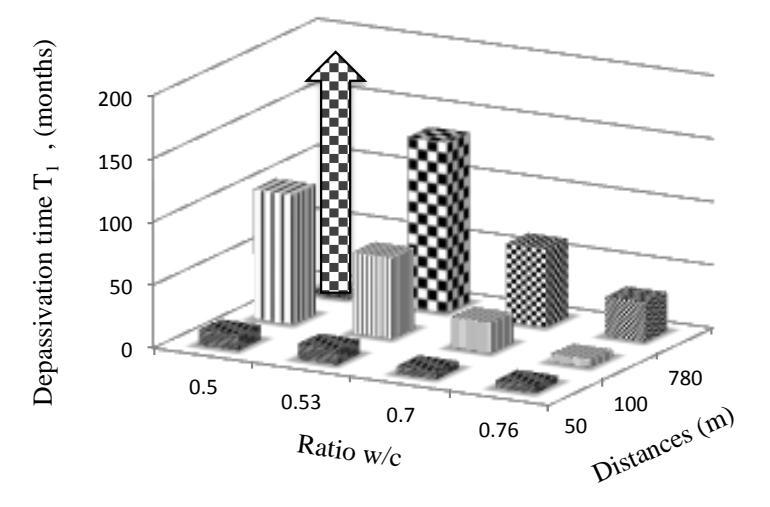
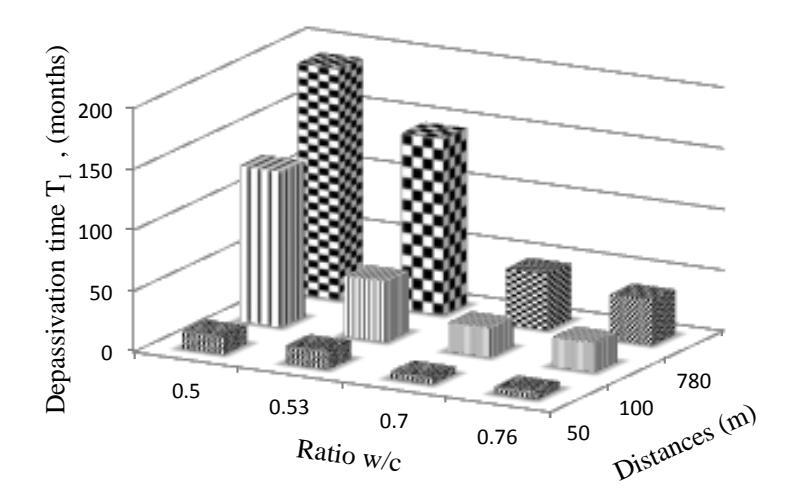
Figure 7. Average value of time (months) of depassivation, *T*₁, for specimens exposed to 50, 100 and 780 m from the seashore, different w/c ratios (0.50, 0.53, 0.70 and 0. 76), and three times of curing: (a) 1 day; (b) 3 days; (c) 7 days.

As observed in Figure 7a (concrete with 1-day curing), an apparent exponential correlation between T_1 and the water/cement ratio is observed regardless of the exposure site distance from the seashore: T_1 decreases by increasing the water/cement ratio. It was also possible to observe that in the cylinders at the 100 m and 780 m exposure sites, T_1 was quite larger than the 50 m exposure site results: 5 times higher at the 100 m site and 11 times higher at the 780 m than 50 m site.

A similar effect was observed for the 3-day curing time concrete (Figure 7b): T_1 values were 5 times greater for the 100 m and 780 m exposure sites than the 50 m exposure site. Same for the 7-day curing time (Figure 7c): T_1 values were 5 and 8 times greater for 100 m and 780 m exposure sites, respectively, than the 50 m exposure site. Arrows shown in figures 7a and 7b for 0.5 water/cement ratio at 780 m exposure site, indicate that the reinforcing steel still remains in a passive state.

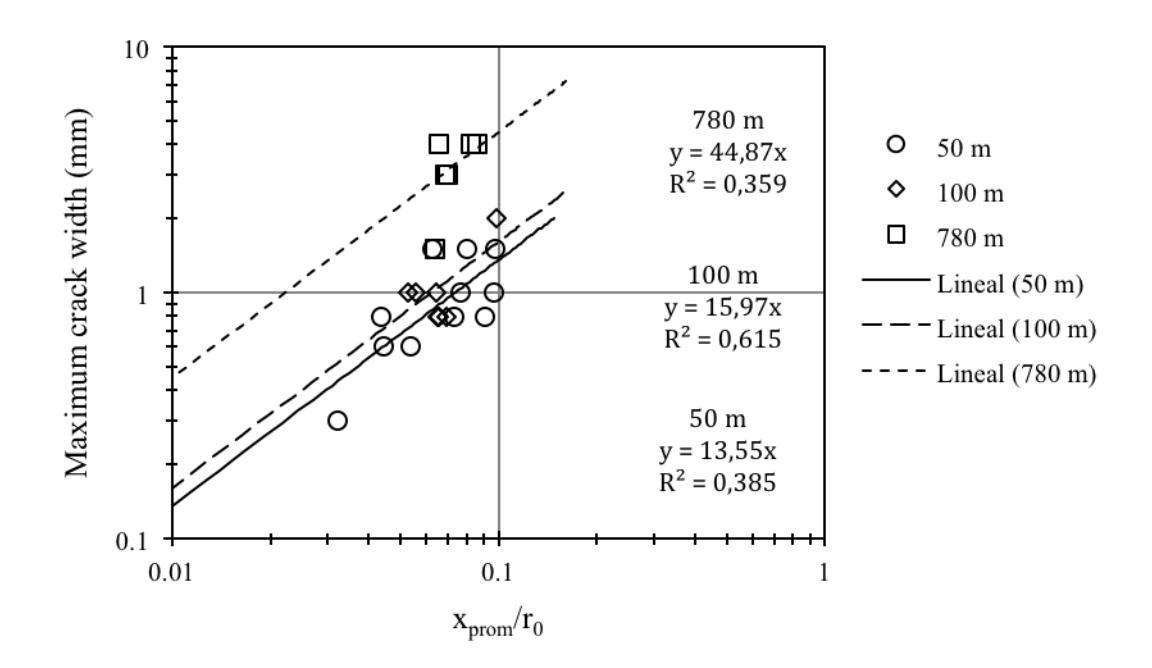
Figure 8. Comparison of the maximum width of crack against the loss of radio reinforcement for the different microclimates.

Figure 8 shows cross section ratio (x_{prom}/r_o) vs. maximum crack width (MCW) data measured on all the specimens evaluated in this research that have shown concrete cover cracking. Same figure shows the empirical correlations between x_{prom}/r_o and MCW according to the exposure site distance from seashore (50, 100, and 780 m), with the purpose of evaluating the effect of distance from seashore on these two parameters. As observed in Figure 8, x_{prom}/r_o values were located between 0.03 to 0.1 (3% to 10 %), regardless of exposure distance from the seashore.

As observed from this figure, the effect of seashore distance had a significant influence on cover concrete crack propagation (MCW), being the maximum values obtained at the 780 m exposure site, while the smallest MCW values correspond to the 50 m test site. With the trend lines can be seen that behavior, although the data collected so far are not sufficient to describe more clearly a general behavior. It is suggested that this behavior is influenced by the effect of concrete quality and the capacity to absorb internal stresses caused by the expansion of the corrosion products [36, 37]. The term, which relates this, is known as attenuation factor. The attenuation factor is define in this research as the ability of concrete to absorb expansive stresses, depending on the quality of the concrete, the mechanisms of corrosion and the environment in which exposes the concrete.

From data in Figure 8 it is clear to observe that this attenuation factor for the 780 m test data is higher than the one for the 50 m exposure site. This might be due to the fact that the corrosion product kinetics is a slower process, allowing the concrete to absorb a certain amount of tensile stresses generated by the expansion of the oxides. While in most of the accelerated corrosion experimentation, the generation of oxides is more rapid and concrete has almost no opportunity to absorb the expansion stresses generated, what gives rise to a sudden cracking. This is how the 50 m exposure site specimens performed, similar to an accelerated corrosion experimental procedure. In accordance with the foregoing, the evidence for natural corrosion from this investigation shows that the distance from the seashore has an effect on the crack width propagation, which could be related to the attenuation factor.

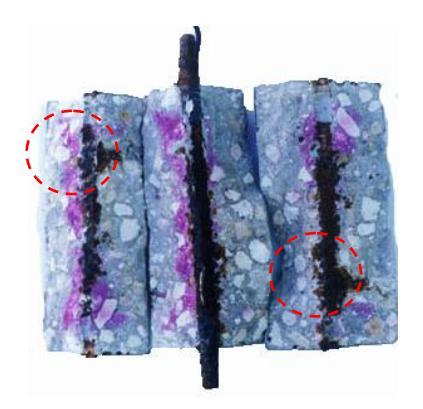
(a) 50 m, 1-day TC and 0.76 w/c

Figure 9. Migration of the corrosion products transported through the concrete cover pore network, for cylinders exposed in the various microclimates (50 m, 100 m and 780 m).

Perhaps this is due to the presence of moisture in the concrete, which may contribute to the migration of corrosion products away from the steel/concrete interface through the pore network, reliving the concrete from the corrosion expansion stresses. Figure 9 shows photographs of the corrosion products penetration in concrete around the reinforcing steel. Therefore, when moisture content in the concrete cover decreased at distances far from the seashore (780 m), i_{corr} may decrease also as compared with i_{corr} at shorter distances from seashore (50 m).

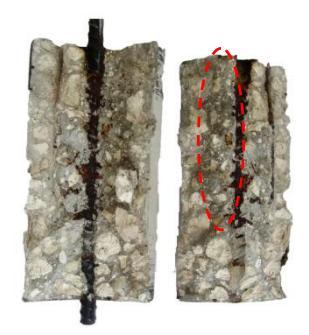
(b) 100 m, 1-day TC and 0.46 w/c

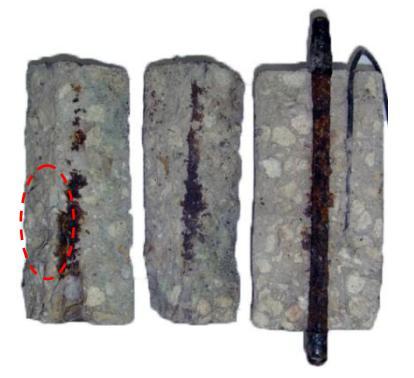
(c) 780 m, 3-day and 0.76 w/c
